**Accident**

<b>Aircraft Type and Registration:</b>	Exodus Deltajet 500 Stingray, G-CMMW
<b>No &amp; Type of Engines:</b>	1 BMW R1200 two-cylinder piston engine
<b>Year of Manufacture:</b>	2023 (Serial no: EA 006)
<b>Date &amp; Time (UTC):</b>	1 May 2024 at 1635 hrs
<b>Location:</b>	St Michael's Airfield, Lancashire
<b>Type of Flight:</b>	Private
<b>Persons on Board:</b>	Crew - 1                      Passengers - None
<b>Injuries:</b>	Crew - 1 (Serious)      Passengers - N/A
<b>Nature of Damage:</b>	Significant damage possibly beyond economic repair
<b>Commander's Licence:</b>	National Private Pilot's Licence
<b>Commander's Age:</b>	70 years
<b>Commander's Flying Experience:</b>	1,143 hours (of which 69 were on type) Last 90 days - 2 hours Last 28 days - 2 hours
<b>Information Source:</b>	Aircraft Accident Report Form submitted by the pilot and further enquiries by the AAIB

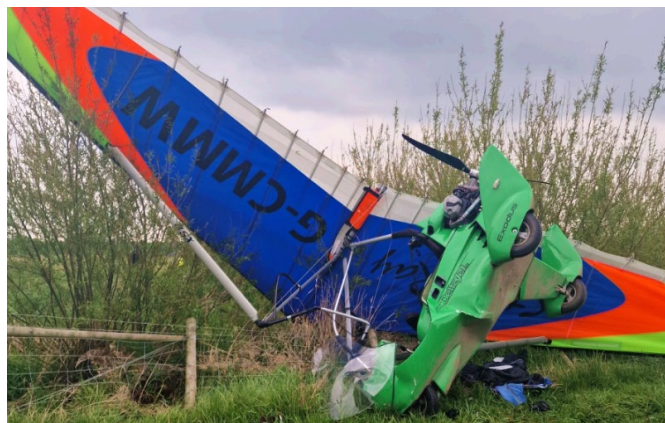
**Figure 1**

Shortly after takeoff, the engine foot throttle jammed with the engine at high rpm, so the pilot shut the engine down and prepared to return to the airfield. He believed he had sufficient height and speed to land safely. To reduce height, he carried out a turn which positioned him further away from the airfield than he intended. As he reached the boundary fence, the aircraft encountered a wind gradient, stalled and subsequently struck the ground. An image of the aircraft after the accident is shown in Figure 1. The pilot suffered serious leg injuries but commented that his injuries would have been much worse had he not been wearing his upper torso restraint and helmet. The cause of the throttle restriction could not be positively determined.

Image showing substantial damage to the fuselage and base bar
