AAIB Bulletin

11/2024

Aircraft Type and Registration:	Piper PA-28-181, G-BVNS
No & Type of Engines:	1 Lycoming O-360-A4M piston engine
Year of Manufacture:	1976 (Serial no: 28-7690358)
Date & Time (UTC):	23 April 2024 at 1503 hrs
Location:	1.5 miles from Prestwick Airport
Type of Flight:	Currency Check flight
Persons on Board:	Crew - 1 Passengers - 1
Injuries:	Crew - 1 (Serious) Passengers - 1 (Serious)
Nature of Damage:	Aircraft damaged beyond economic repair
Commander's Licence:	Light Aircraft Pilot's Licence
Commander's Age:	75 years
Commander's Flying Experience:	307 hours (of which 101 were on type) Last 90 days - 0 hours Last 28 days - 0 hours
Information Source:	AAIB Field Investigation

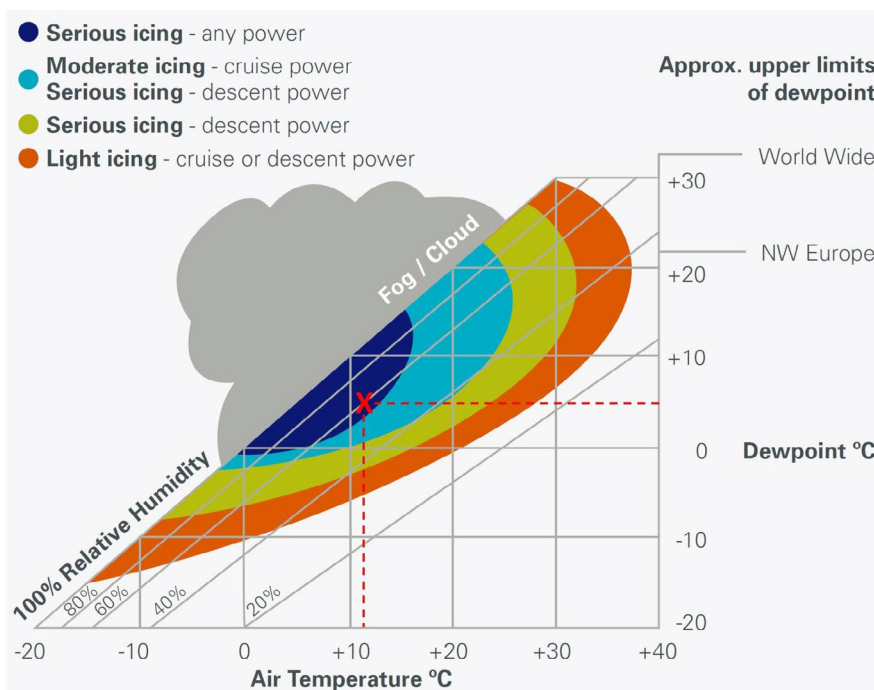
Figure 6

The temperature and dewpoint combination plotted on a CAA carburettor icing risk chart (Figure 6) from the CAA's Safety Sense Leaflet (SSL) 14 – *Piston Engine Icing*¹ indicates the conditions of the day would have created a serious risk of carburettor icing at any power.

CAA icing risk chart from SSL 14

The weather conditions at the time of the flight were such that there was a serious risk of carburettor icing at any power. The carburettor air inlet valve was found in the full cold position, indicating that carburettor heat was not selected. The valve installation is such that the valve could not have changed position when the aircraft struck the ground.

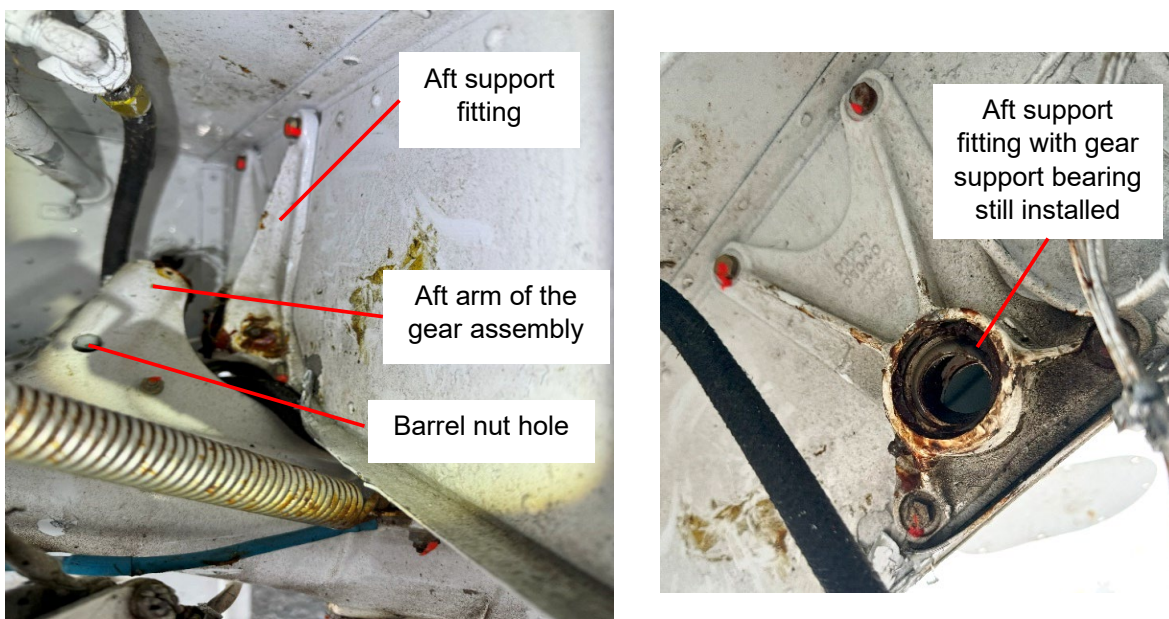
Figure 4

The aft support fitting was largely undamaged with the aft gear support bearing intact and still installed in the fitting (Figure 4). The aft arm of the gear assembly was located close to the support fitting but not connected by the retainer tube assembly that would have been fitted during the installation of the landing gear leg. Once the access panel in the lower surface of the wing adjacent to the wheel well was opened, the retainer tube assembly was found loose in the access space. The barrel nut for the tube assembly bolt was still in place in the hole forward of the aft arm of the gear assembly (Figures 2 and 4).

Looking upwards into the wheel bay at the aft support fitting (Left) and the undamaged fitting showing the intact gear support bearing still installed (Right)

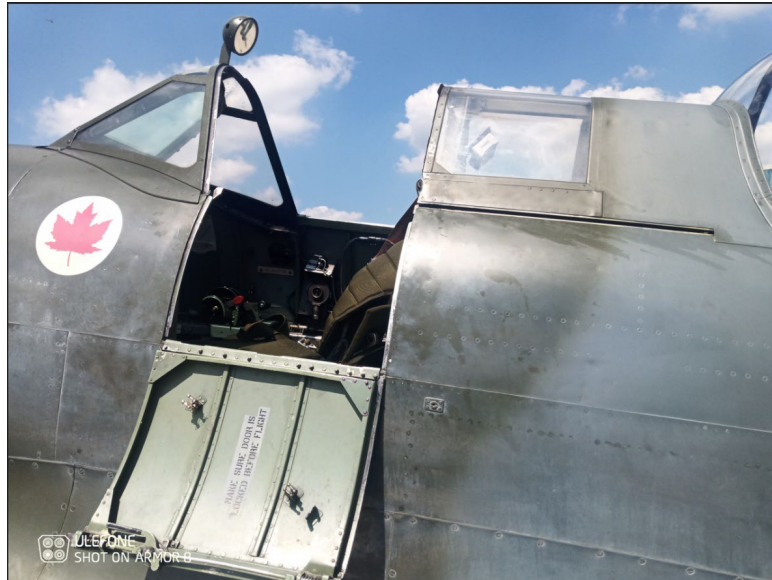
Figure 1

The aircraft was undamaged but at the time of reporting, the canopy which fell into fields adjacent to the airport, had not been recovered. The canopy of the rear cockpit, in which the passenger was sat, remained securely latched through the flight.

G-BMSB after landing showing absent front canopy and open cockpit side door

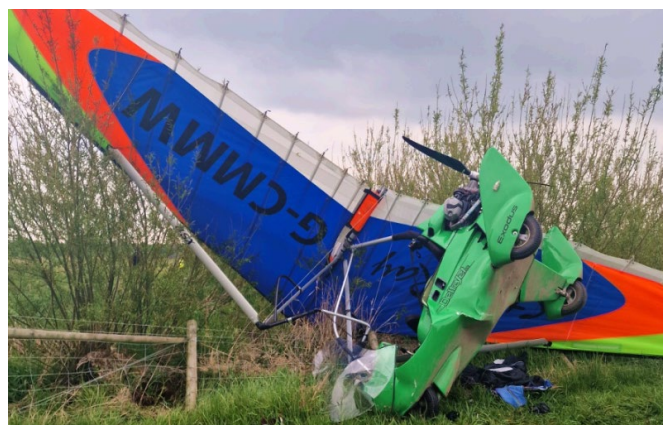
Figure 1

Shortly after takeoff, the engine foot throttle jammed with the engine at high rpm, so the pilot shut the engine down and prepared to return to the airfield. He believed he had sufficient height and speed to land safely. To reduce height, he carried out a turn which positioned him further away from the airfield than he intended. As he reached the boundary fence, the aircraft encountered a wind gradient, stalled and subsequently struck the ground. An image of the aircraft after the accident is shown in Figure 1. The pilot suffered serious leg injuries but commented that his injuries would have been much worse had he not been wearing his upper torso restraint and helmet. The cause of the throttle restriction could not be positively determined.

Image showing substantial damage to the fuselage and base bar
