AAIB Bulletin

11/2024

Published: 14 November 2024.

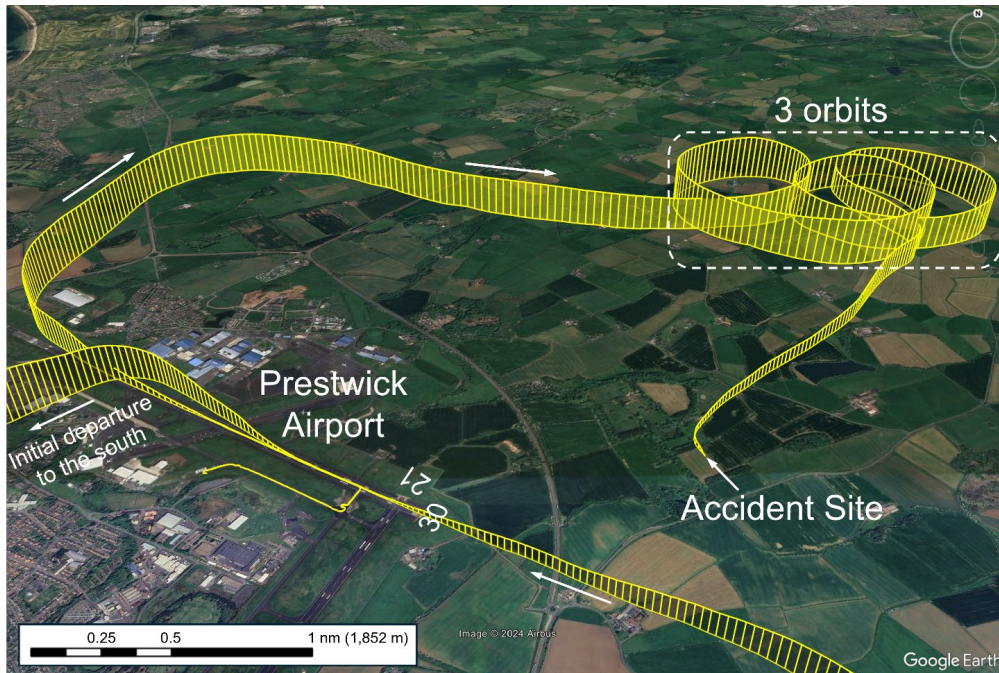
Figure 3

The CFI was using a flight-planning and navigation app on his mobile phone which recorded the aircraft's GPS flight path (Figure 3). The figure highlights the three orbits flown at the end of the downwind leg of the circuit and the proximity of the crash site from the airport.

Flight path of right hand circuit with downwind orbits highlighted

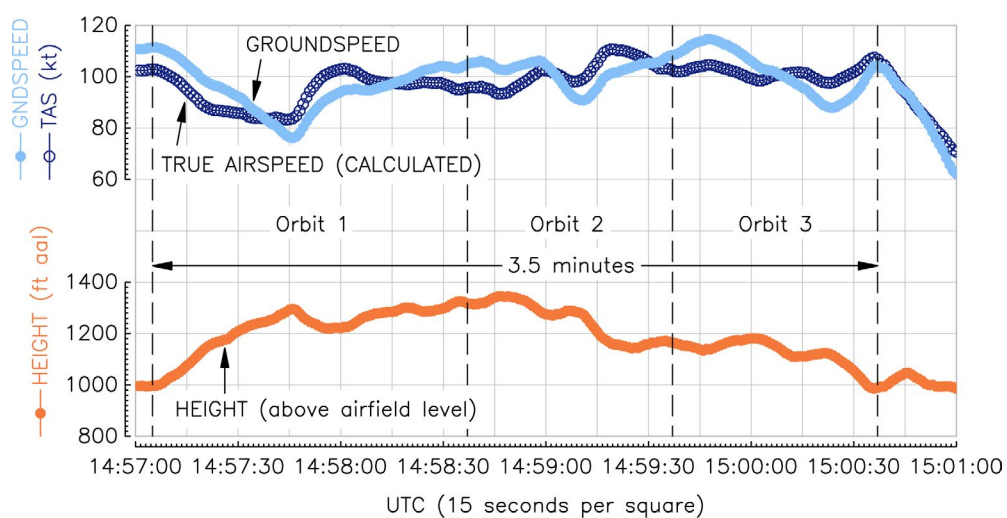
Figure 4

The orbits were flown over a period of 3.5 minutes during which the aircraft climbed and descended about 300 ft. The airspeed varied between about 83 and 110 kt (Figure 4).

GPS derived data for the three orbits

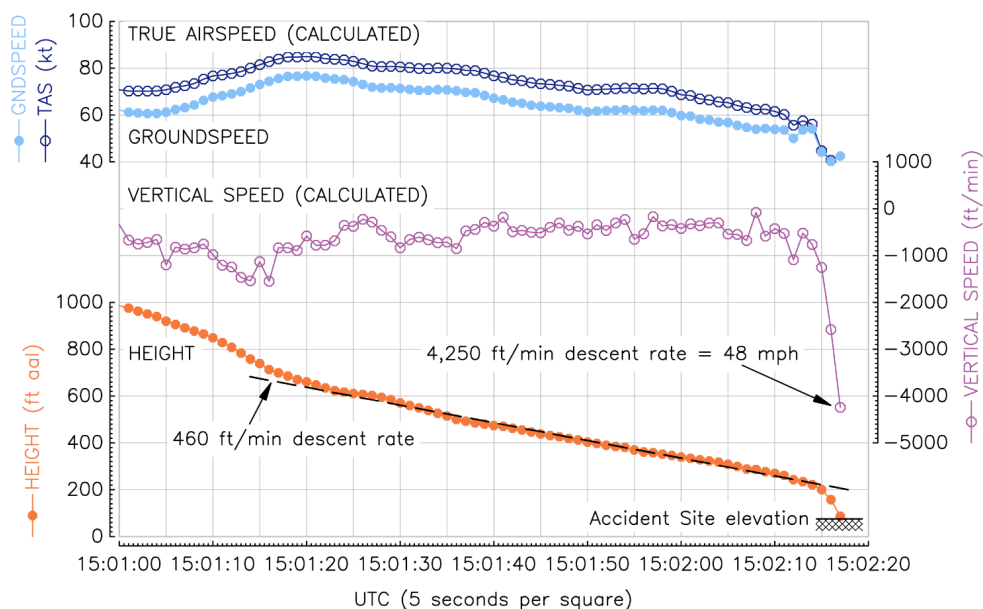
Figure 5 plots data for the descent starting with the aircraft descending through 1,000 ft amsl (980 ft aal and about 600 ft agl) on base, at about 800 ft/min, just under 2 nm from the threshold of Runways 21 and 30. The descent rate reduced to about 460 ft/min for the remaining 60 seconds of the descent, during which the airspeed reduced from 85 to below 60 kt. The aircraft then struck the tree, after which it descended towards the ground at about 4,250 ft/min (equivalent to 48 mph).

Figure 5
GPS derived data for the descent

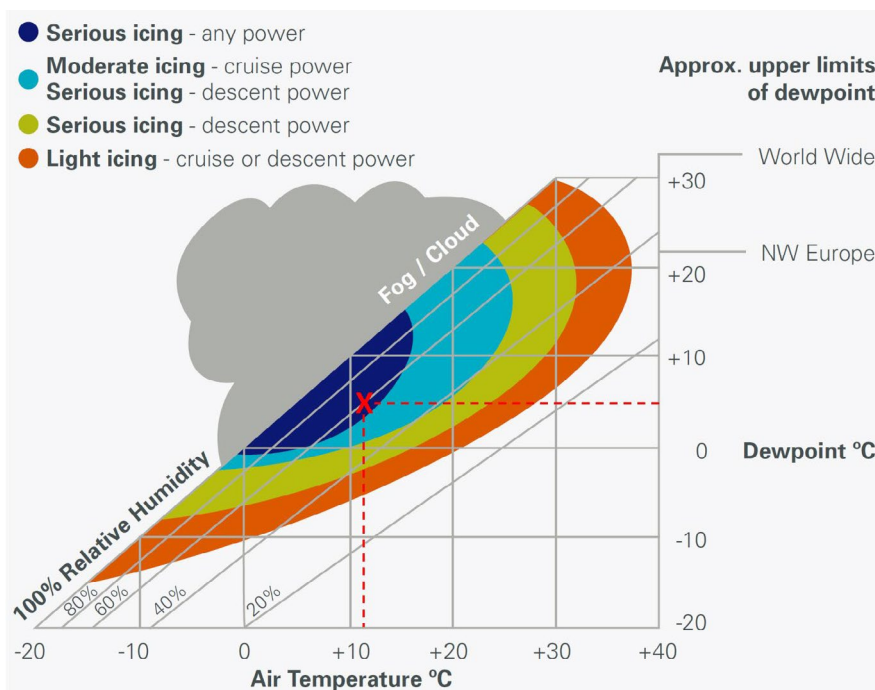
Figure 6

The temperature and dewpoint combination plotted on a CAA carburettor icing risk chart (Figure 6) from the CAA's Safety Sense Leaflet (SSL) 14 – *Piston Engine Icing*¹ indicates the conditions of the day would have created a serious risk of carburettor icing at any power.

CAA icing risk chart from SSL 14

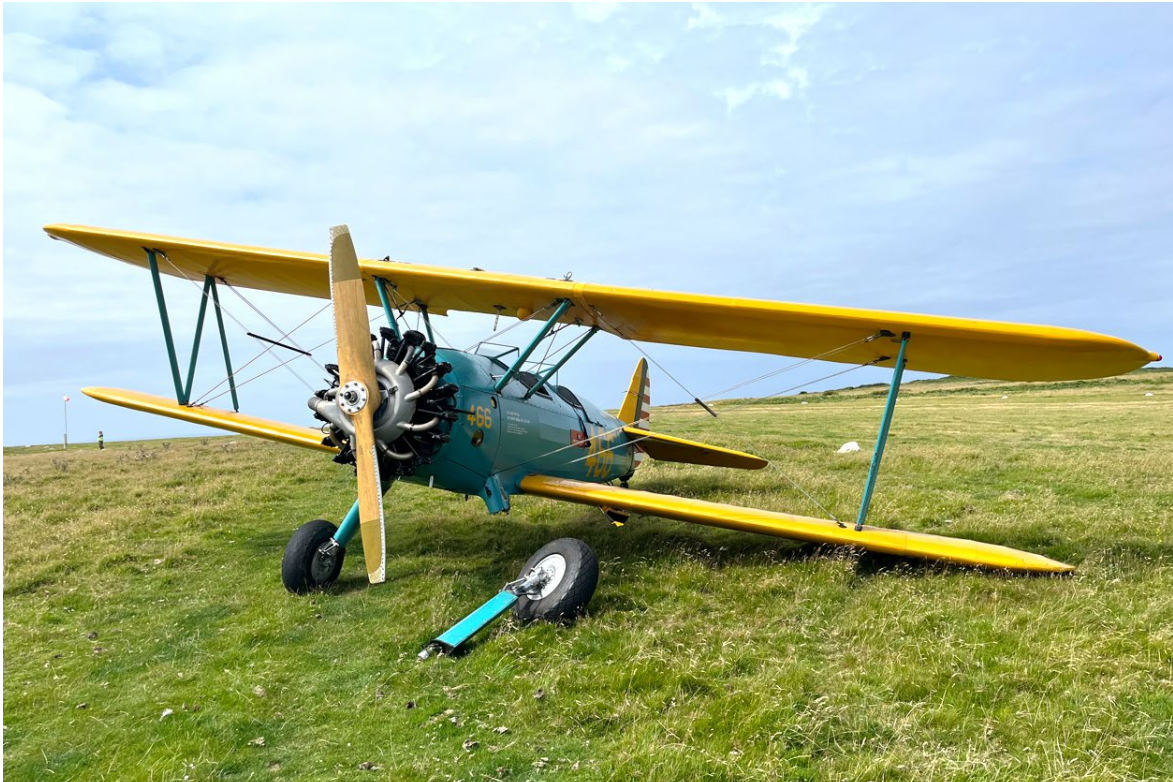
Figure 1

G-PTBA after the accident, with white-painted runway edge marker rocks visible behind

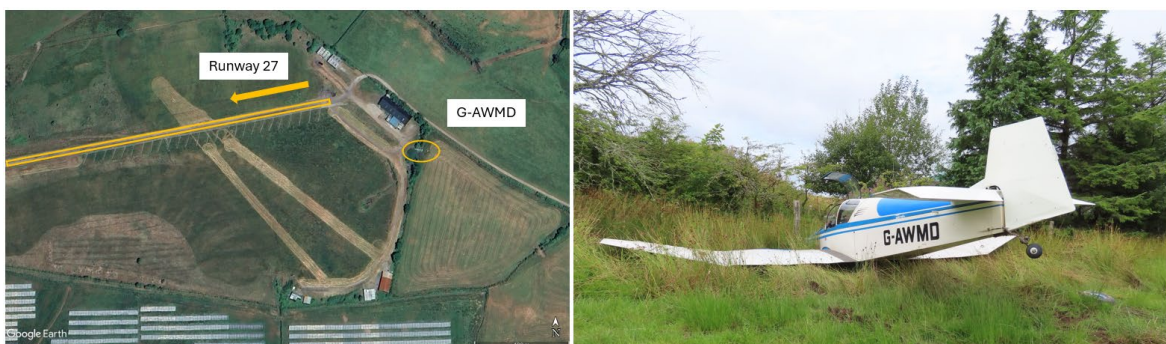
Figure 1

The pilot was practising approaches to Runway 27R at Rhigos airfield when, on the second approach, he reduced throttle and set the carburettor heat to ON. Shortly afterwards the engine stopped, and he noticed that fuel mixture had been cut instead of the carburettor heat being set to ON. He reset the mixture to RICH and tried restarting the engine, but it only ran for a few seconds, by which time he was slow and low on final approach. The aircraft struck a bank which formed part of the airfield boundary (Figure 1) and the pilot suffered serious facial and spinal injuries.

Rhigos Airfield and G-AWMD at the accident site

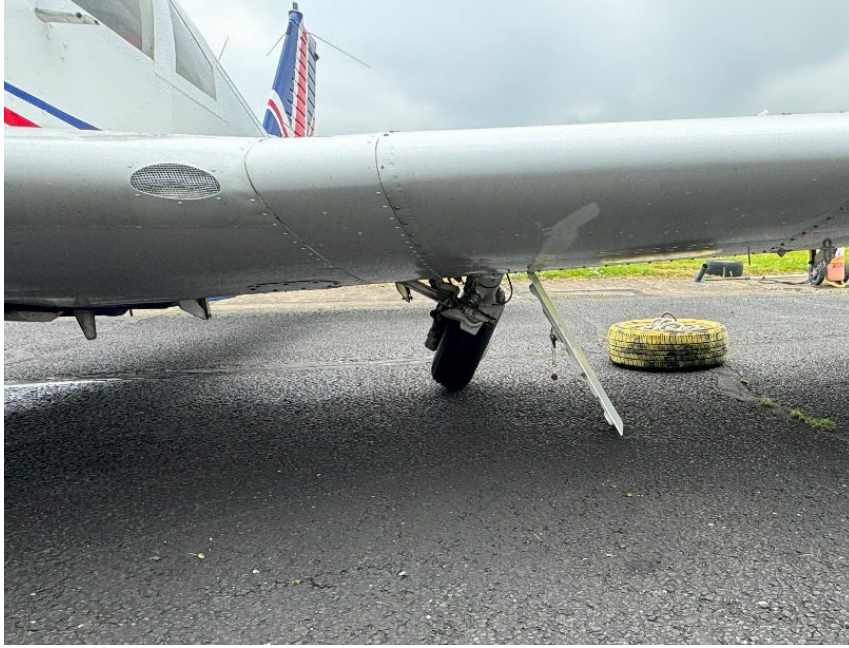
Figure 1

The pilot had completed a 50 hr check and planned to go for a short local flight. He taxied to hold C of Runway 05 to carry out engine checks, but as he turned left into the wind, he heard a loud thud and the left wing dropped. He shut down the engine, turned off the master switch and, uninjured, vacated the aircraft. External visual inspection confirmed that the left main landing gear had collapsed. Contrary to the pilot's expectation, however, the leg had not folded inwards as it would during a retraction, but instead it was pointing aft (Figure 1).

Left main landing gear collapsed rearwards

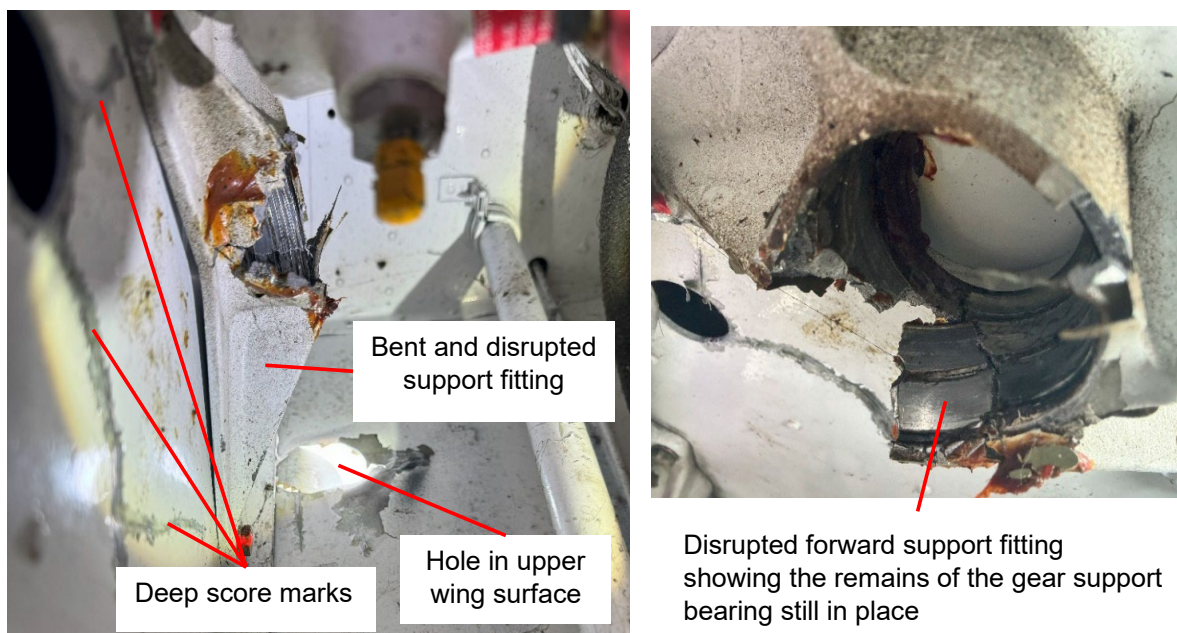
Figure 3

Inside the left wheel well, the landing gear was found mechanically disconnected from the wing. The forward support fitting was disrupted around the gear support bearing with parts of the bearing missing but some fractured remains still in the bracket (Figure 3). The centre of the forward support fitting was bent away from the wing spar and a hole had been punched through the upper surface of the wing. There were also deep score marks around a circular cut-out in the web of the spar.

Looking upwards into the wheel bay at the forward support fitting (Left) and the disrupted fitting with the remains of the bearing still in place (Right)

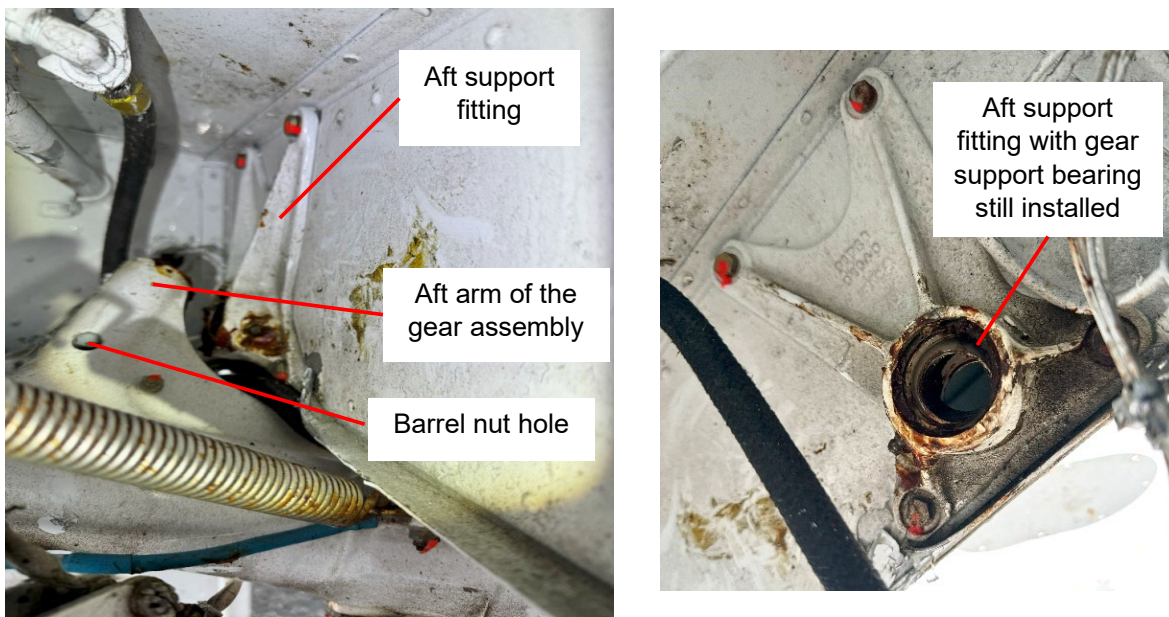
Figure 4

The aft support fitting was largely undamaged with the aft gear support bearing intact and still installed in the fitting (Figure 4). The aft arm of the gear assembly was located close to the support fitting but not connected by the retainer tube assembly that would have been fitted during the installation of the landing gear leg. Once the access panel in the lower surface of the wing adjacent to the wheel well was opened, the retainer tube assembly was found loose in the access space. The barrel nut for the tube assembly bolt was still in place in the hole forward of the aft arm of the gear assembly (Figures 2 and 4).

Looking upwards into the wheel bay at the aft support fitting (Left) and the undamaged fitting showing the intact gear support bearing still installed (Right)

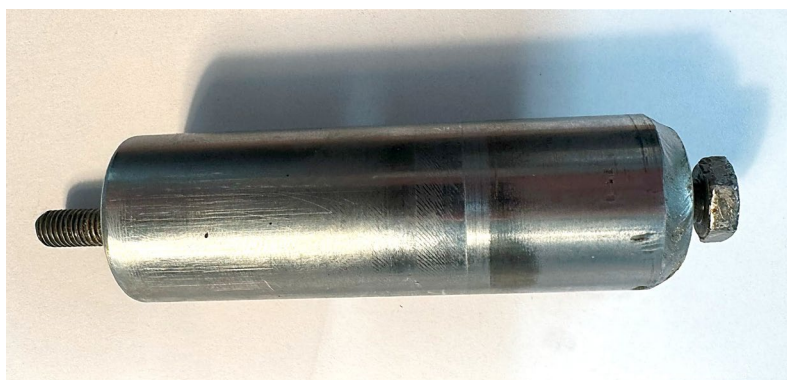
Figure 5

Although the tube assembly showed some signs of wear, the bolt was intact (Figure 5). The thread of the bolt and the barrel nut were also undamaged but with some signs of wear. The barrel nut and tube assembly bolt were screwed back together successfully with no play evident.

Retainer tube assembly and bolt

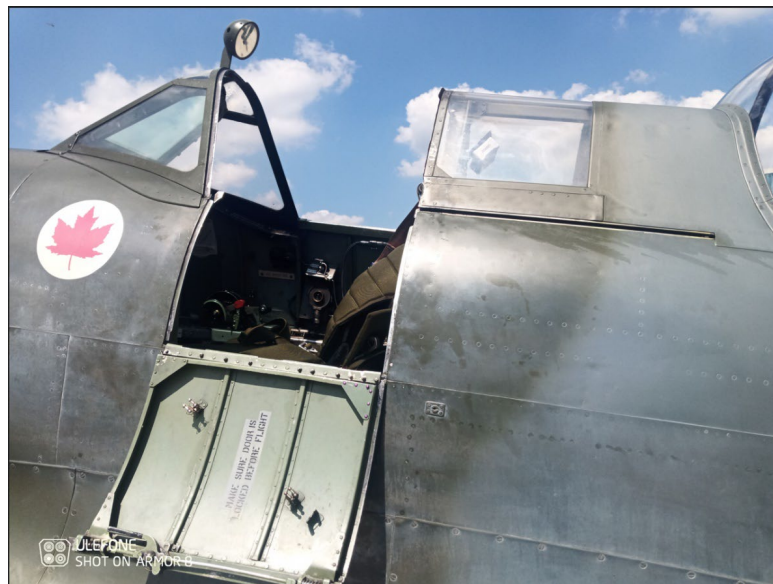
Figure 1

The aircraft was undamaged but at the time of reporting, the canopy which fell into fields adjacent to the airport, had not been recovered. The canopy of the rear cockpit, in which the passenger was sat, remained securely latched through the flight.

G-BMSB after landing showing absent front canopy and open cockpit side door

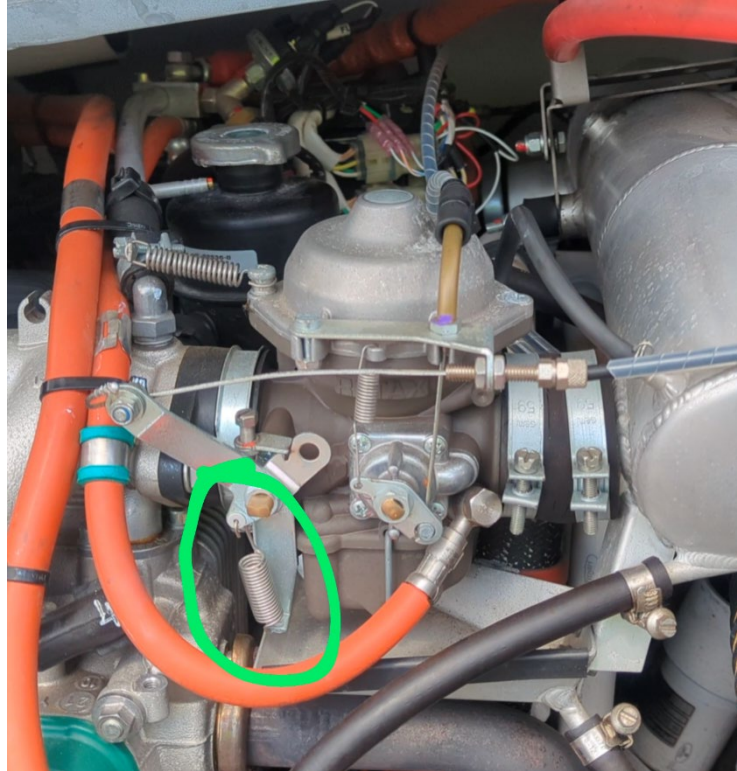
Examination of the aircraft found the left carburettor throttle butterfly valve spring was missing. This led to an imbalance between the two carburettors and resulted in the power loss. The cable operated throttle system relies on the butterfly valve spring tension to open the throttle as power demands are made when the hand control is pushed forwards in the cockpit. To close the throttle, the hand control is pulled rearwards against spring pressure. Without the spring there can be a tendency for the throttle cable to 'buckle' rather than move the butterfly valve lever which is what happened in this case. Figure 1 shows the system with the spring present.

Cable, throttle and spring system (picture courtesy of the pilot)

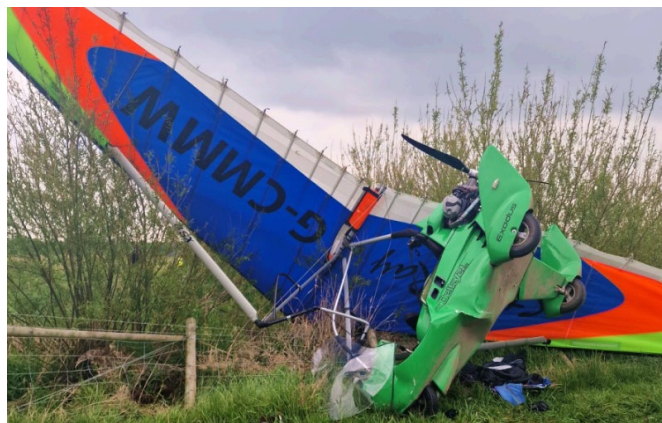
Figure 1

Shortly after takeoff, the engine foot throttle jammed with the engine at high rpm, so the pilot shut the engine down and prepared to return to the airfield. He believed he had sufficient height and speed to land safely. To reduce height, he carried out a turn which positioned him further away from the airfield than he intended. As he reached the boundary fence, the aircraft encountered a wind gradient, stalled and subsequently struck the ground. An image of the aircraft after the accident is shown in Figure 1. The pilot suffered serious leg injuries but commented that his injuries would have been much worse had he not been wearing his upper torso restraint and helmet. The cause of the throttle restriction could not be positively determined.

Image showing substantial damage to the fuselage and base bar
