Investigation into Seven Sisters PTI Incident

Presented by Ryan Dearlove - Operations Development Manager

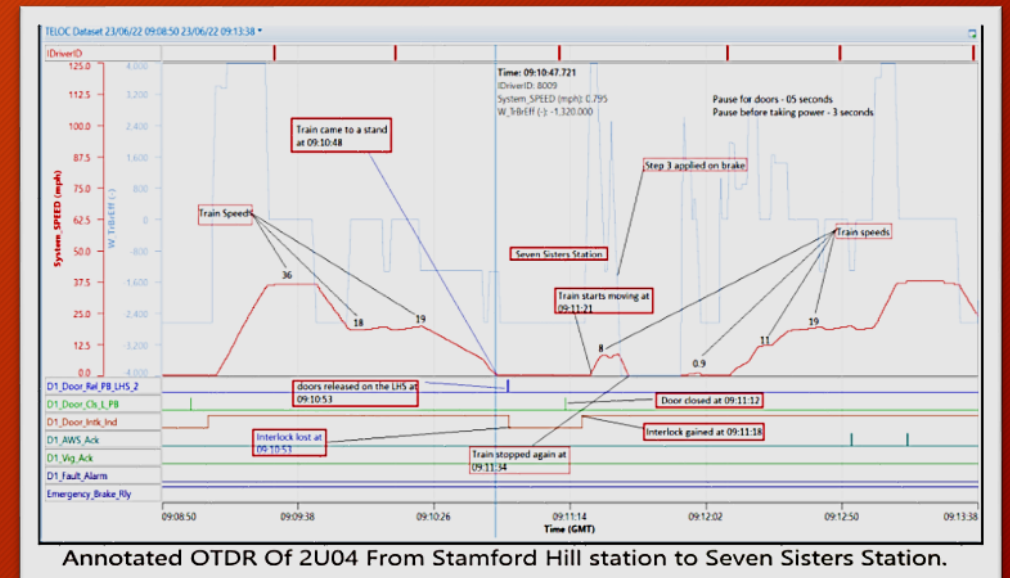
- 2U04 arrives at Seven Sisters Station platform 2 at approx. 09:10:48, (23min later than booked due to disruptions experienced earlier as well as additional passengers during LU strike)
- The passenger saloon doors were released at approx. 09:10:53.
- 2U04 was stationary at Seven Sisters Station with the passenger saloon doors released for 25sec, with the driver operating the door close button at 09:11:12, and gaining traction interlock at 09:11:18.

Annotated OTDR Of 2U04 From Stamford Hill station to Seven Sisters Station.

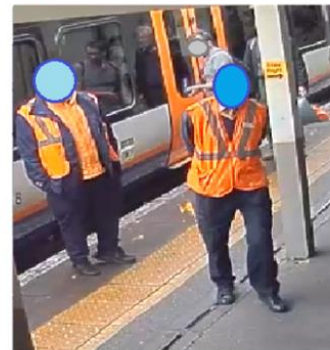
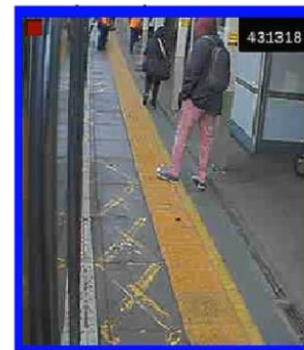
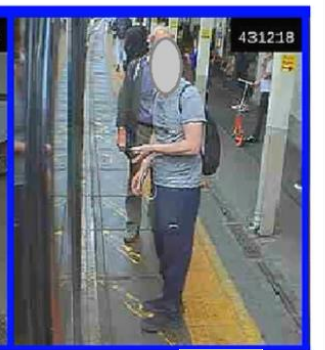
Figure: 9

Results Of Test On Camera Alignment; **Indicating DOO Camera 431318 Is Out Of Alignment.**

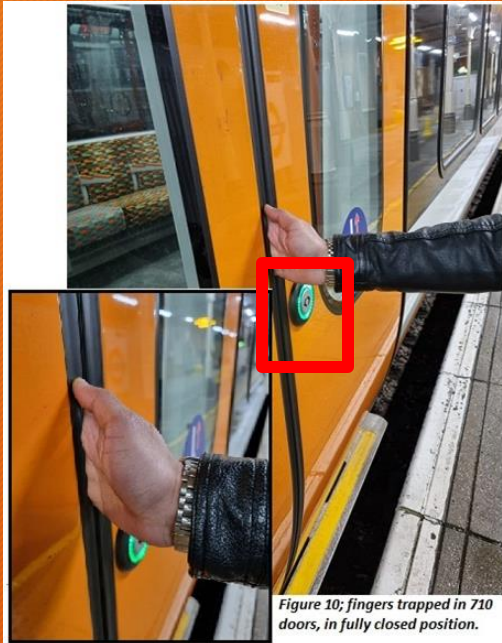
Figure 10; fingers trapped in 710 doors, in fully closed position.

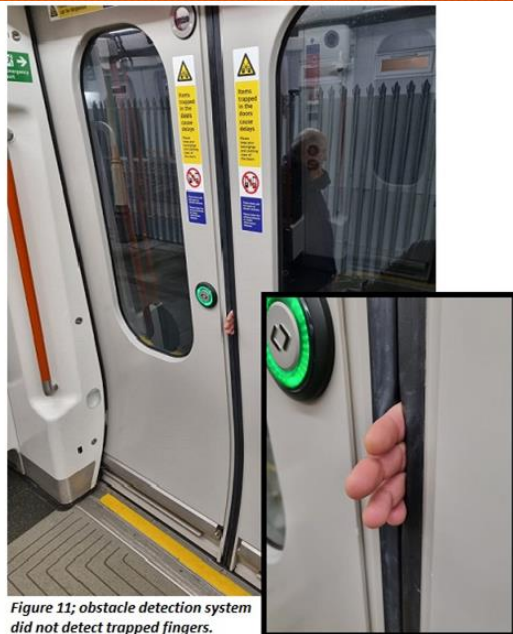
Figure 11; obstacle detection system did not detect trapped fingers.

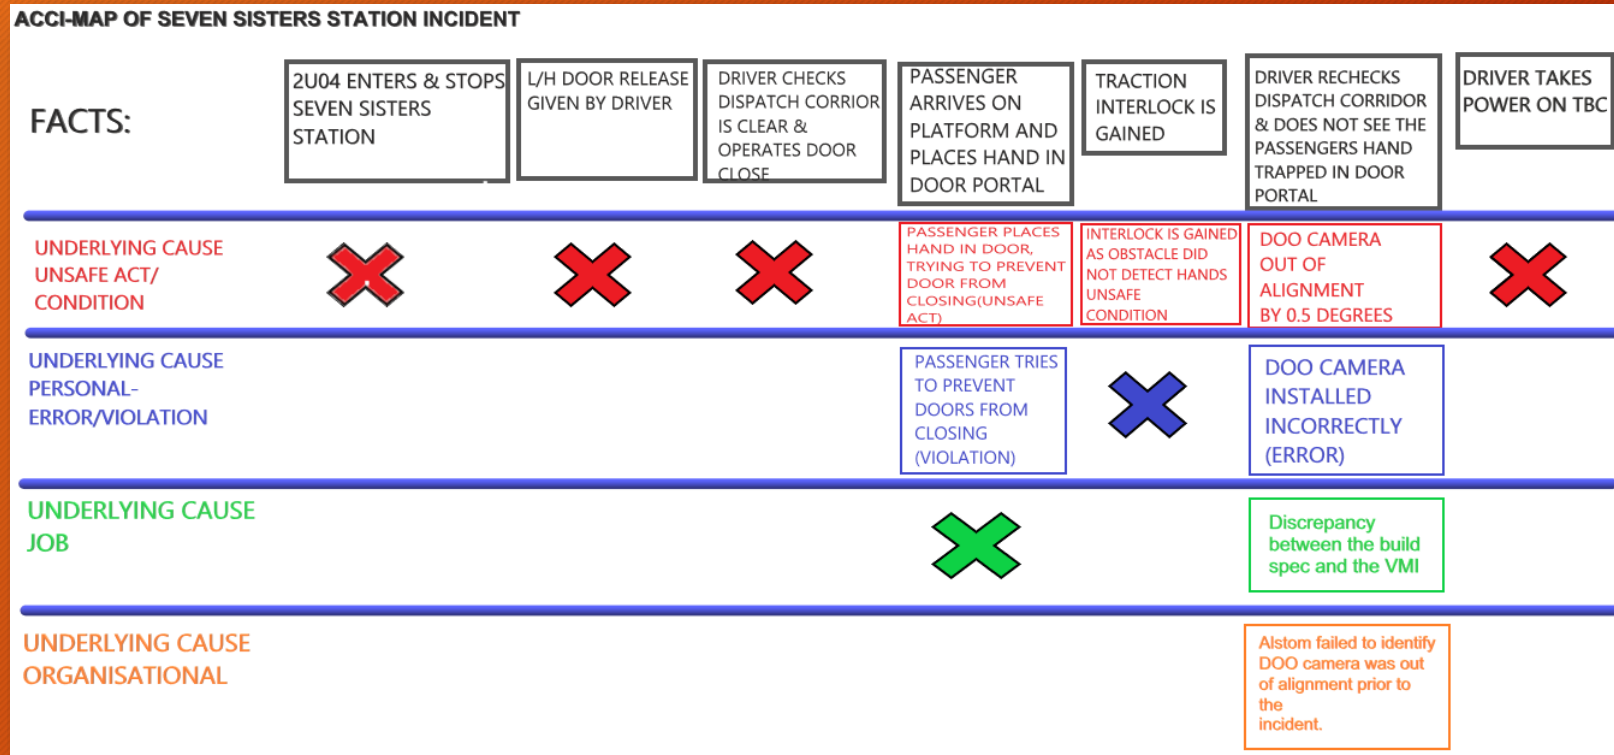
Acci-map of incident is produced

- PTI brief for all drivers - All ARL drivers to receive further brief for platform train interface risks.
- Added to safety plans and reviewed in QA plan of assessments - Limitations of OTDR assessments.
- Review of Change management process of stations staff.
- Fleet checks.
