Accident

Aircraft Type and Registration:	Eurofox 912(S), G-CIEF	
No & Type of Engines:	1 Rotax 912ULS piston engine	
Year of Manufacture:	2014 (Serial no: LAA 376-15218)	
Date & Time (UTC):	26 July 2023 at 1115 hrs	
Location:	Approx 1 mile to the east of Darlton Airfield, near Retford, Nottinghamshire	
Type of Flight:	Private	
Persons on Board:	Crew - 1	Passengers - None
Injuries:	Crew - 1 (Fatal)	Passengers - N/A
Nature of Damage:	Aircraft Destroyed	
Commander's Licence:	Light Aircraft Pilot's Licence	
Commander's Age:	75 years	
Commander's Flying Experience:	719 hours Last 90 days - 12 hours Last 28 days - 2 hours	
Information Source:	AAIB Field Investigation

Synopsis

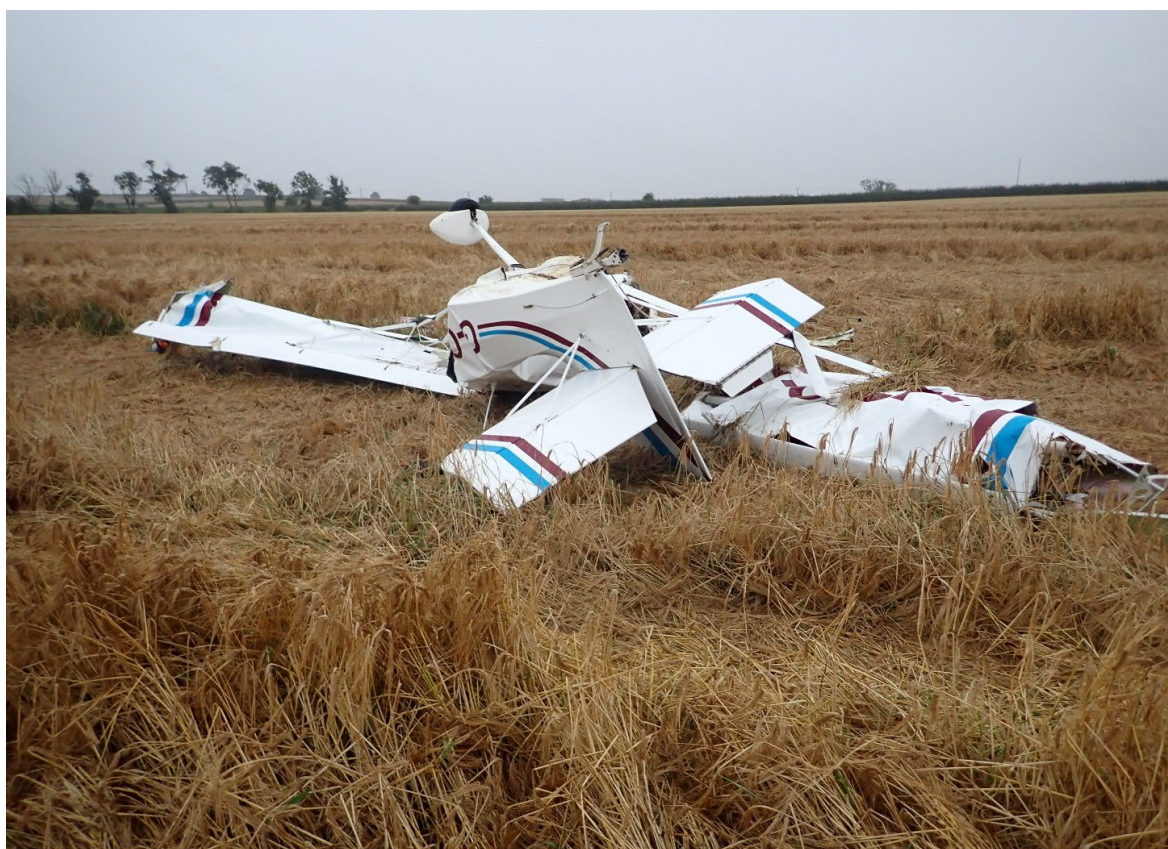
Figure 1
Accident site

The accident site was in a crop field (Figure 1). There was an initial witness mark on the ground which was made by the left wing then a small debris trail which led to the main accident site. Due to the high energy involved, the aircraft suffered structural break up as it hit the ground before finally coming to rest inverted approximately 33 metres from the initial impact point. There was no fire at the scene and fuel was recovered from both wing tanks.

The damage observed to the structure of the aircraft was consistent with an accident sequence that commenced with the left wing striking the ground first, and this correlated with the dashcam footage. All other damage observed was assessed to be due to the impact forces. There was no evidence of fatigue failure of primary or secondary structures that would have affected the integrity of the aircraft structure in flight.

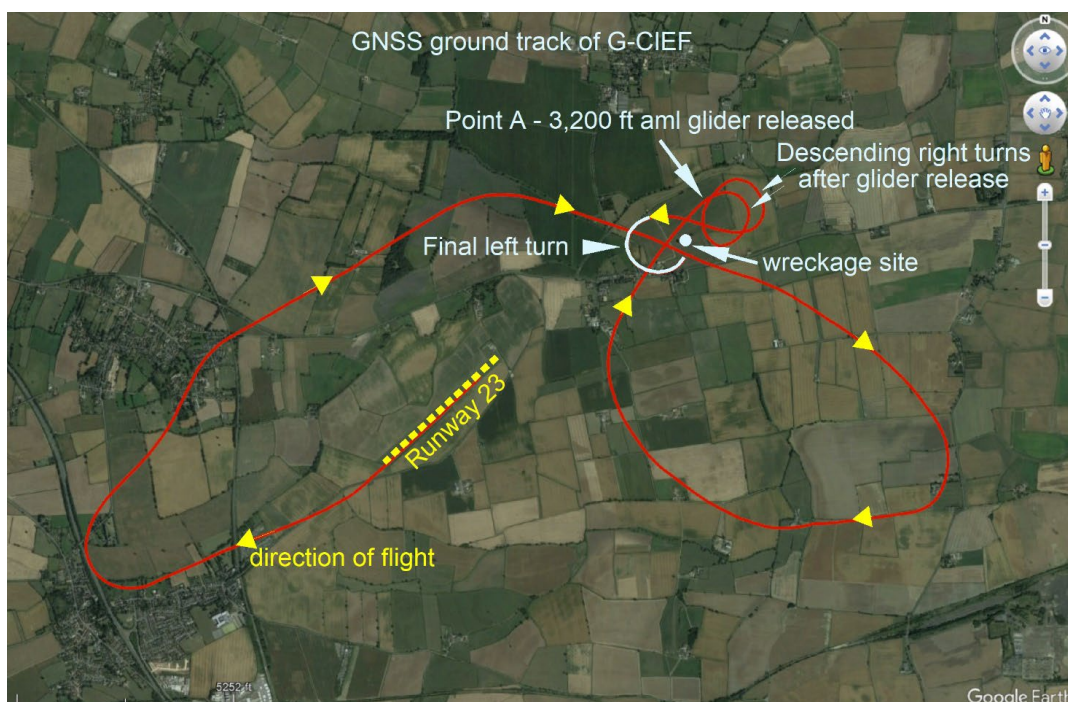
Figure 2

The aircraft and aerotow glider took off from Runway 23 at 1107 hrs and flew to the east of the airfield where they climbed to 3,200 ft amsl, at which point the glider released (Figure 2 and Figure 3, Point A). G-CIEF then made a descending right turn. Its descent rate initially reached about 3,000 ft/min but then gradually reduced to 2,200 ft/min as it completed a turn through 360°. The right turn continued for a further 270° at which point the aircraft started to roll out of the turn at an altitude of about 1,400 ft amsl. The bank angle during the right turns reached about 45°.

The aircraft continued to descend and at about 1,100 ft amsl (~1,050 ft agl) it entered a left turn (Figure 2 Point B, Figure 3 and 4). Its groundspeed was 75 kt (an estimated airspeed of about 80 kt based on a wind from 230° at 11 kt) and the descent rate was approximately 1,800 ft/min. As the turn continued, the estimated bank angle of the aircraft increased progressively at an average rate of about 2°/s.

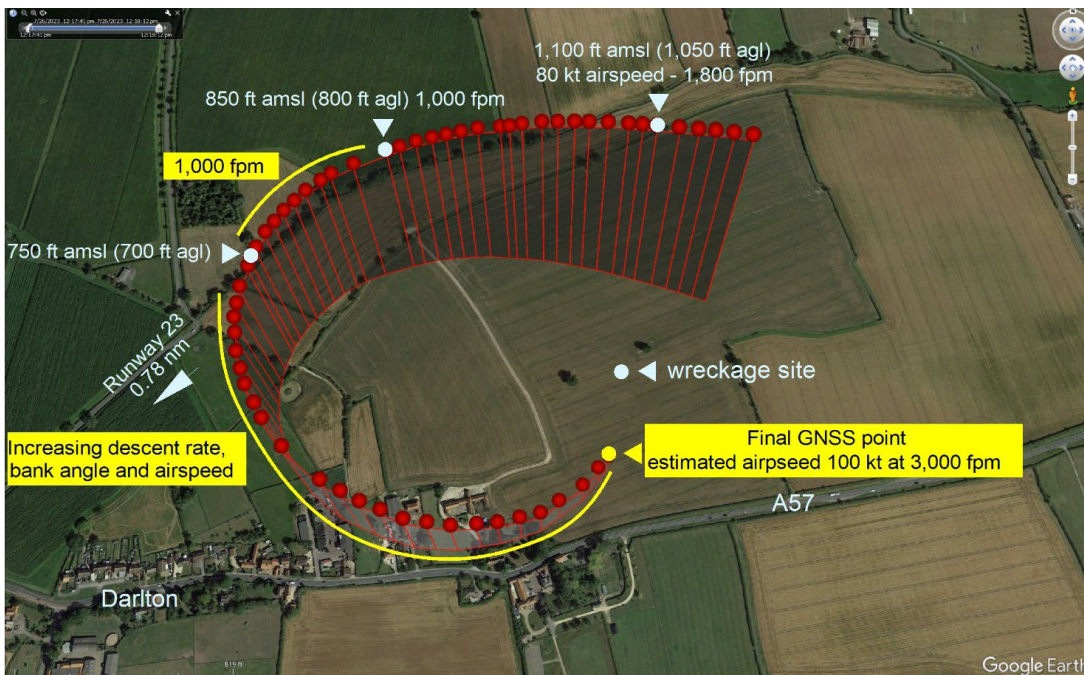
Figure 4
Final descending turn

When the aircraft was at about 850 ft amsl (~800 ft agl) the data indicates that the descent rate had briefly reduced to about 1,000 fpm (Figure 4 and 5) but shortly thereafter started to increase again. The aircraft's bank angle at this point was estimated to have been about 30° and the normal load was approximately 1.15 g. The aircraft continued to descend, during which its rate of descent, calculated airspeed, bank angle and load factor continued to progressively increase.

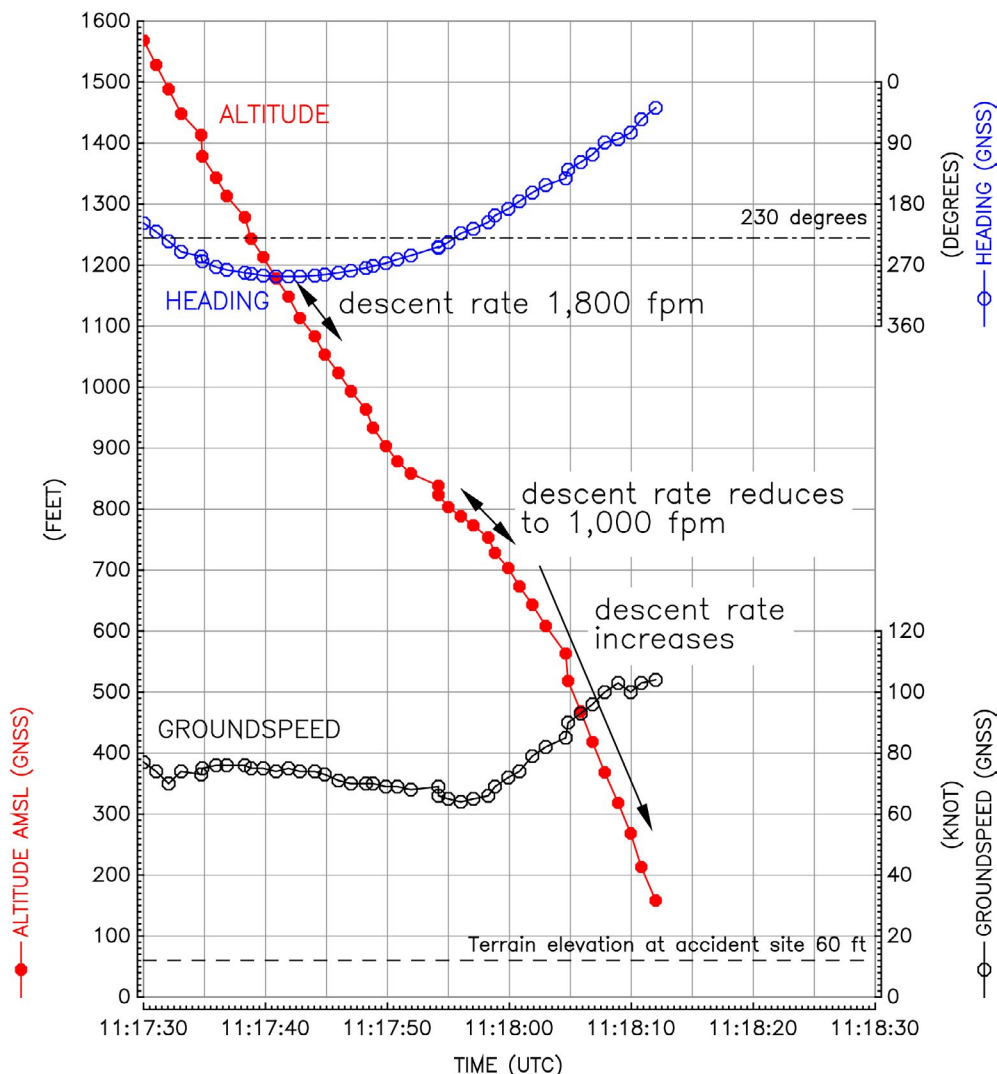
Figure 5
Plot of final descending turn

The final recorded GNSS data point was recorded at 1118:12 hrs, which was shortly before the aircraft struck the ground. It was estimated that the aircraft's descent rate was about 3,000 ft/min, its airspeed was approximately 100 kt, the bank angle was about 55° left wing down and the normal load was nearly 2 g.
