Serious Incident

Aircraft Type and Registration:	Boeing 737-8200, EI-HET	
No & Type of Engines:	2 CFM LEAP-1B27 turbofan engines	
Year of Manufacture:	2019 (Serial no: 62310)	
Date & Time (UTC):	4 December 2023 at 1103 hrs	
Location:	London Stansted Airport	
Type of Flight:	Commercial Air Transport (Passenger)	
Persons on Board:	Crew - 4	Passengers - 122
Injuries:	Crew - None	Passengers - None
Nature of Damage:	None	
Commander's Licence:	Airline Transport Pilot's Licence	
Commander's Age:	46 years	
Commander's Flying Experience:	5,300 hours (of which 2,800 were on type) Last 90 days - 235 hours Last 28 days - 29 hours	
Information Source:	AAIB Field Investigation

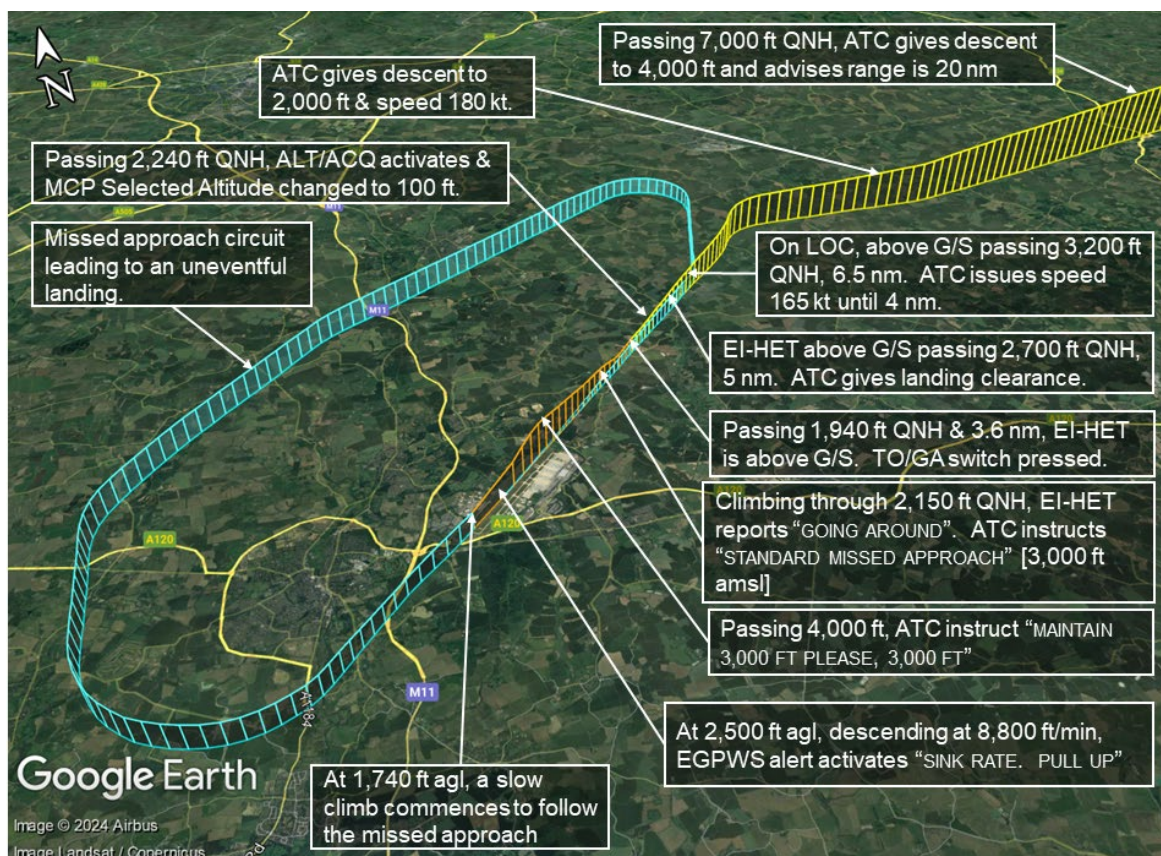
Figure 1

EI-HET's radar flightpath as it approached Stansted (yellow), the GA, level bust and descent (orange), and second approach and landing (blue)

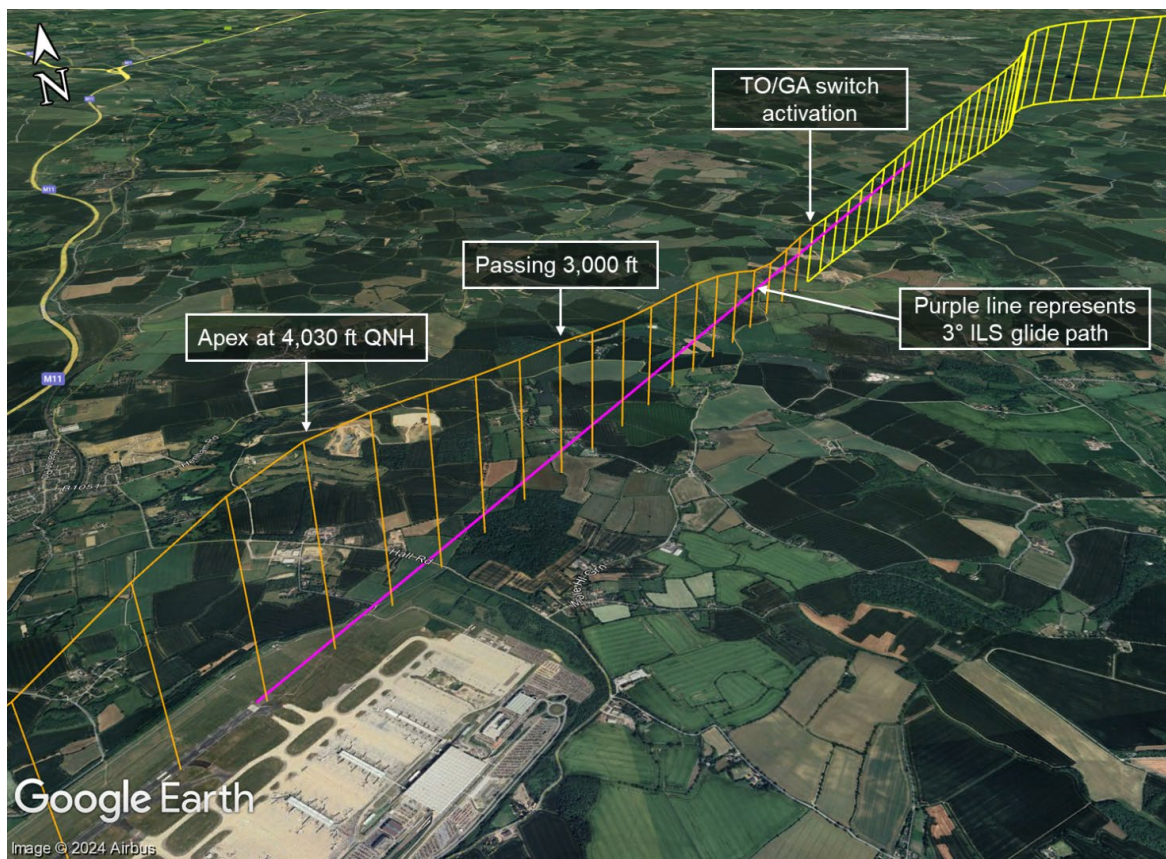
At 1,940 ft amsl (1,579 ft aal) and 3.6 nm from touchdown, the commander initiated a go-around (GA) and the co-pilot advised ATC of this. See Figure 2 for EI-HET's approach from radar data, showing the path before the GA was initiated, and the aircraft's subsequent track.

EI-HETs approach from radar data, showing path before TO/GA switch activation (yellow track), and subsequent track (orange track). 3° ILS G/S illustrated by purple line

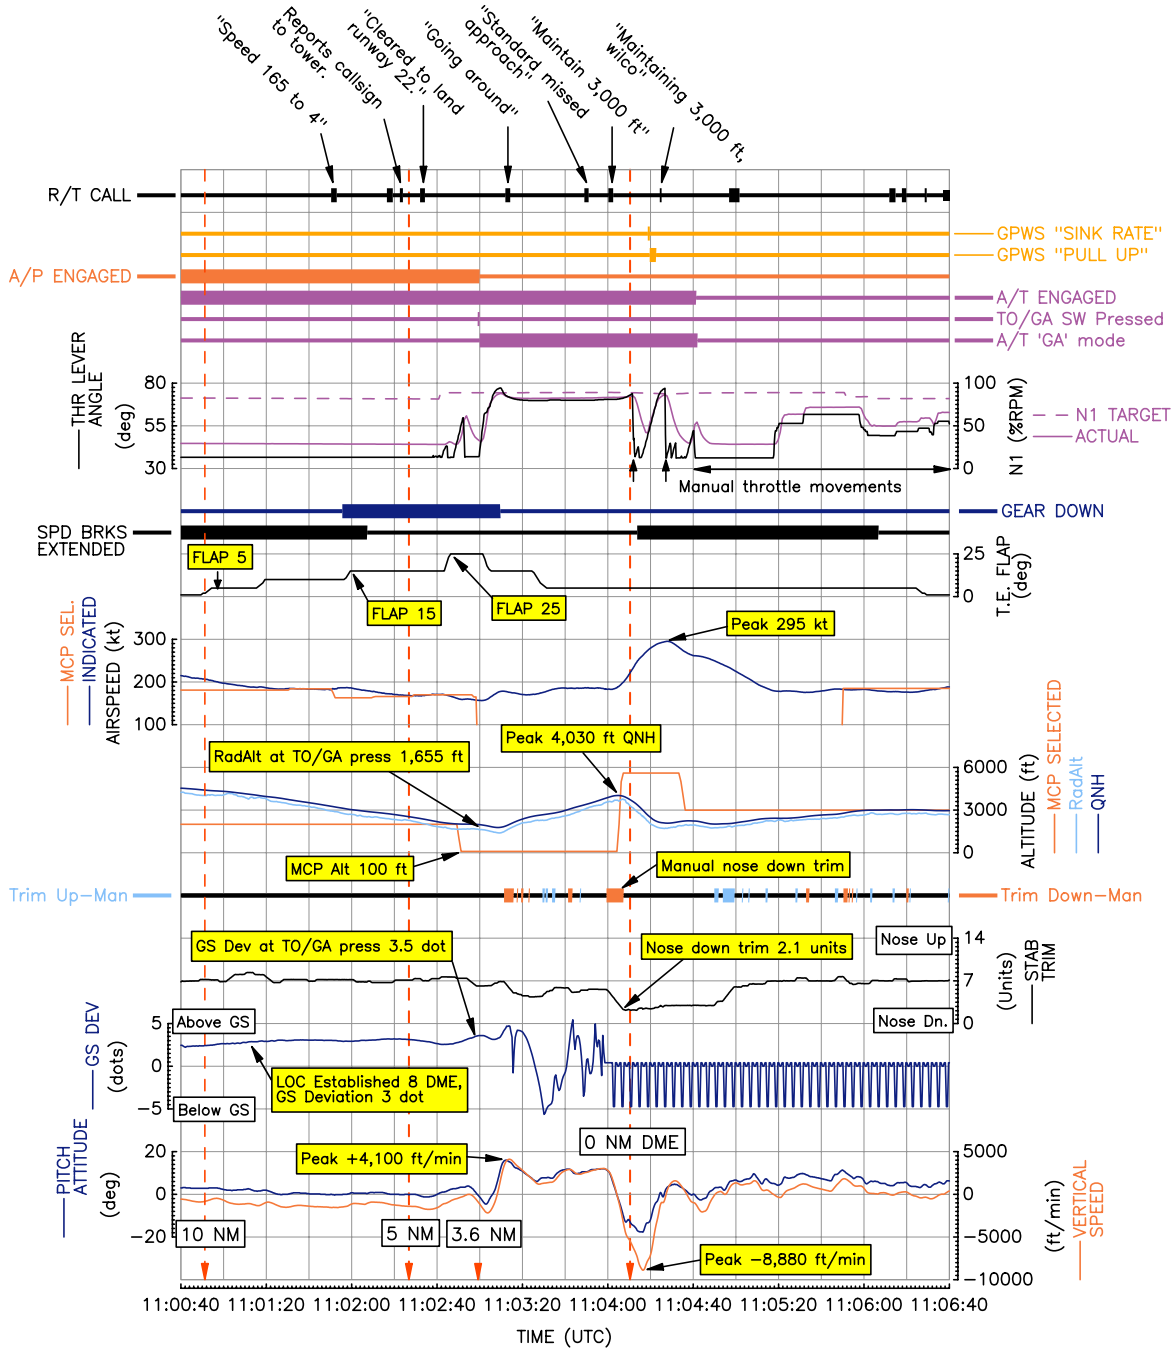
Figure 4
 Pertinent parameters from the FDR, with R/T transmissions to ATC

At the time of the descent during the MAP, the FDR recorded a forward control column input by the PF. The FDR also recorded pilot-commanded nose-down stabiliser trim movements, until the stabiliser reached about 2.5 units of trim, and the spoilers being extended.

The FDR indicated that the trim was manually commanded to a significant nose-down value of approximately 2.2 units, following ATC's prompt to maintain 3,000 ft following the level bust.
