Serious Incident

Aircraft Type and Registration:	ATR 72-202, G-NPTF	
No & Type of Engines:	2 Pratt & Whitney Canada PW121 turboprop engines	
Year of Manufacture:	1990 (Serial no: 192)	
Date & Time (UTC):	7 March 2023 at 0138 hrs	
Location:	Belfast International Airport	
Type of Flight:	Commercial Air Transport (Cargo)	
Persons on Board:	Crew - 2	Passengers - None
Injuries:	Crew - None	Passengers - N/A
Nature of Damage:	None reported	
Commander's Licence:	Airline Transport Pilot's Licence	
Commander's Age:	45 years	
Commander's Flying Experience:	6,750 hours (of which 92 were on type) Last 90 days - 65 hours Last 28 days - 25 hours	
Information Source:	AAIB Field Investigation

Synopsis

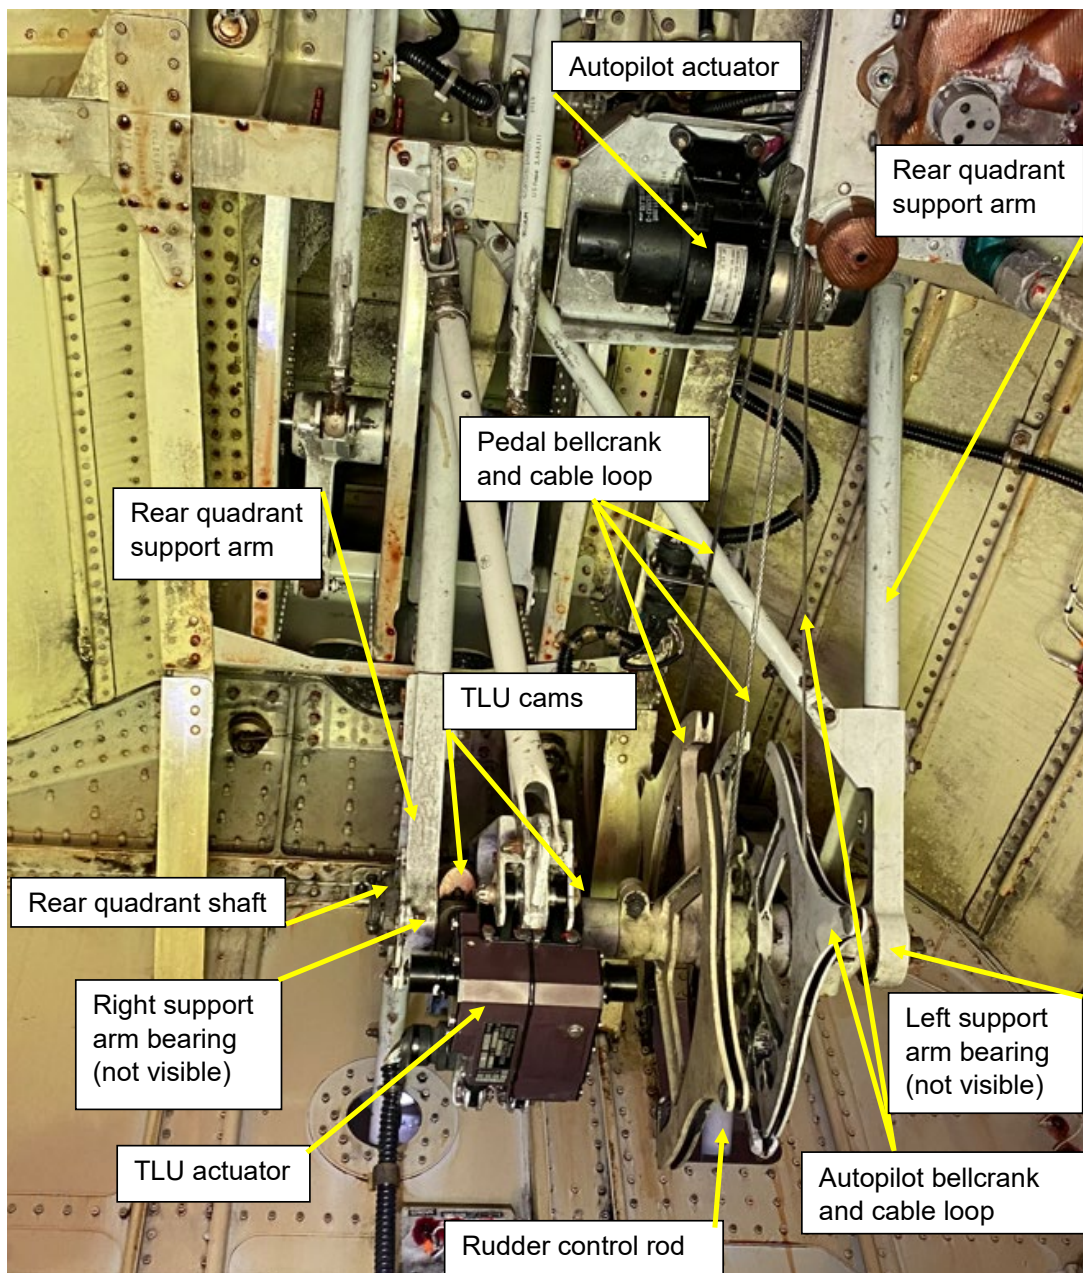
Figure 2

G-NPTF's rudder rear quadrant (view looking aft)

The rear bay, directly underneath the vertical stabiliser, and in which the rudder rear quadrant is located, appeared dry and there was no evidence of moisture or ice accumulation. The internal surfaces of the rear bay, rear quadrant shaft support structure and bellcranks were dirty, with a light film of old grease/dirt (Figure 2).

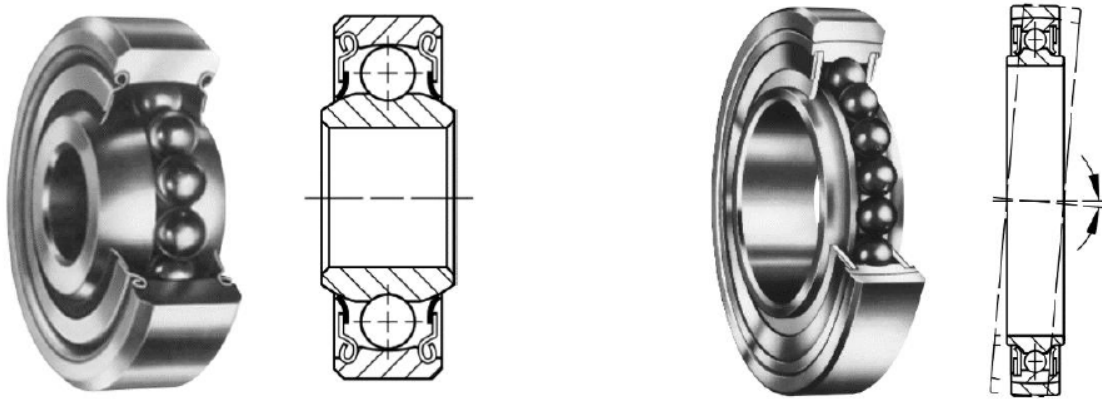
Figure 3

The raceways and balls of both bearings were made from 52100 grade steel which does not have significant corrosion resistance. The exposed surfaces, the bore, cap and seals were cadmium-plated.

Original production standard rear quadrant shaft support bearings fitted to G-NPTF

Following this occurrence, G-NPTF's rear quadrant shaft and bearings were replaced prior to its return to service. As SB 72-27-1020 had not been embodied on G-NPTF, only the original standard steel bearings were approved for installation and so pre-modification bearings were re-fitted.

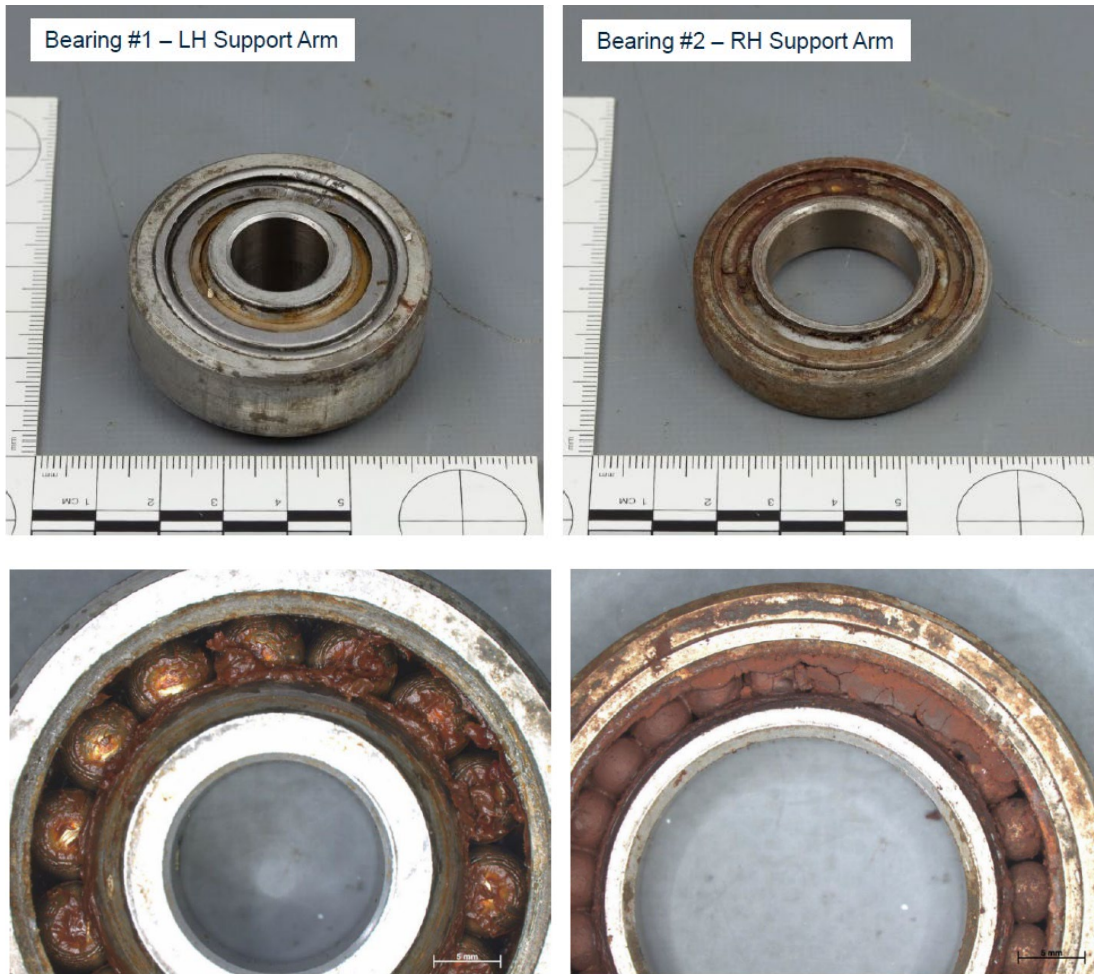
Figure 4

Bearing No 2 displayed corrosion and a brown deposit on the outer surface. It contained a full complement of balls which appeared to be extensively corroded. No grease was present, although there was a thick brown deposit throughout, which appeared to be a combination of corrosion product and dried grease residue (Figure 4).

Rear quadrant support arm bearings from G-NPTF

The predominant source of stiffness/friction in the rudder system was determined to be the degradation of the rear quadrant support bearings. Both bearings showed evidence of corrosive attack. The No 2 bearing was completely seized when examined in the laboratory and there was a complete absence of fresh grease, despite being a sealed bearing. The No 1 bearing was rough when rotated and had also suffered from corrosion, although to a lesser extent.

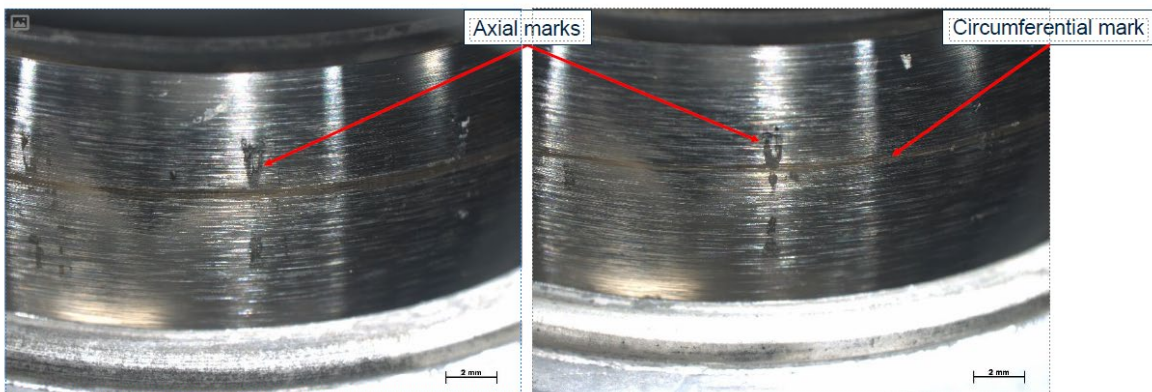
Figure 5

After cleaning, visual examination of the inner surfaces of bearing No1 showed axial marks consistent with the ball positions and circumferential marks around the approximate midpoint of the outer race (Figure 5).

Bearing No 1 axial and circumferential marks

Examination of the bearing No 1 outer race in the scanning electron microscope (SEM) showed that the axial marks had resulted from a combination of corrosion and sliding in the axial direction. The track of circumferential marks had resulted from a combination of corrosion and wear. Within this track was a line where the machining marks on the outer

race had been polished flat. This was considered consistent with the type of wear that occurs with in-service bearings. However, within this track, patches of corrosion were also observed, which is not typical. The corrosion is likely to have contributed to the rough running of the bearing.

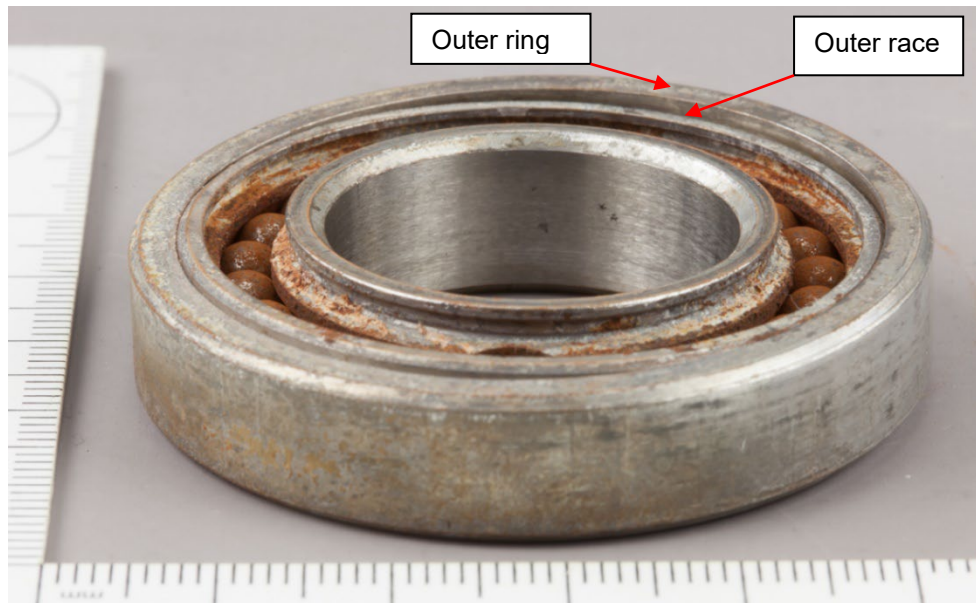
Axial misalignment, measured at 2.9° , was noted between the outer ring and outer race of the bearing No 2 (Figure 6).

Figure 6
Bearing No 2 misalignment

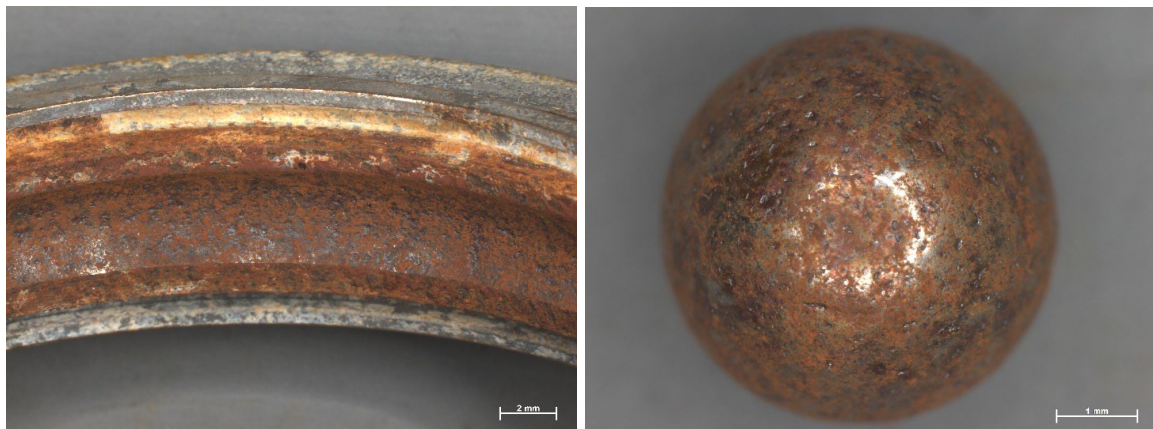
After cleaning, extensive corrosion pitting was evident on the inner and outer bearing races and balls of bearing No 2 (Figure 7).

Figure 7
Bearing No 2 corrosion and pitting (outer race shown, inner similar)

Bearing No 2 was not examined in the SEM because of the extensive pitting corrosion that was observed during the visual examination.

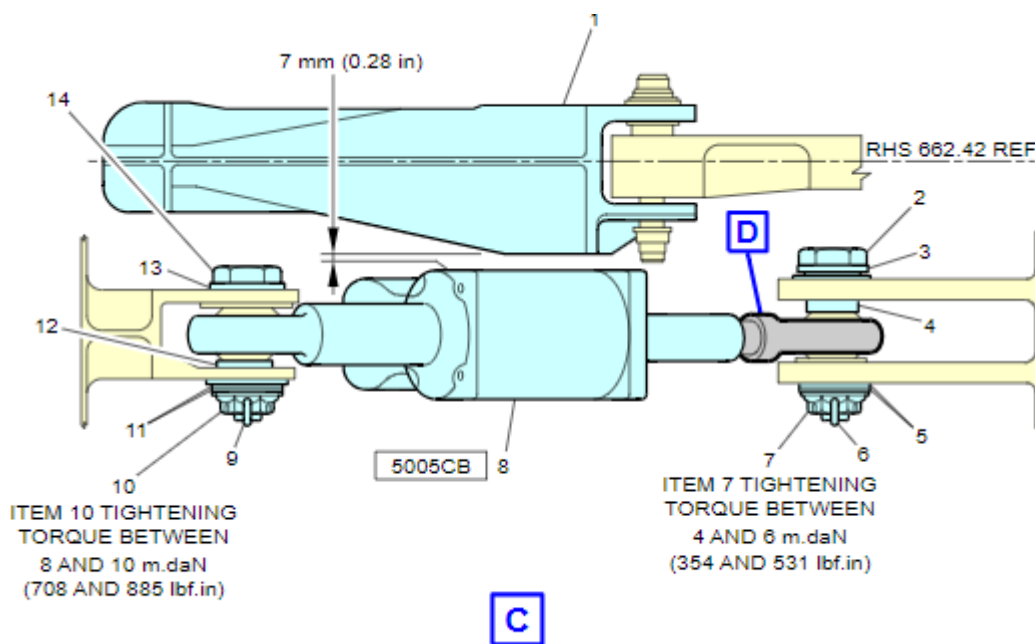
Figure 8

A subsequent torque check of rudder damper attachment bolts revealed that the torque on the forward attachment bolt (vertical stabiliser side) was within limits (allowable 8-10 daNm). However, the aft attachment bolt (rudder side) had been over-torqued and required more than 10 daNm to loosen it (allowable 4 – 6 daNm). When the bolt was removed, moisture was present on the bolt shank and within the attachment lugs and the bushing was seized to the bolt. There was no evidence of grease present at either attachment.

Extract from ATR 72 AMM figure showing rudder damper attachment allowable torque values

Some residual stiffness remained in the rudder/actuation circuit and the investigation identified that the aft attachment bolt for the rudder damper had been over-torqued. Its installation had contributed to stiffness with the rudder circuit, albeit to a much lesser degree than the degraded bearings.
