Report on the investigation of the
fatal man overboard from the potting vessel

***Pioneer* (NN200)**

south of Hastings, England

on 29 July 2021

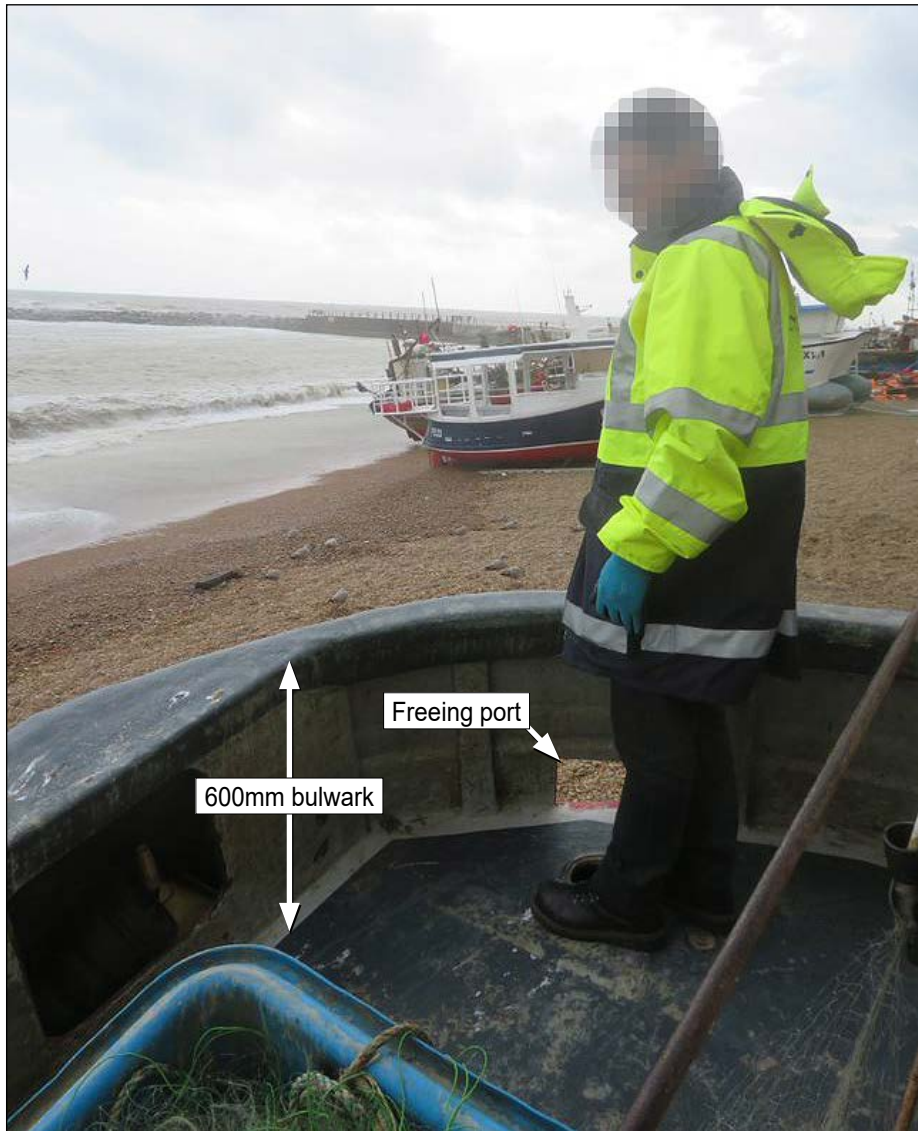
Figure 3: View of aft deck bulwark with a person who is 172cm tall standing adjacent

The skipper was alone on *Pioneer's* aft deck just before the accident and it is possible that the vessel's movement in the 2m swell caused him to lose his footing, which in turn led his centre of gravity to momentarily act outboard of the bulwark and result in his fall overboard. It is also possible that an obstacle on *Pioneer's* relatively small aft deck, such as the net box or missing fuel filler cover, caused the skipper to trip and stumble over the vessel's side. Further, as the skipper had a pre-existing heart condition it cannot be ruled out that he suffered a non-fatal heart attack that caused him to fall overboard. In each of these scenarios the low bulwark height, which was approximately coincident with the skipper's knee height, offered little protection from a fall over the vessel's side. Similar to the *About Time* and *St Amant* accidents, a bulwark height of 1000mm, recommended in both MGN 570 (F) and MSIS 27 and now mandatory for fishing vessels of 15m or less length overall following Amendment No. 2 of the Code, combined with the wearing of a tethered safety harness would have mitigated the risk of falling overboard.

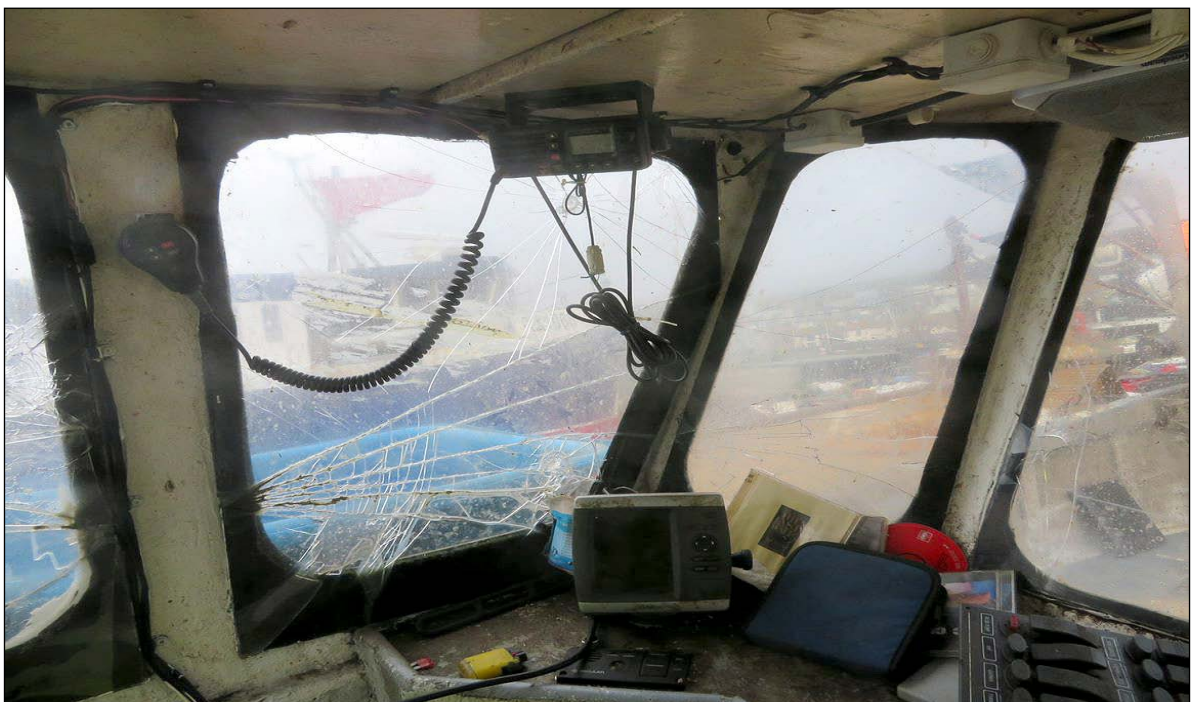
Figure 4: Pioneer's VHF digital selective calling radio

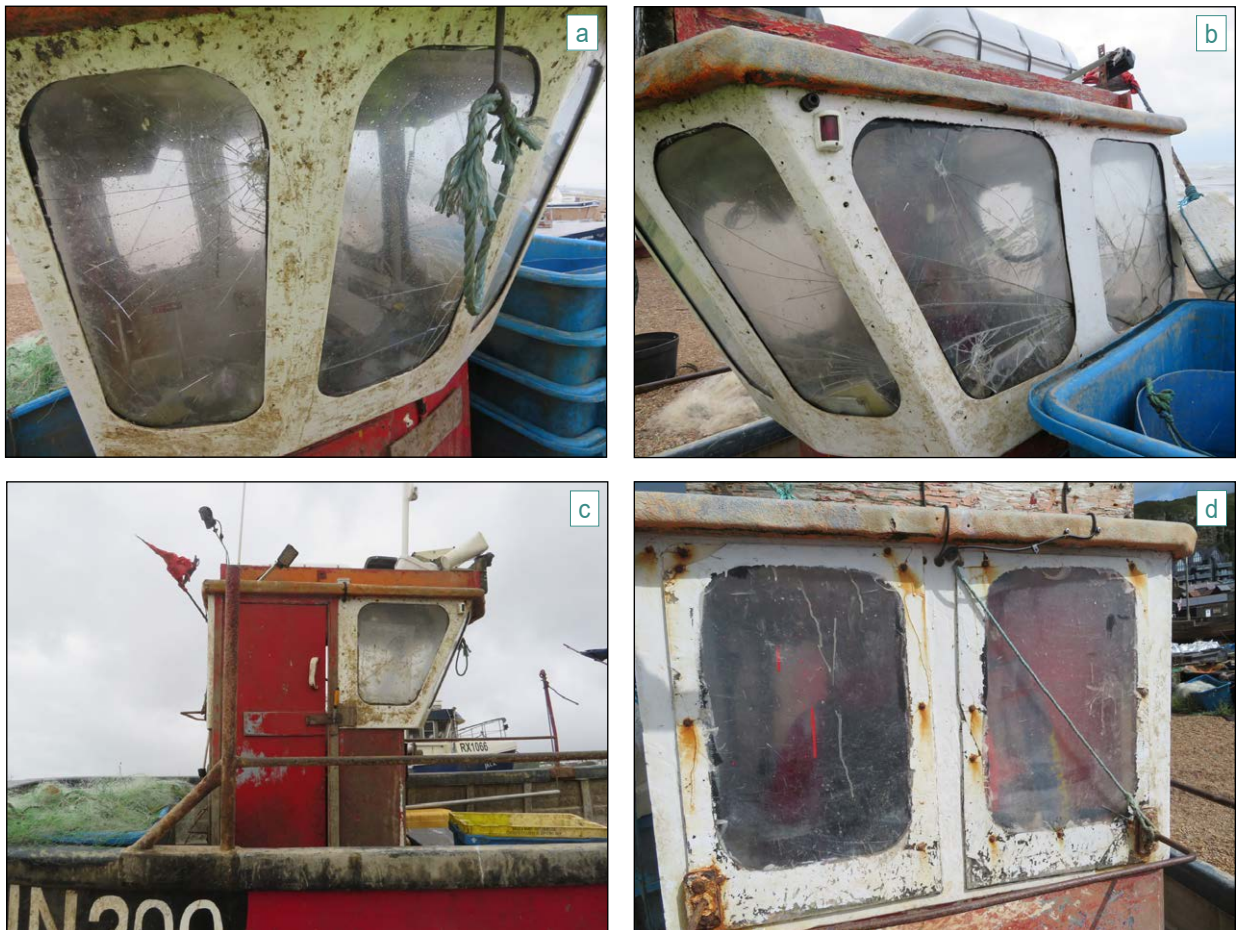
The wheelhouse was fitted with three windows on its forward elevation (**Figure 5a**), two on its port side (**Figure 5b**), one on its starboard side (**Figure 5c**), and two on its aft elevation (**Figure 5d**). The window panes were made of Perspex⁷ and were all semiopaque, scratched and/or cracked. The window on the starboard side of the aft elevation became partially obscured when the wheelhouse door was open and tied back, limiting visibility to the aft deck.

Figure 5: Pioneer's wheelhouse windows

The windows of *Pioneer's* wheelhouse were semiopaque and cracked, which limited visibility and was contrary to the MGN 571 (F) requirement that good visibility of deck areas should be maintained to facilitate early awareness of an MOB situation. Other safety critical defects and trip hazards on the aft deck were also present on the day of the accident, thereby increasing the risk of an MOB.

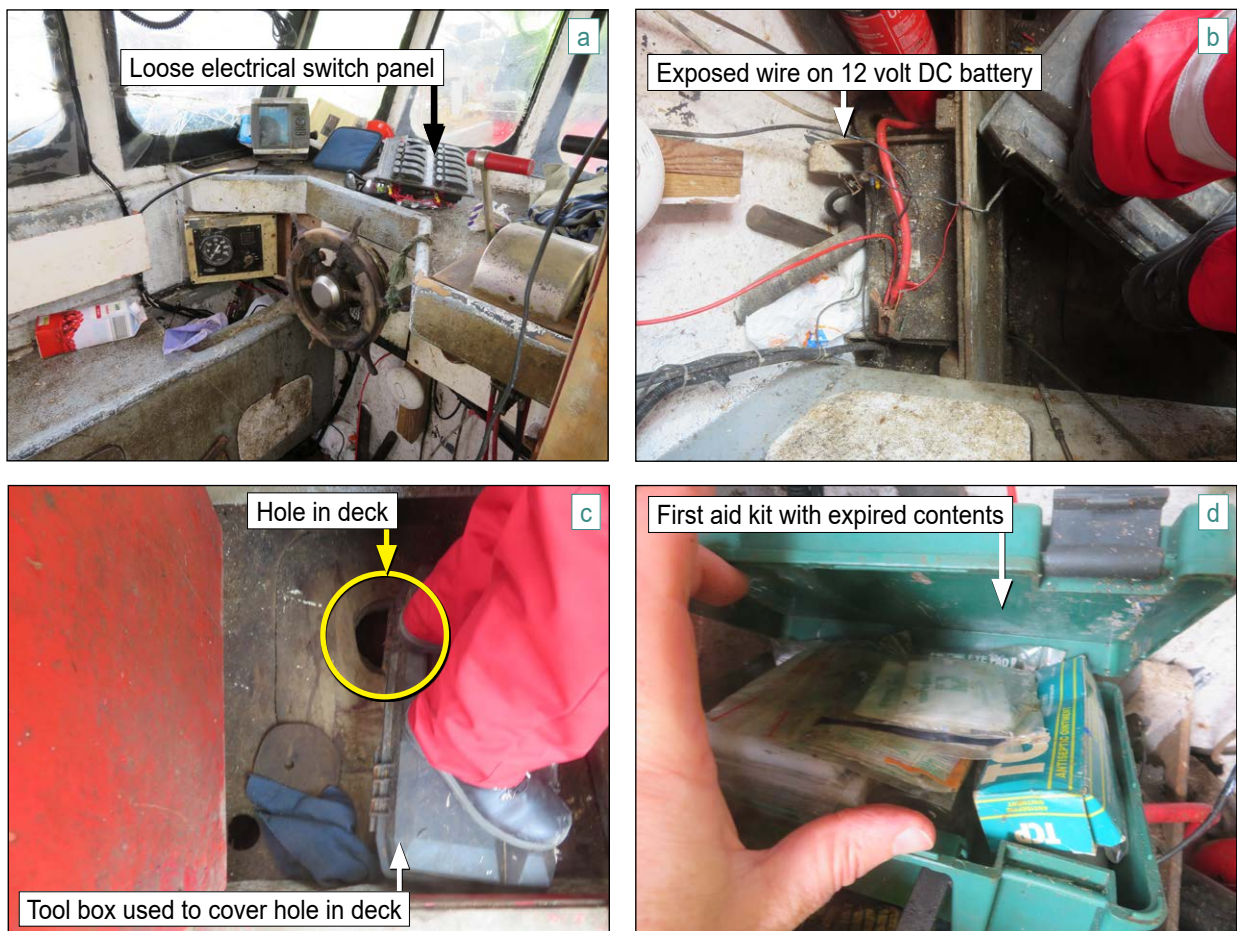
Further inspection of the wheelhouse found that: the electrical switch panel for the lights was lying loose on the console above the helm (**Figure 6a**); the wire terminals of the 12-volt direct current battery were fully exposed (**Figure 6b**); a toolbox had been used to cover a hole in the deck (**Figure 6c**); and the contents of the first aid kit had expired (**Figure 6d**).

Figure 6: Pioneer's wheelhouse at time of MAIB examination

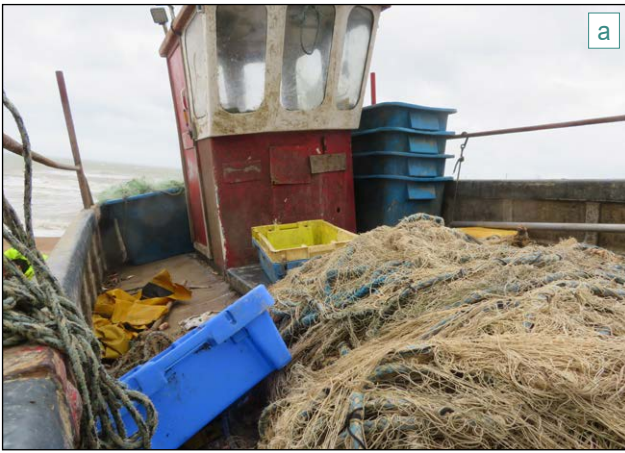
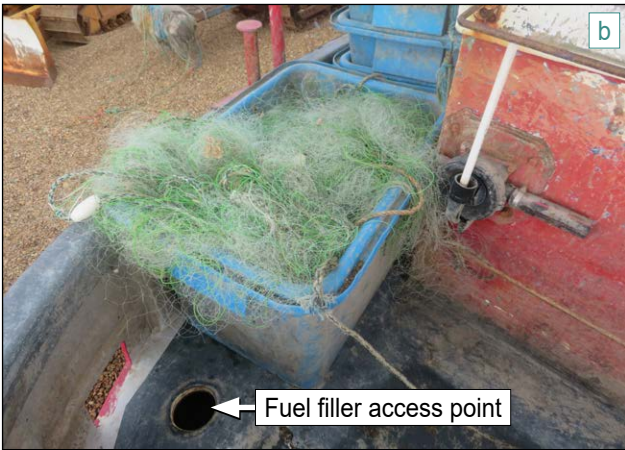
Two gill nets were lying loose on the freeboard deck (**Figure 7a**) and one net was stowed in a plastic bin (**Figure 7b**) on the port side of the aft deck. A 140mm hole in the deck just aft of the bin was missing its cover, exposing the access to the fuel filler.

Figure 7: *Pioneer's* gill nets and fuel filler access point with cover missing

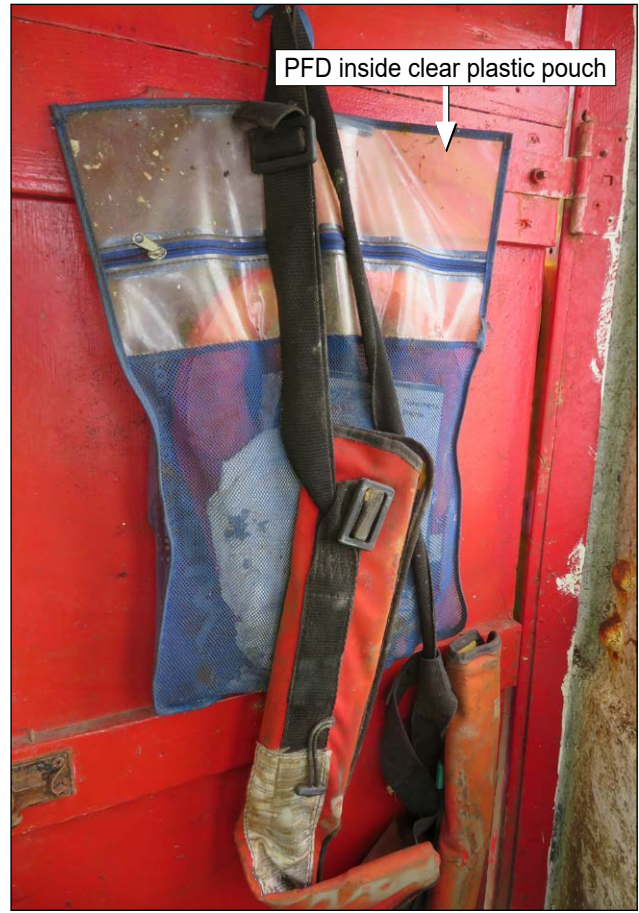
Two 150N⁸ auto inflate PFDs were found hanging on the inside of *Pioneer*'s wheelhouse door (**Figure 8**), one of which was in a clear plastic pouch with a zip that was corroded and jammed. The outer fabric to both PFDs was torn and dirty and neither had been serviced since 2013.

Figure 8: Personal flotation devices hanging on *Pioneer's* door

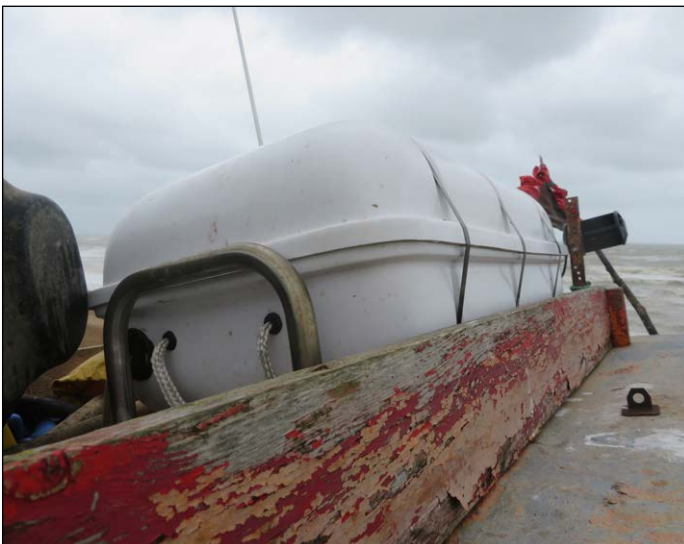
A four-person liferaft (**Figure 9**) was stowed on the port side of the wheelhouse roof and was due to be serviced in February 2022; it was unsecured, there was no hydrostatic release unit (HRU) and its painter was not attached.

Figure 9: *Pioneer's* four-person liferaft

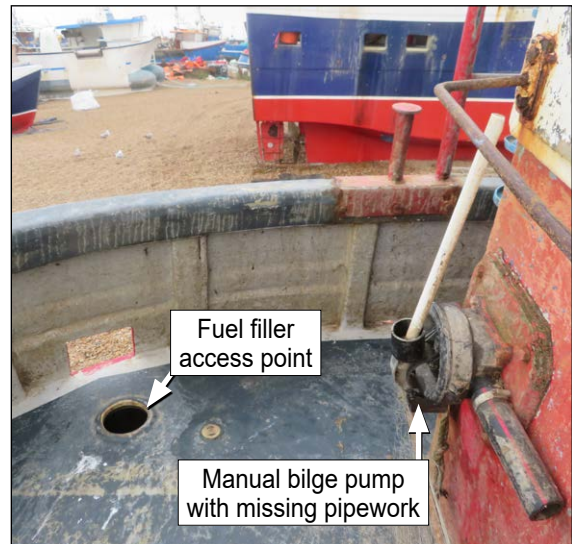
A manual bilge pump (**Figure 10**) was mounted on the aft elevation of the wheelhouse. No pipework was attached to the pump. All of the distress flares had expired in December 2017. No safety documents were found on board *Pioneer*.

Figure 10: *Pioneer's* manual bilge pump

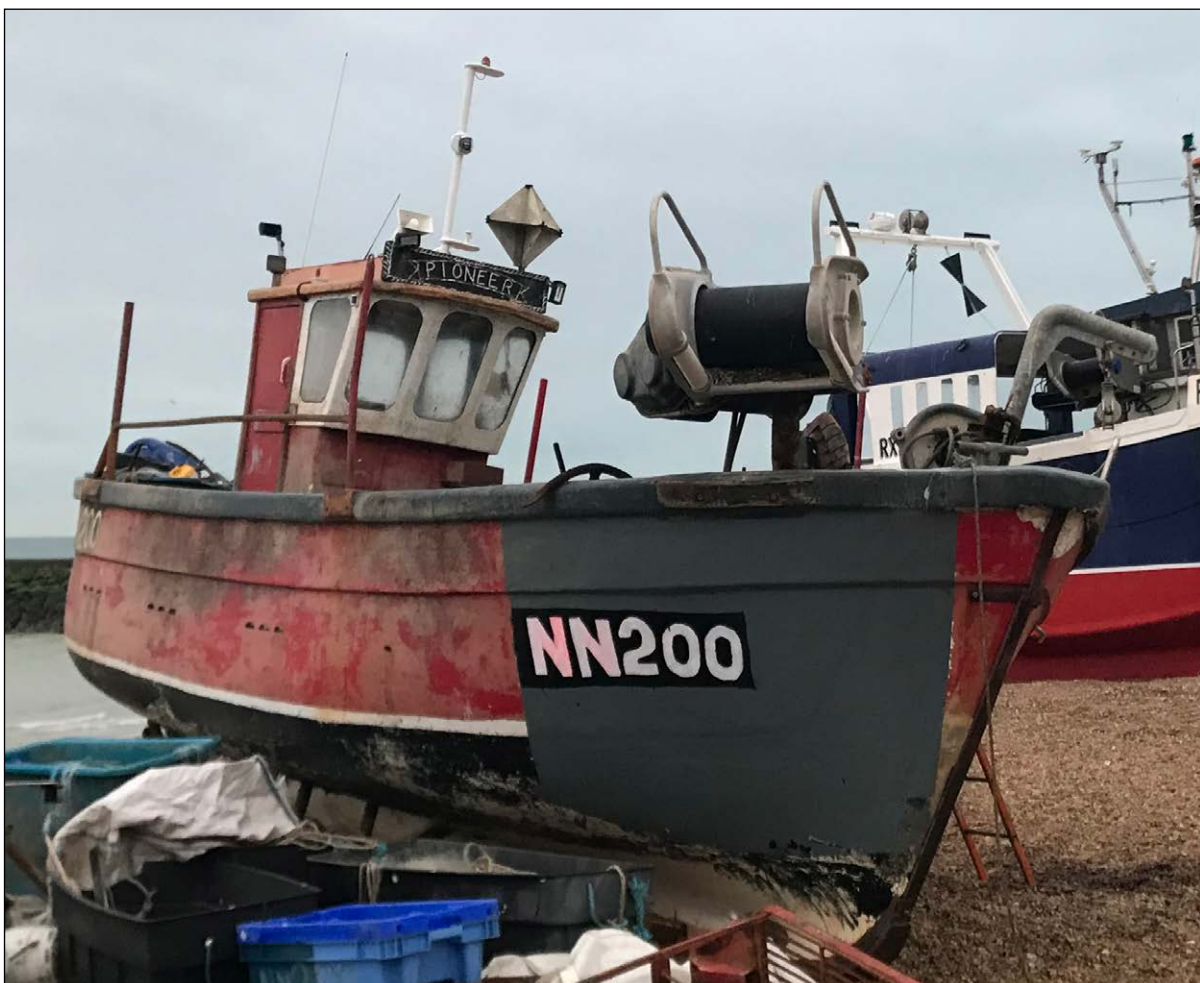
Before the accident the MCA had last inspected *Pioneer* on 26 November 2020, at its beach standing in Hastings. The attending MCA surveyor completed checklist MSF 1341 (Revision 04/18) and identified seven deficiencies (**Annex B**), all of which were assigned action codes 17 and 98 and required rectification before the vessel could proceed to sea. The surveyor took one photograph of *Pioneer* during this inspection (**Figure 11**).

Figure 11: *Pioneer* at time of the MCA survey (November 2020)

It is likely that the MCA's November 2020 inspection of *Pioneer* was not conducted using aide-memoire MSF 5549 and possibly resulted in a number of deficiencies being missed, including the low bulwark height and the poor visibility from inside the wheelhouse. Both of these deficiencies were contrary to MGN 571(F) and the instructions to surveyors, and were apparent in the photograph taken at the time of inspection. The lack of safety training certification for the skipper and absence of a written MOB risk assessment as required by the Code also went unrecorded.
