## Serious Incident

<b>Aircraft Type and Registration:</b>	Boeing 737-8K5, G-FDZS	
<b>No &amp; Type of Engines:</b>	2 CFM56-7B27/3 turbofan engines	
<b>Year of Manufacture:</b>	2009 (Serial no: 35147)	
<b>Date &amp; Time (UTC):</b>	4 March 2024 at 1104 hrs	
<b>Location:</b>	On take off from Bristol Airport	
<b>Type of Flight:</b>	Commercial Air Transport (Passenger)	
<b>Persons on Board:</b>	Crew - 6	Passengers - 163
<b>Injuries:</b>	Crew - None	Passengers - None
<b>Nature of Damage:</b>	None reported	
<b>Commander's Licence:</b>	Airline Transport Pilot's Licence	
<b>Commander's Age:</b>	47 years	
<b>Commander's Flying Experience:</b>	14,500 hours (of which 4,500 were on type) Last 90 days - 220 hours Last 28 days - 81 hours	
<b>Information Source:</b>	AAIB Field Investigation

## Synopsis

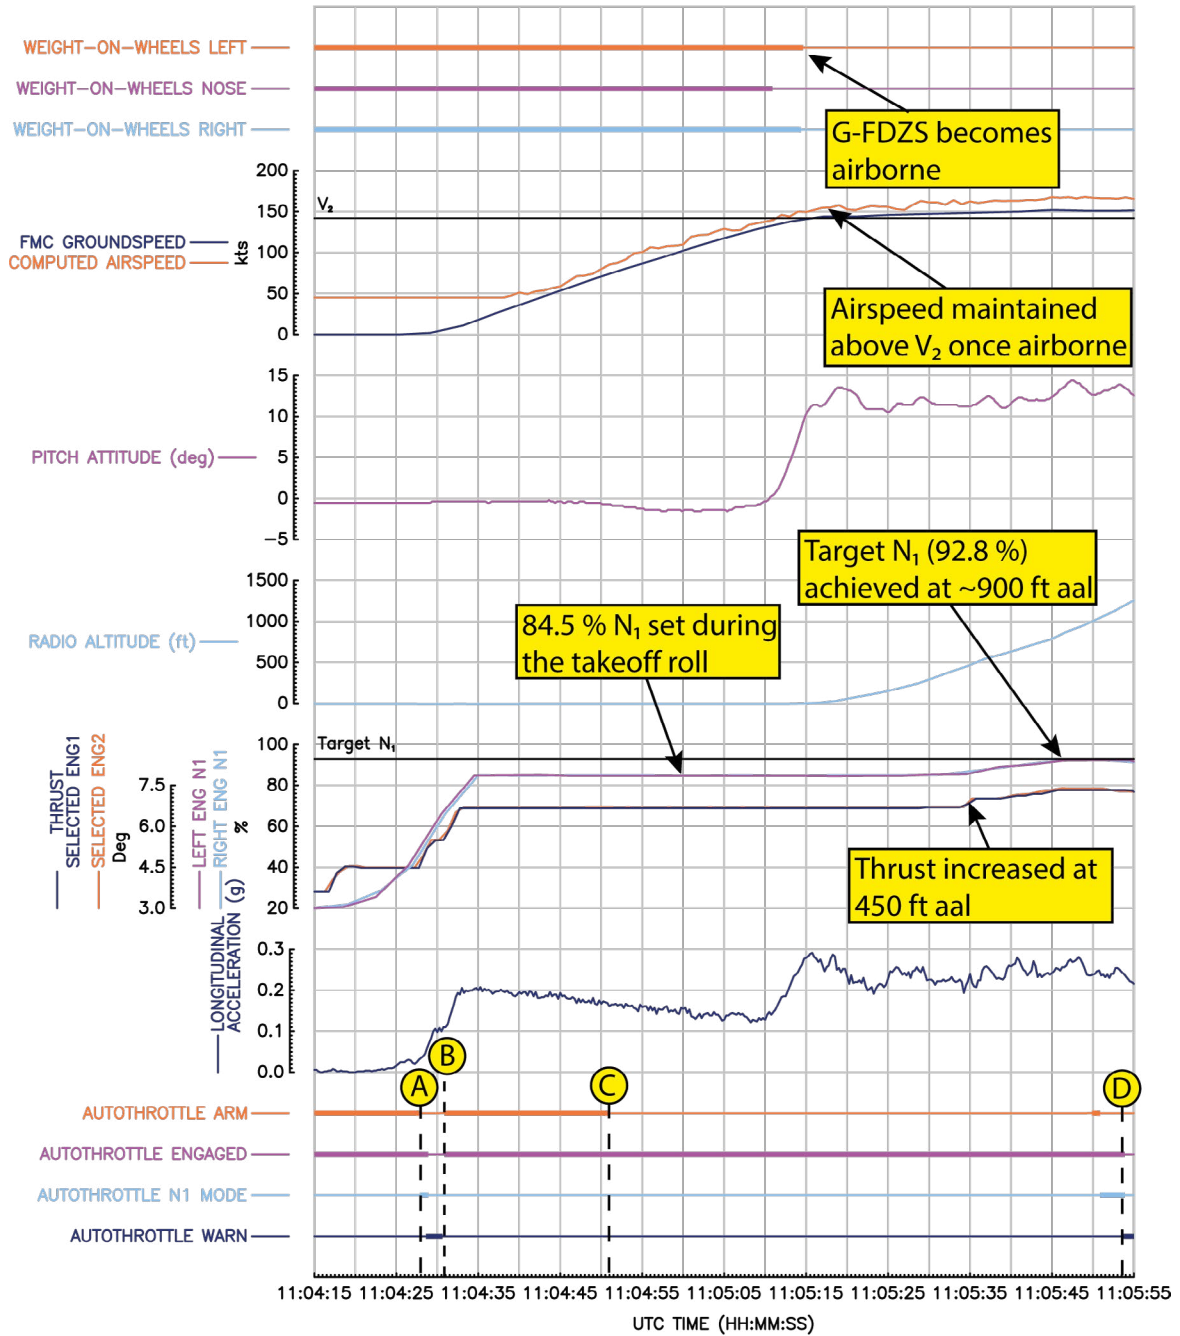
**Figure 1**

- (A) A/T transitions from ARM to N1 mode on TOGA selection, disconnects almost immediately with a warning
- (B) A/T re-armed within five seconds but no active mode selected
- (C) A/T transitions to ARM HOLD mode, as per design, at 84 kt
- (D) A/T transitions from ARM to N1 mode, but disconnects with a warning almost immediately (2nd uncommanded disconnect)

FDR data for the takeoff

The data shows that 84.5%  $N_1$  was set for the takeoff instead of 92.8%  $N_1$  and, although the thrust setting was increased from 450 ft aal, the required takeoff thrust setting was

not attained until passing approximately 900 ft aal. As a result, G-FDZS became airborne 260 m from the end of Runway 09 and the runway end was overflowed at a height of approximately 10 ft.

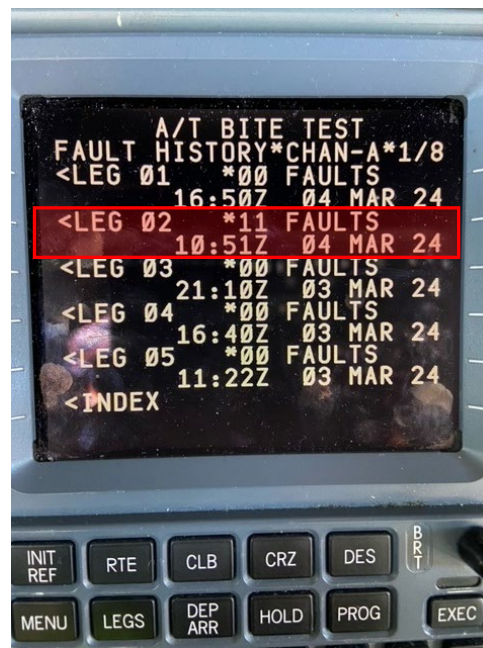
**Figure 2**

A/T fault history for the incident flight and the preceding day

Five of the 11 logged faults related to uncommanded A/T disconnections. The first of these fault records is shown in Figure 3, and occurred at 1104 hrs when, from the FDR data, G-FDZS was on the runway at the beginning of the takeoff roll.

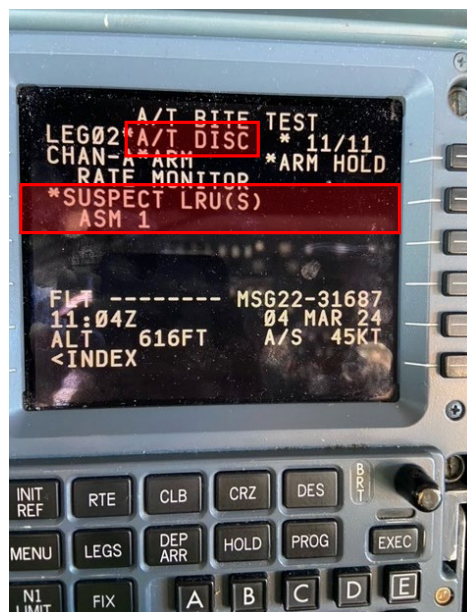
**Figure 3**

Detailed fault record for the initial uncommanded A/T disconnection, showing the suspected cause as the rate monitor logic within ASM 1

The fault record indicates the suspected cause of the uncommanded A/T disconnection as the rate monitor logic within ASM 1, the A/T servo motor for the No 1 engine throttle lever. A further four uncommanded A/T disconnections occurred during the flight to Las Palmas, two during the initial climb to altitude and two during the cruise. A series of other fault messages were logged, after the initial A/T disconnection, as G-FDZS accelerated for takeoff. These were generated passing 90 kt airspeed and all related to the mis-set thrust, indicating that the correct takeoff thrust had not yet been set.

It is likely that the uncommanded disconnect of the A/T was caused by low voltage to the ASM when TOGA was selected. This issue is one widely known to the manufacturer. The aircraft manufacturer and ASM manufacturer investigated the nuisance disconnects on the 737NG and produced a new design of ASM which was more resistant to the problem and therefore less likely to have uncommanded disconnects. Whilst the fitment of the new design of ASM is not mandatory, the manufacturer does recommend that operators should retrofit their aircraft when they experience problems. G-FDZS was fitted with the original model of ASM on both throttles.

The manufacturer recommends that any operators of the B737NG who are affected by these disconnects should retrofit their aircraft with the newer model of ASM and associated FCC software. The manufacturer released a Fleet Team Digest in October 2021 detailing the issue and the available Service Bulletin (SB) for replacement. The Fleet Team Digest was revised in August 2022. At the time of this event G-FDZS was fitted with the earlier model of ASMs.

The operator took action to raise awareness of the issue and what actions are expected as well as strengthening their FDM programme to better monitor the occurrences. The manufacturer encourages any operators who experience nuisance disconnects to replace the ASM with the newer model and ensure a later standard of FCC Software loaded.

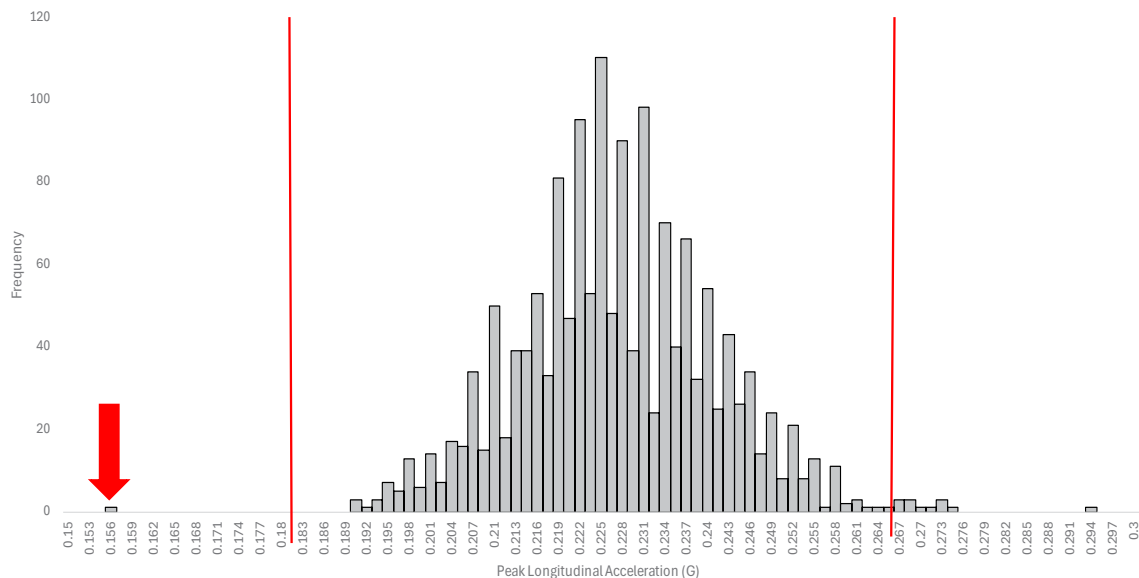
**Figure 4**

groundspeed and the Y-axis the number of takeoffs that are represented by each bar. The incident takeoff is shown by the red arrow in Figure 4, far to the left of the bulk of the data, whereas for a normal distribution of data 99.7% of all takeoffs would be expected to lie within the region marked by the two vertical red lines.

Histogram of 737 takeoffs at Bristol,  
showing the normal spread of peak accelerations and the incident takeoff

The takeoff performance using the thrust that was actually set was to the extreme left of the normal distribution curve in post-incident analysis conducted by the operator (Figure 4) and the aircraft did not make the regulated performance requirements. The aircraft passed the upwind threshold of the runway at approximately 10 ft with both engines operating.

- Event trigger created for A/T disconnection during takeoff. The event allows an understanding the historical and current level of nuisance A/T disconnects being experienced.
- Further refinement of the slow acceleration trigger using the statistical analysis.
- Event trigger created for a  $N_1$  Reference and actual takeoff thrust delta. This is part of a layered approach to give visibility of potential events which do not meet the required takeoff thrust. This event compliments the slow acceleration FDM trigger.

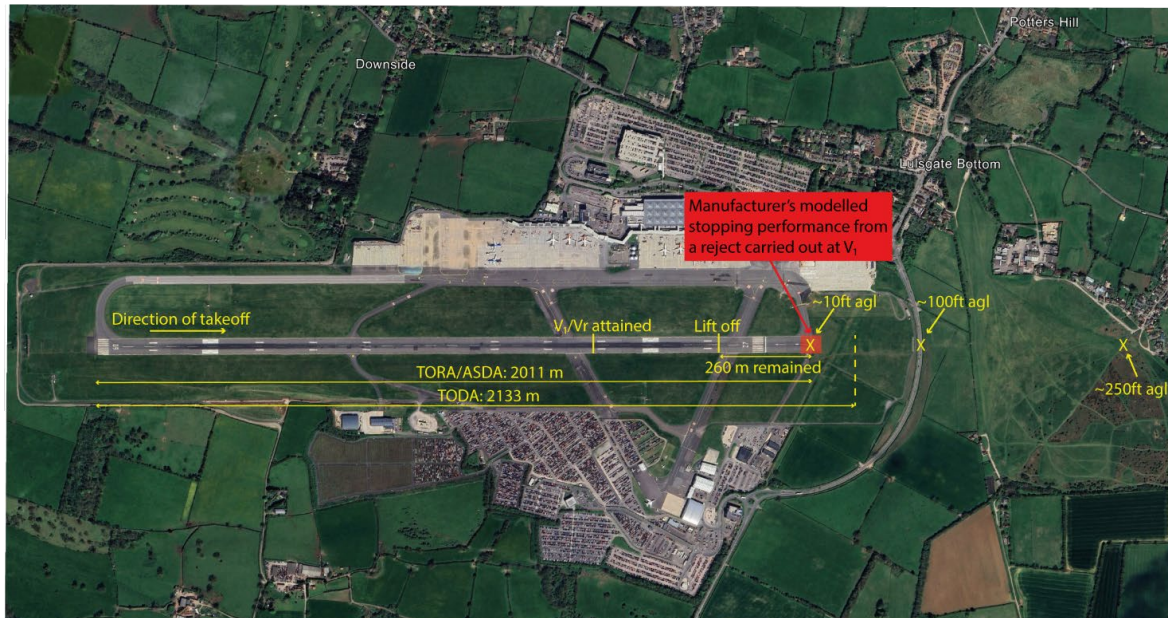
**Figure 7**

Unfactored calculations by the aircraft manufacturer indicated that with no increase in thrust, had an engine failed at  $V_1$  and the crew decided to stop, the aircraft would probably have stopped on the runway as long as the crew had used maximum reverse thrust. Had the crew elected to continue or if the engine failed above  $V_1$ , calculations indicate that the aircraft would not have been able to climb away without the application of more power. Figure 7 shows some of this data on a graphic of Bristol Airport.

Graphic of G-FDZS's takeoff from Bristol Airport  
© 2024 Google, Image © 2024 Airbus

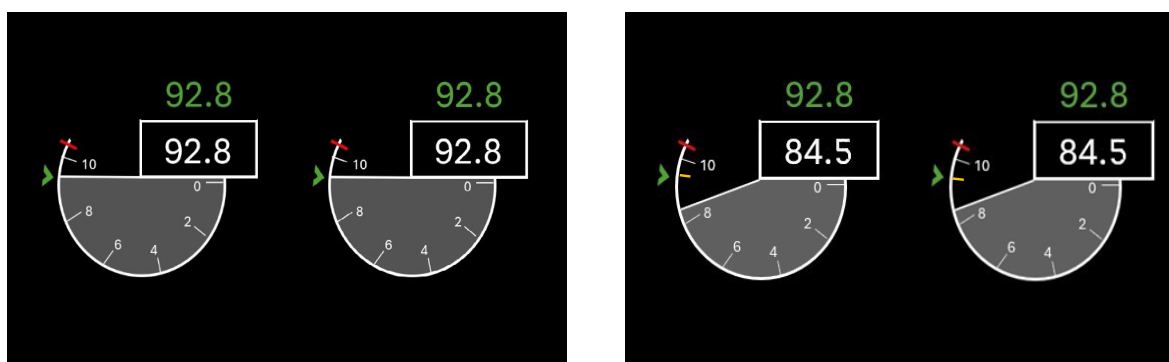
**Figure 8**

The reference  $N_1$  was set in the FMC at 92.8% as per the performance calculation completed before departure from the stand. This reference  $N_1$  was displayed on the  $N_1$  gauges as previously described. During the takeoff run, after the A/T had disengaged, the selected  $N_1$  was 84.5%. A demonstration of what the  $N_1$  gauges should have looked like compared to the actual  $N_1$  used for takeoff is shown at Figure 8.

$N_1$  display as should have been (left) and with the  $N_1$  used for takeoff showing (right)
