Report on the investigation of an engine room fire
on board the roll-on/roll-off passenger ferry

Stena Europe

while approaching Fishguard, Wales

on 11 February 2023

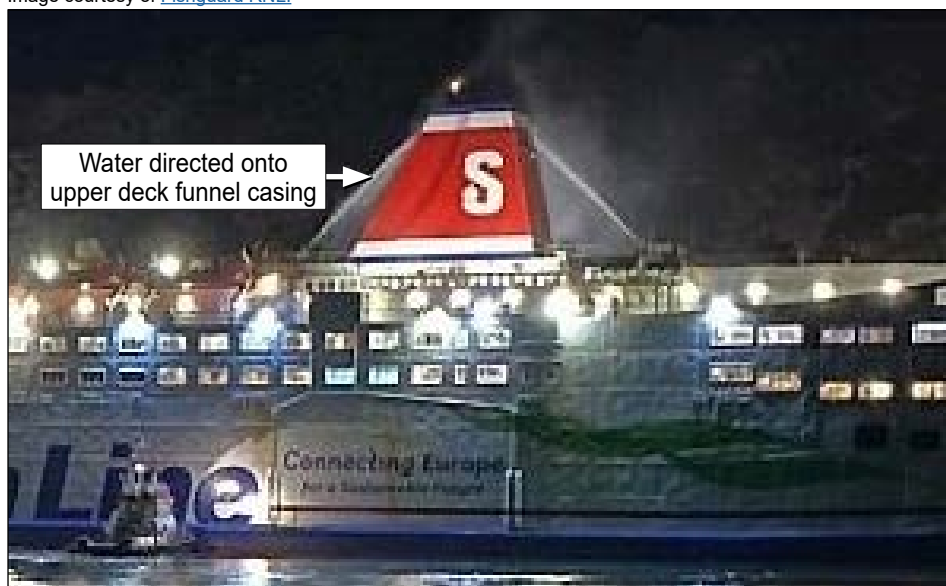
The bridge team received reports from several passengers of a large fireball coming out of the funnel. The day master responded to these reports by making an all-area announcement using the ship's public address system, requiring all passengers to vacate the upper deck and to remain inside the ship. The 3/O instructed the deck fire team to start boundary cooling the funnel from the upper deck (**Figure 3**).

Figure 3: Boundary cooling of *Stena Europe's* funnel casing

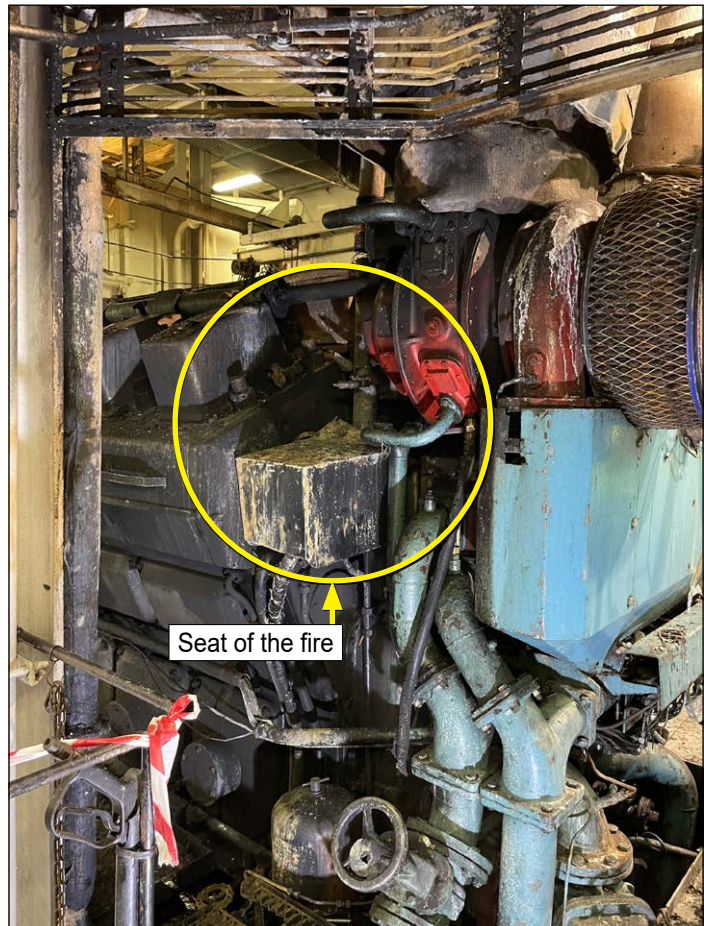
An inspection of the port engine room the day after the fire identified that the seat of the fire was at the inboard front end of ME3 (**Figure 5**). Closer inspection revealed an exposed fuel pipe flanged connection partially covered by incomplete shielding (**Figure 6**). One of the two flange securing screws was found to be missing, and the sealing O-ring was observed protruding from the joint (**Figure 7**). This was identified as the source of fuel leakage for the fire.

Figure 5: The seat of the fire at the front inboard end of ME3

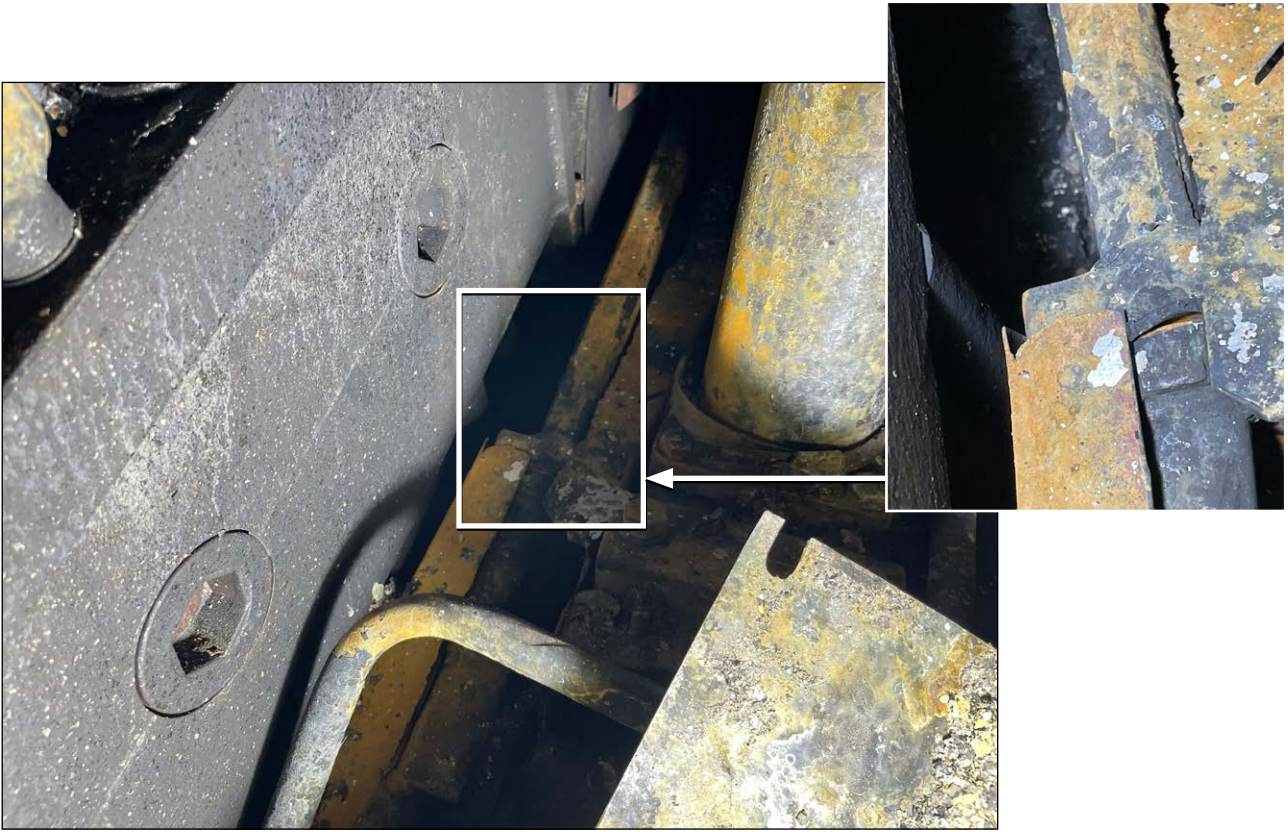
Investigators found that anti-splashing tape had not been used on the pressurised oil systems of any of the main or auxiliary engines, and identified many areas where shielding was either missing, poorly fitted or damaged to the point of providing inadequate protection.

Figure 6: Incomplete shielding with exposed fuel pipe flange connection

- Modified the external fuel piping on ME3 to incorporate four-screw flanges.
- Repaired or replaced the shielding and lagging around the external fuel systems and hot surfaces and fitted anti-splashing tape to all joints on the low-pressure fuel systems on all of *Stena Europe's* operational engines.

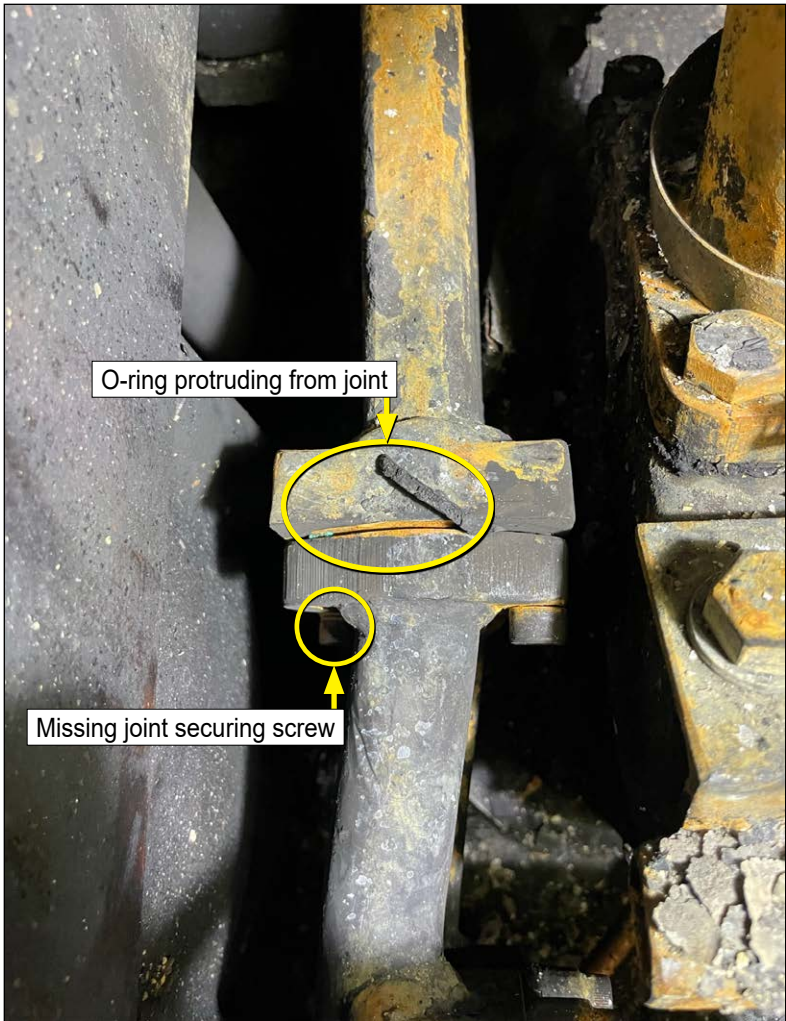
Figure 7: Fuel system joint

Over time, the blind screw threads⁴ in the two-screw flanges suffered from wear due to vibration and fretting that caused the screws to loosen and reduced their clamping force. Consequently, the system pressure could dislodge the O-ring from its groove in the flange and allow fuel to leak from the joint.

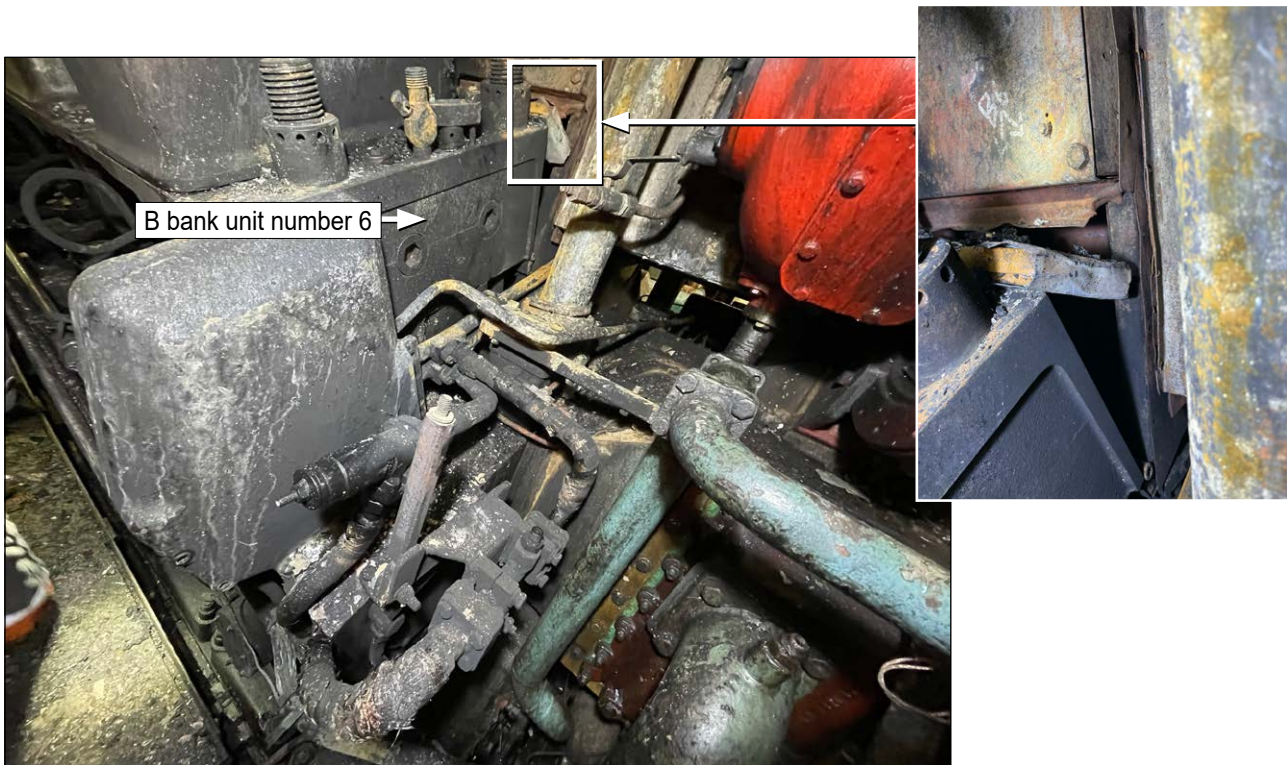
Behind the cylinder head of B bank unit number 6, the protective insulated shielding was found to be displaced. This exposed the exhaust manifold (**Figure 8**), which had an operating temperature of over 400°C and was identified as the most likely source of ignition for the fire.

Figure 8: Protective insulated shielding behind B bank unit number 6 and (inset) the most likely source of ignition

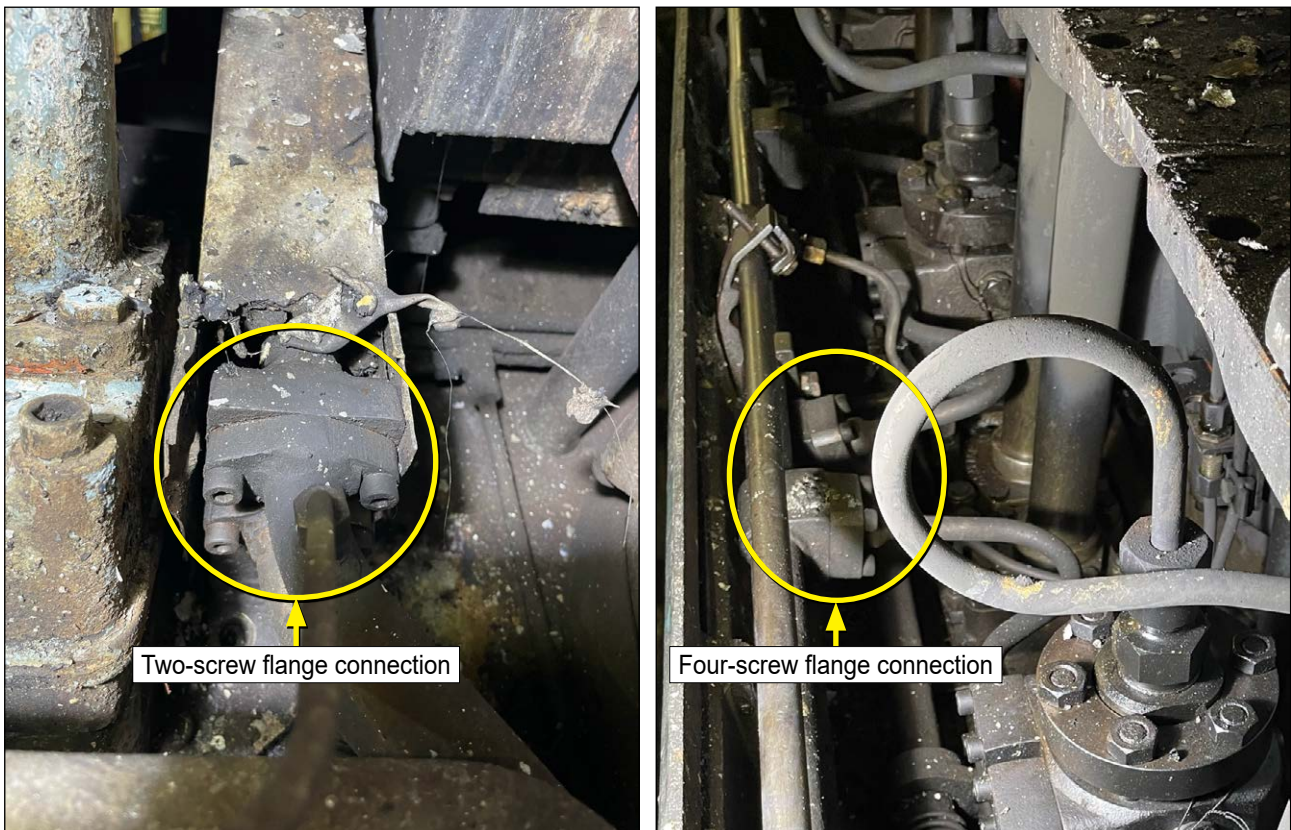
Figure 11: Fuel system flange connections

Most of the recommended inspection and replacement works were completed under the supervision of the Wärtsilä superintendent. The external low-pressure fuel system was inspected and sealing O-rings were replaced. The original two-screw flange arrangement was refitted due to a long lead time for the new component parts required to modify the system to the four-screw arrangement, which were ordered at the time the work was being completed. ME3 returned to operational service on 17 May 2023.

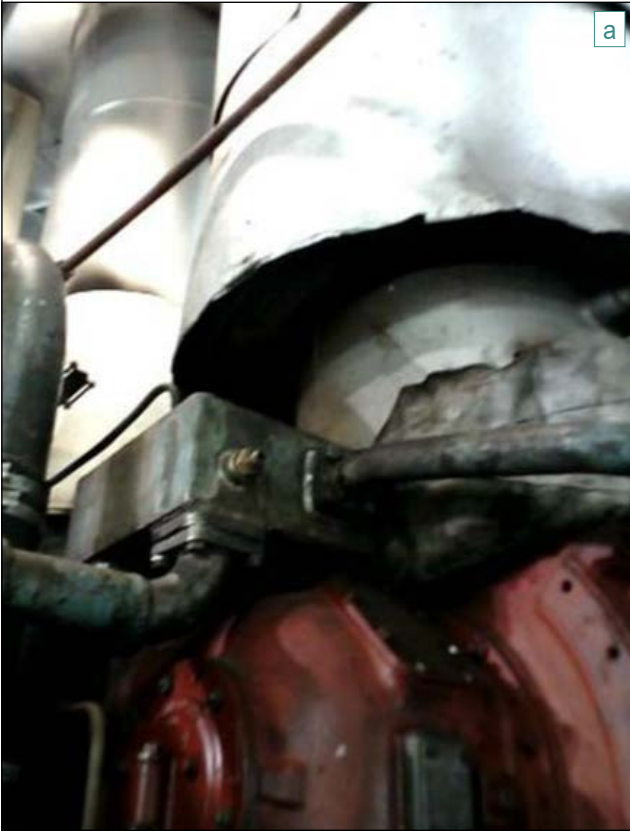
Photograph of ME4 B bank turbocharger and uptake

Figure 12: Exposed hot surfaces in the engine room identified using a TIC

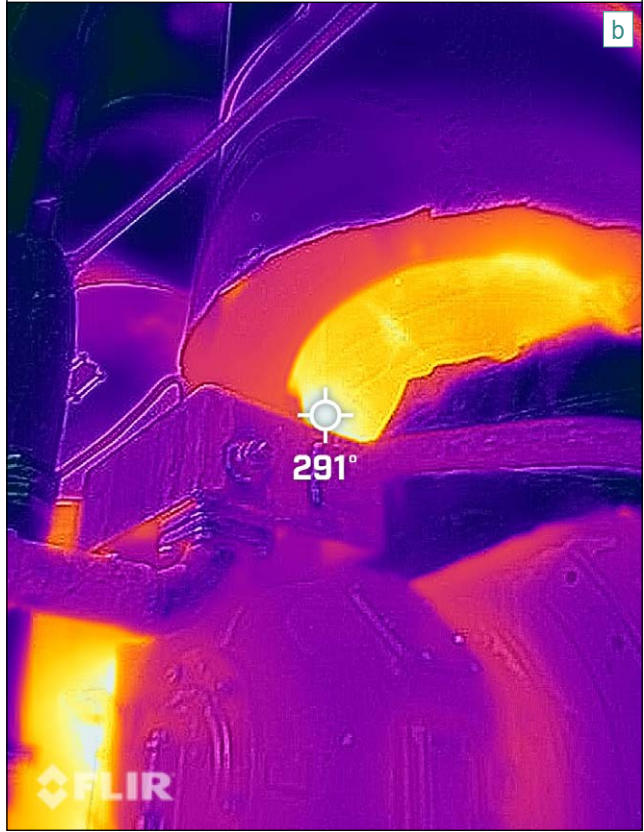
TIC still, showing hotspot of 291°C behind seemingly intact lagging

The use of infrared spot thermometers in engine spaces limited their effectiveness as they could only provide an indication of the temperature of the spot where the thermometer was pointed. The investigators' use of thermal imaging cameras to highlight *Stena Europe's* continued hot spot hazard to Stena management resulted in re-evaluation of the local insulation provision.

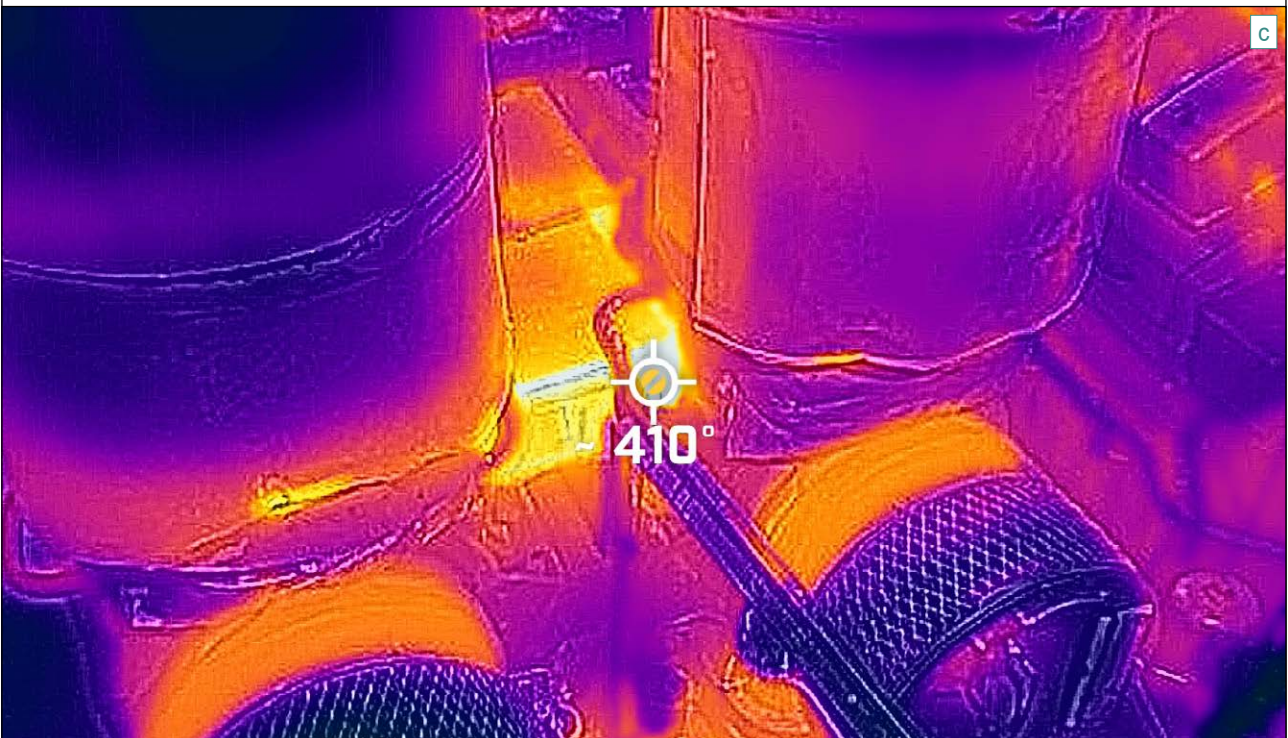
TIC still of the front of ME1, showing an unidentified exposed hot surface of 410°C
