Accident

Aircraft Type and Registration:	Diamond DA 40 NG, G-LDGB	
No & Type of Engines:	1 Austro E4-A piston engine	
Year of Manufacture:	2015 (Serial no: 40.N296)	
Date & Time (UTC):	16 May 2023 at 1445 hrs	
Location:	3 nm north-west of Oxford Airport	
Type of Flight:	Training	
Persons on Board:	Crew - 2	Passengers - 1
Injuries:	Crew - None	Passengers - None
Nature of Damage:	Rear passenger door detached from airframe	
Commander's Licence:	Commercial Pilot's Licence	
Commander's Age:	33 years	
Commander's Flying Experience:	1,700 hours (of which 500 were on type) Last 90 days - 52 hours Last 28 days - 32 hours	
Information Source:	Aircraft Accident Report Form submitted by the pilot and further AAIB enquiries

Synopsis

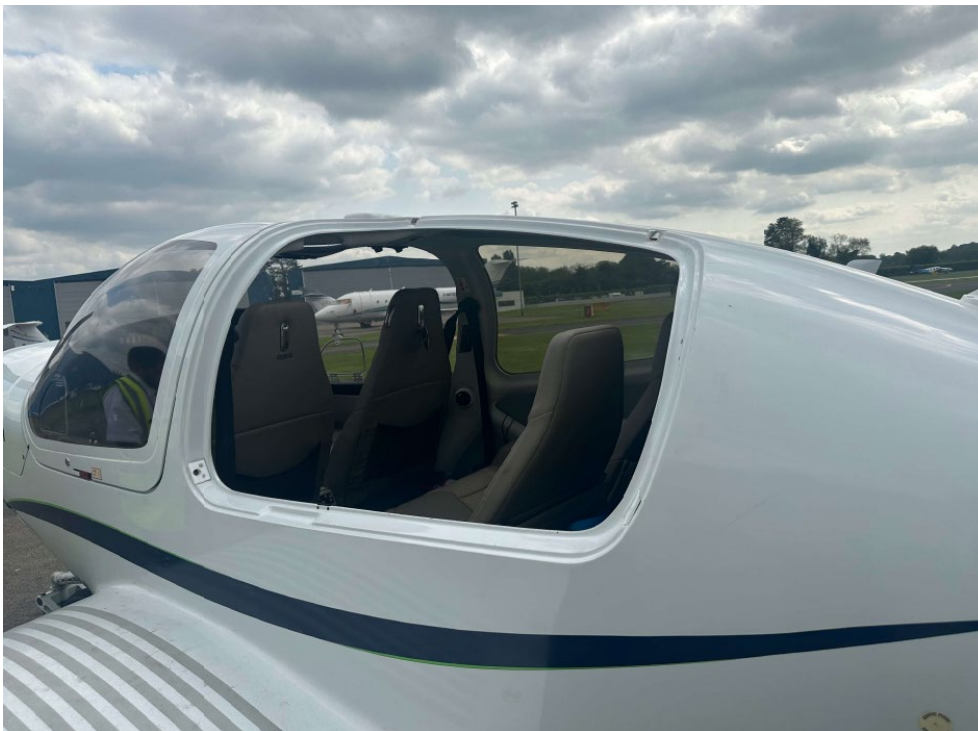
Figure 1

With the student pilot still flying, the instructor and rear seat student assessed the situation. The rear seat passenger could not reach the door to close it due to the seat restraint harnesses and shortly afterwards the door fully detached from the airframe. The instructor took control of the aircraft, contacted ATC to advise of the situation and was given clearance to land. The return to the airfield, landing and taxi were uneventful and there were no injuries to the occupants. The aircraft is shown below (Figure 1).

G-LDGB with rear door missing (image used with permission)

A check of the airframe and the recovered detached door was undertaken by the Continuing Airworthiness Management Organisation (CAMO) which concluded the following: there was no fault with the primary or secondary door locking mechanisms, the door hinges were damaged where the door had been torn away in-flight and there was no evidence of impact damage to the rest of the airframe from the door detaching in-flight.

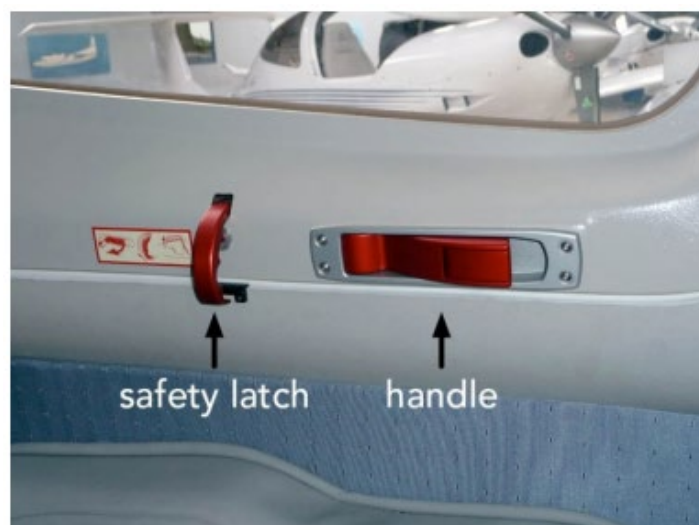
Figure 2

An additional safety latch is fitted (Figure 2). The function of this red safety latch is to hold the unlocked passenger door in a near closed position, whilst the aircraft is parked on the ground, protecting the passenger door from wind gusts. It also helps reduce the risk of a passenger door separation in case of an inadvertent opening of the door locking mechanism by a passenger during flight. Although it should be noted that the original design intent of the red safety latch was not to prevent a passenger door from separating from the aircraft because of a failure to lock the passenger door before flight.

Rear passenger door handle configuration (image used with permission)
