Accident

Aircraft Type and Registration:	Rans S6-ES, G-BZKO	
No & Type of Engines:	1 Rotax 912-UL piston engine	
Year of Manufacture:	2000 (Serial no: PFA 204-13564)	
Date & Time (UTC):	26 February 2024 at 1400 hrs	
Location:	Newtownards Airport, County Down	
Type of Flight:	Training	
Persons on Board:	Crew - 2	Passengers - None
Injuries:	Crew - 2 (Minor)	Passengers - N/A
Nature of Damage:	Shattered windscreen and skylight. Right door damaged and cuts in the Dacron fuselage covering	
Commander's Licence:	Private Pilot's Licence	
Commander's Age:	75 years	
Commander's Flying Experience:	7,627 hours (of which 10 were on type) Last 90 days - 51 hours Last 28 days - 24 hours	
Information Source:	Aircraft Accident Report Form submitted by the pilot and further AAIB enquiries

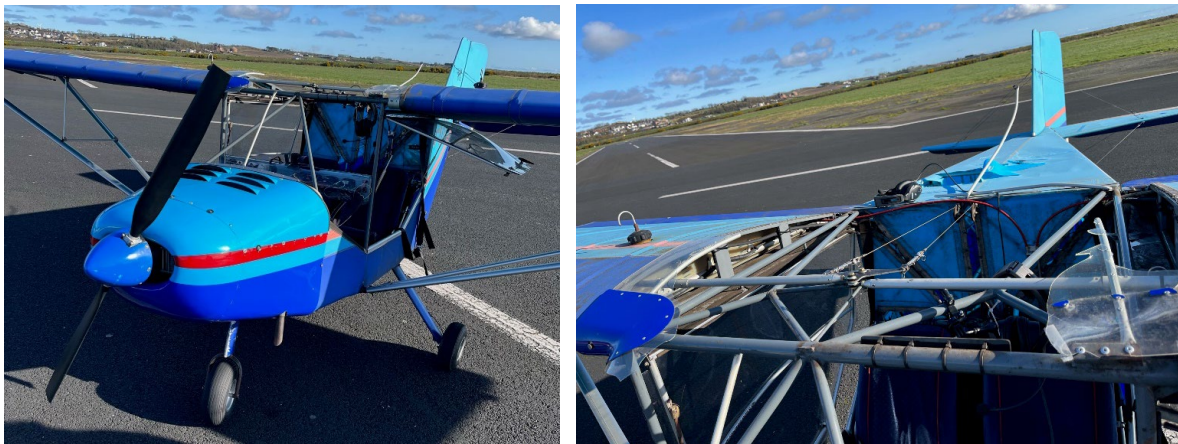
The owner said that the windscreen and skylight broke into numerous pieces and the majority had departed from the aircraft. The right door was damaged, and the Dacron fuselage material was torn in a few areas where it had been hit by broken parts. Figures 1 and 2 show the aircraft and some of the damage after landing.

Broken windscreen and torn fuselage coating

The owner's headset was reported to have been found in the rear fuselage, having apparently entered through a hole in the damaged fuselage cover. The owner visited the area where they had been flying and recovered several broken parts from the ground. He said there were no obvious indications of a bird strike.

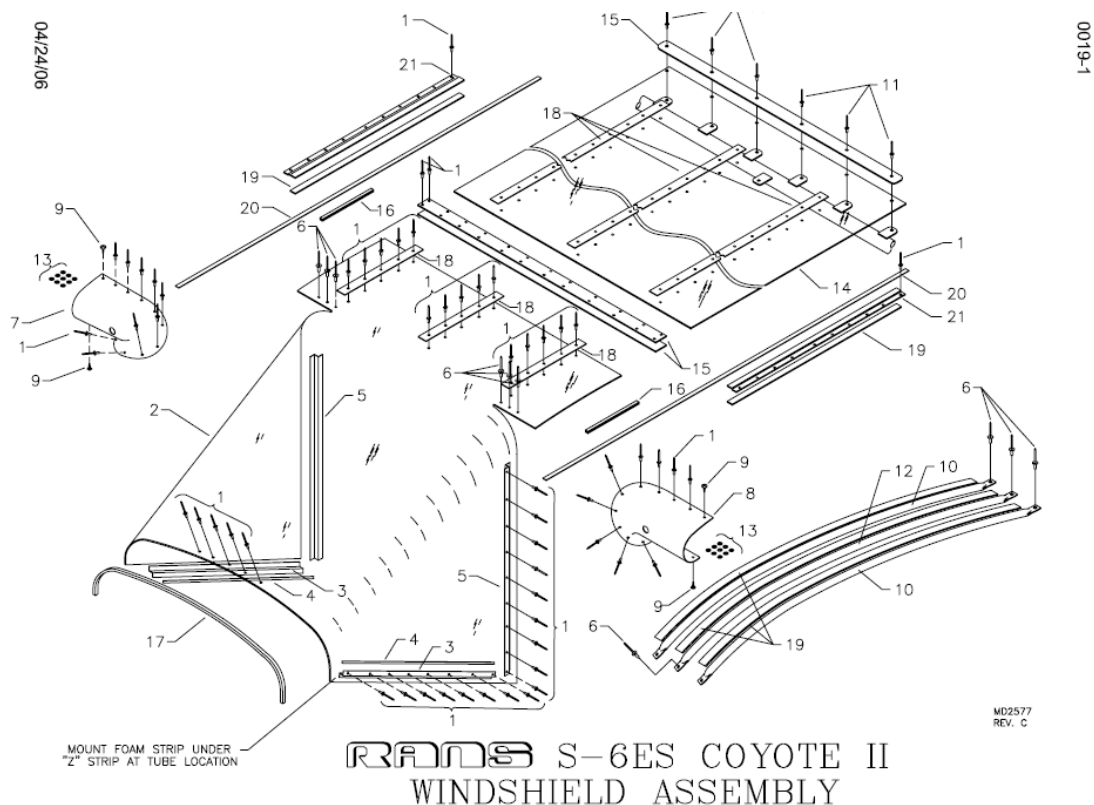
Figure 3

The windscreen and skylight assemblies are made of Lexan¹. The current aircraft parts catalogue and the build manual show the assemblies are rivetted to the aircraft framework, but 'sandwiched' between foam strips and metallic trim strips (Figure 3). The trim strips under the rivet heads spread the loads over a larger surface area, which reduces the risk of the Lexan cracking around the rivet holes. Photographs of G-BZKO after the accident showed that neither the foam strips nor the trim strips were fitted.

Parts catalogue showing the foam strips (items 19) and the trim strips (items 18)

Neither pilot could discount the possibility of a bird strike, but there was no obvious evidence. Similarly, the possibility of the windscreen shattering for another reason could not be discounted. Photographs showed that foam strips and trim strips, intended to reduce localised stresses in the acrylic, were not fitted. The trim strips were introduced in 1995, but the foam strips were a requirement from the original design. The absence of the foam strips could potentially have contributed to the failure if their omission caused localised cracking in the Lexan.

The LAA will publish an article in their Light Aviation magazine to highlight the potential consequences of a windscreen shattering in flight, and the need to comply with manufacturer's construction drawings and assembly methods.
