Rail Accident Investigation Branch

# Rail Accident Report

## **Collision between on-track machines near to Strood, Kent 16 November 2023**

Report 11/2024  
October 2024

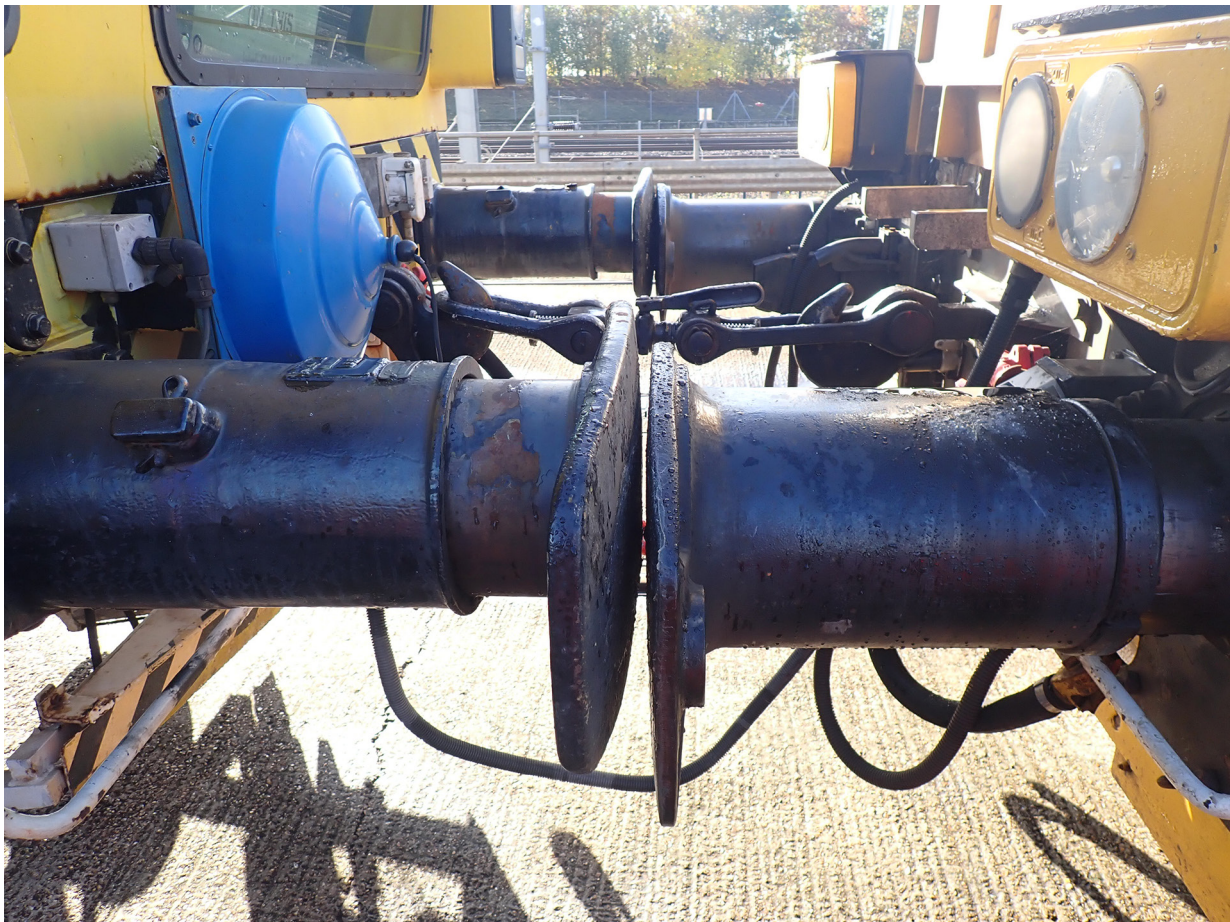
- 38 When MPV2 struck the tamper, driver 1 was in the space between MPV1 and the tamper (figure 8), about to place the tamper's coupling shackle over the hook on MPV1. The impact caused the vehicles to move around 1.4 metres. Driver 1 was hit in the back, knocked to the ground and overrun by the front end of the tamper.

Figure 8: The space between MPV1 and the tamper in which driver 1 was standing.

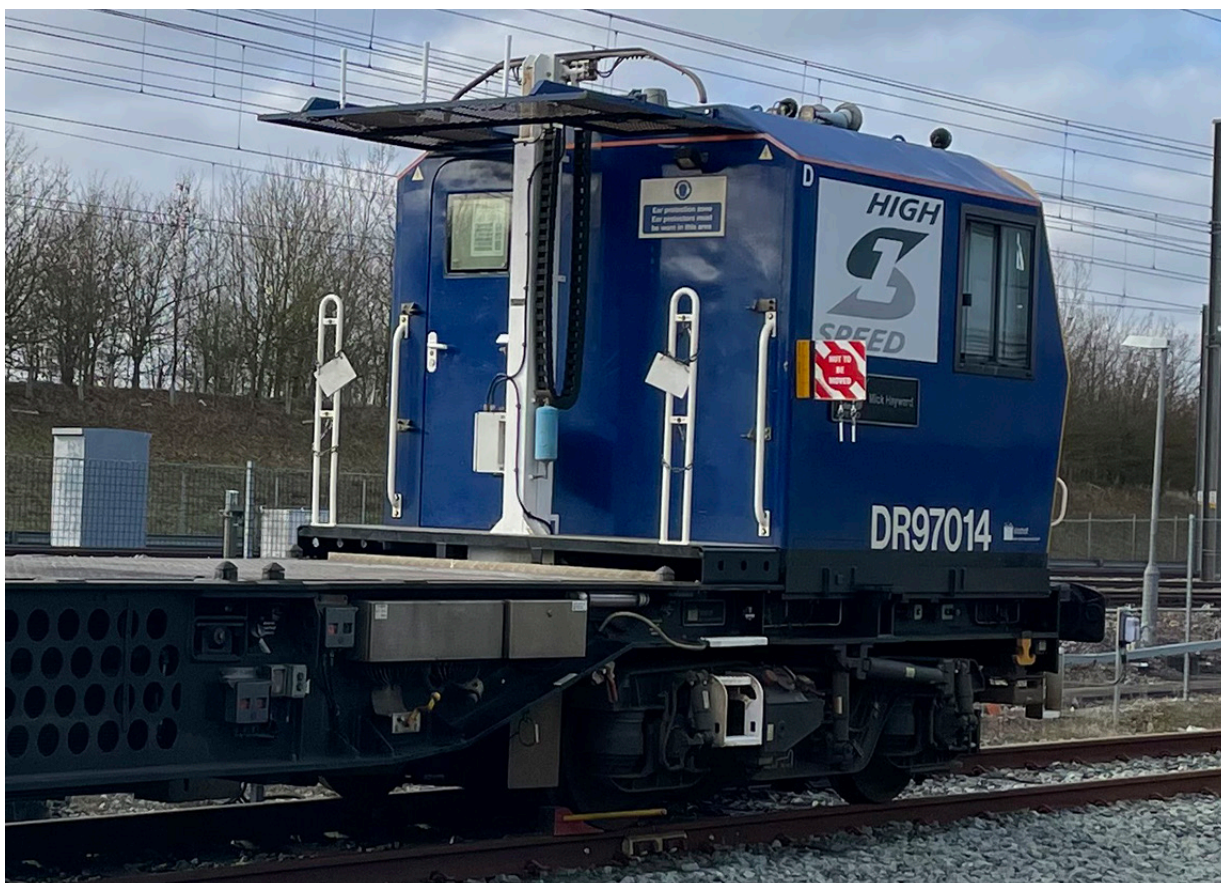
- 49 There was no view to the rear of the vehicle (which was the leading end during the movement) from the MPV's cab which would have permitted driver 2 to see the line ahead during this propelling move. Although driver 2 was in the habit of leaving the cab side window open when making propelling moves and there was a window in the cab door (figure 9), a container on the rear deck of MPV2 on the night of the accident blocked the driver's view of both the line ahead and of the machine controller. This meant that driver 2 was solely reliant on radio instructions from the machine controller to know when to stop the vehicle.

Figure 9: The rear of an HS1 MPV cab. On the night of the accident a container was mounted on the rear deck.

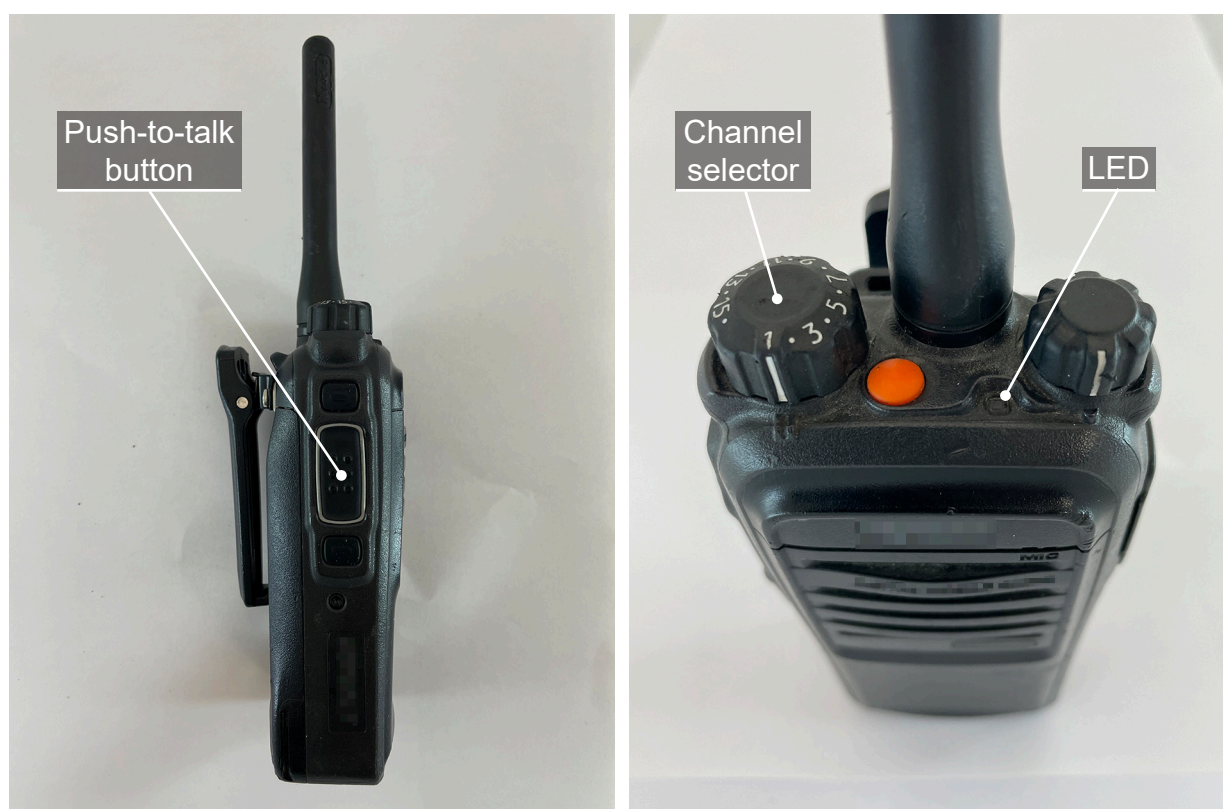
- 57 RAIB tested the radios used on the night of the accident and found that, although driver 2's radio functioned as expected, the machine controller's radio had an intermittent fault, which caused the battery to lose electrical contact with the radio. This removed power from the radio, which would then cease to function.
- 58 Tests also showed that, after the radio had been switched on for a few seconds, it did not display any indication that it was switched on and ready to transmit. When the push-to-talk button was pressed, the light-emitting diode (LED) indicator on the radio illuminated red to show that a transmission was being made. When receiving a transmission from another handset this LED illuminated green (figure 10). These features are as the radio was designed.

Figure 10: Radio used by the machine controller on the night of the accident, showing LED, channel selector and push-to-talk button.

- 59 As the radios do not display any visual indication that they are on, other than when transmitting or receiving, it is not possible for a user to tell whether the radio is live and functioning correctly or not without pressing the push-to-talk button and observing the LED indicator illuminate.

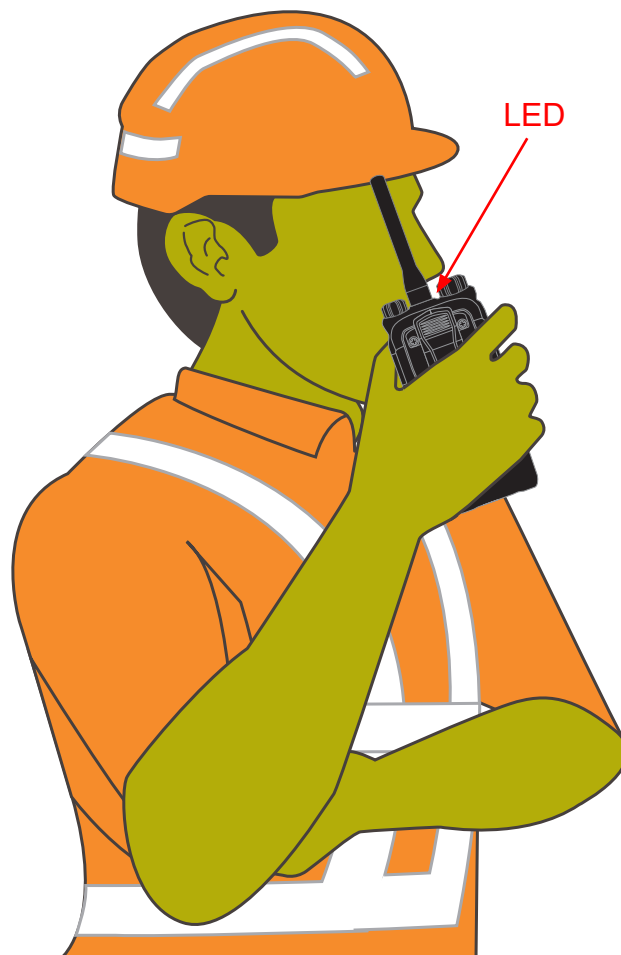
- 61 Given the LED's position on the handset, it is possible that the machine controller would not have noticed whether this LED illuminated or not when the push-to-talk button was pressed, as the radio would have been positioned very close to the machine controller's face to enable them to transmit a clear message to driver 2 (figure 11).

Figure 11: Radio held in a talking position, making the LED difficult to see.

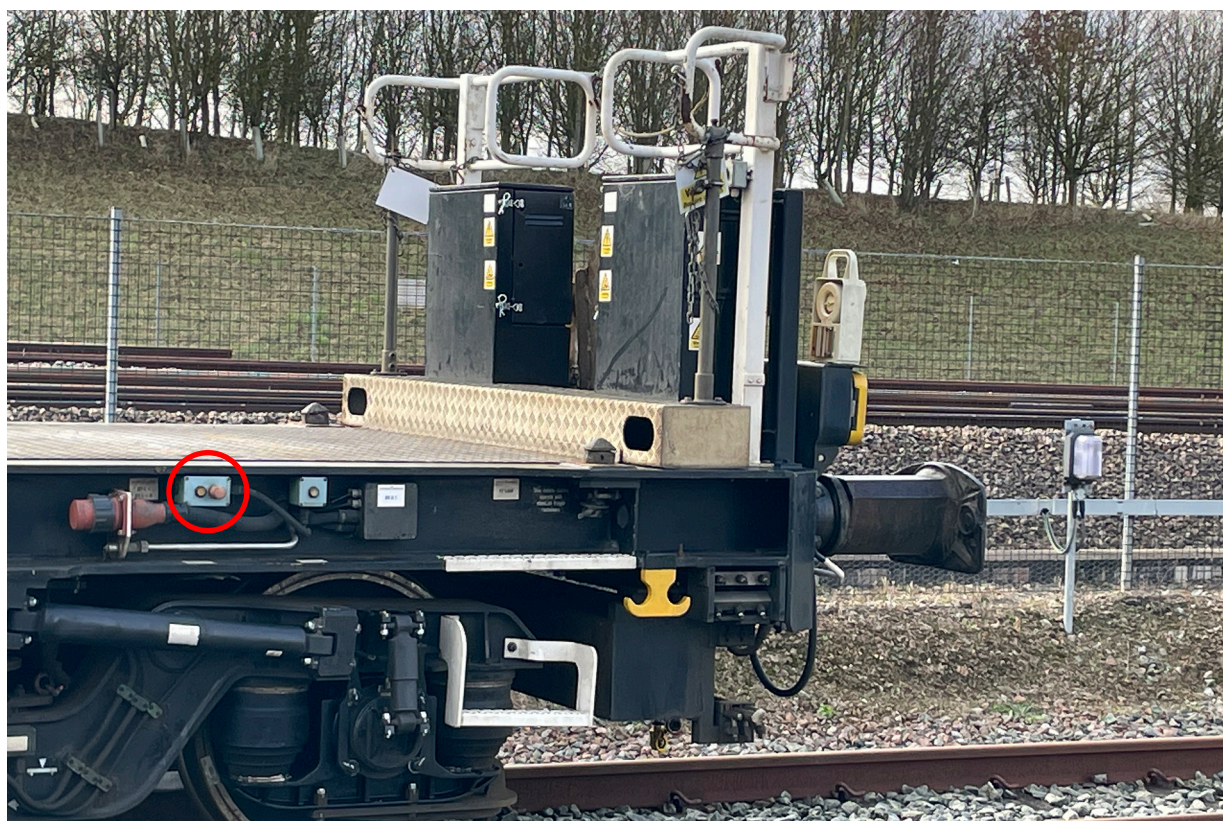
73 The HS1 MPVs were manufactured with a single cab at the front. Braking controls, in the form of emergency stop buttons, are fitted at several locations along the sides of the vehicle (figure 12), but these were intended for use by personnel working or walking alongside the machine. As the buttons were out of the reach of a machine controller riding on the rear of the load deck, they were not safe to operate while the MPV was moving.

Figure 12: The emergency stop buttons fitted to the sides of HS1 MPVs.

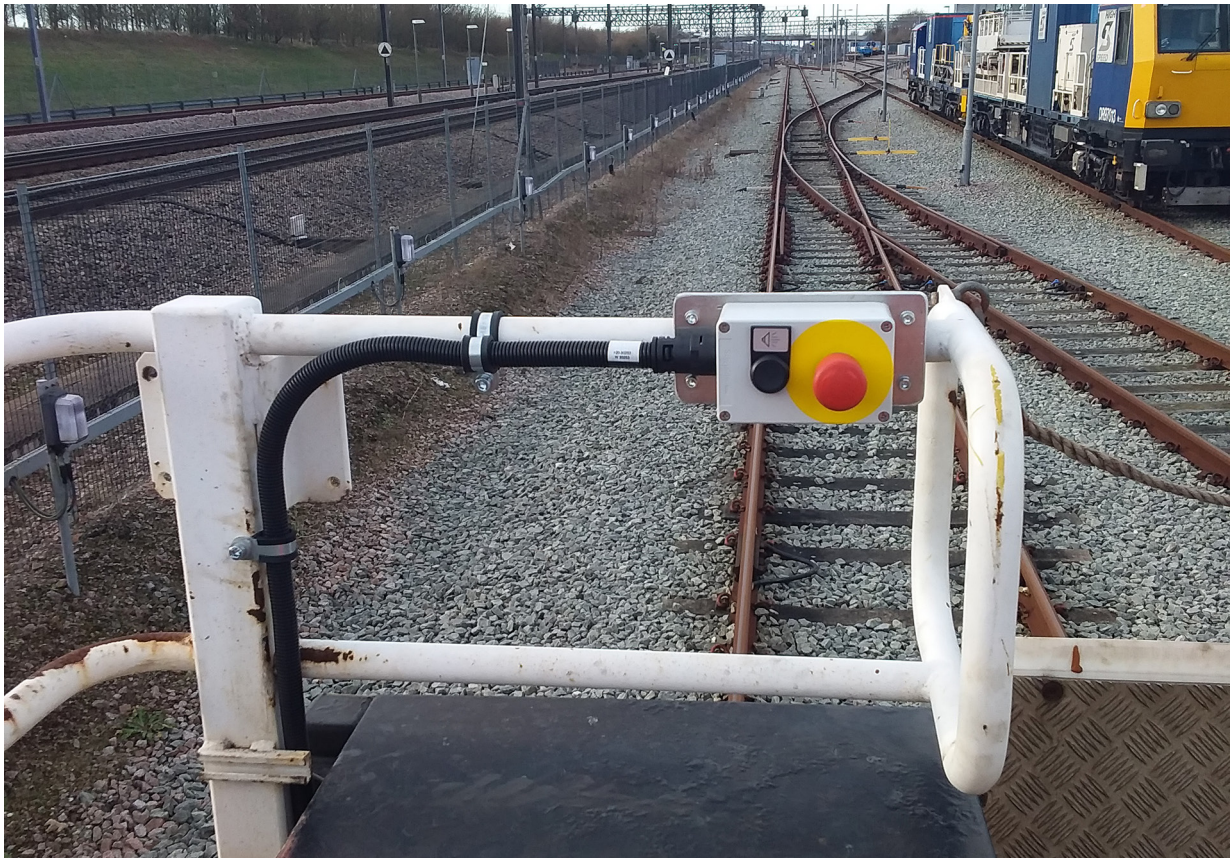
Figure 14: The new emergency stop and horn buttons on HS1 MPVs.

- a. fitted emergency stop and warning horn buttons to the rear deck positions of each MPV (figure 14), which, like the controls on each side of the MPV, apply the vehicle's emergency brakes
- b. purchased headsets that enable secure open microphone communication between the cab and the rear standing positions of each MPV
- c. updated the HS1 Rule Book with instructions for use of these radios and a requirement for drivers to stop if there is no communication for 10 seconds.
