Rail Accident Investigation Branch

Rail Accident Report

Collision between a road-rail vehicle and a trolley near Brading, Isle of Wight 22 November 2023

Report 12/2024
October 2024

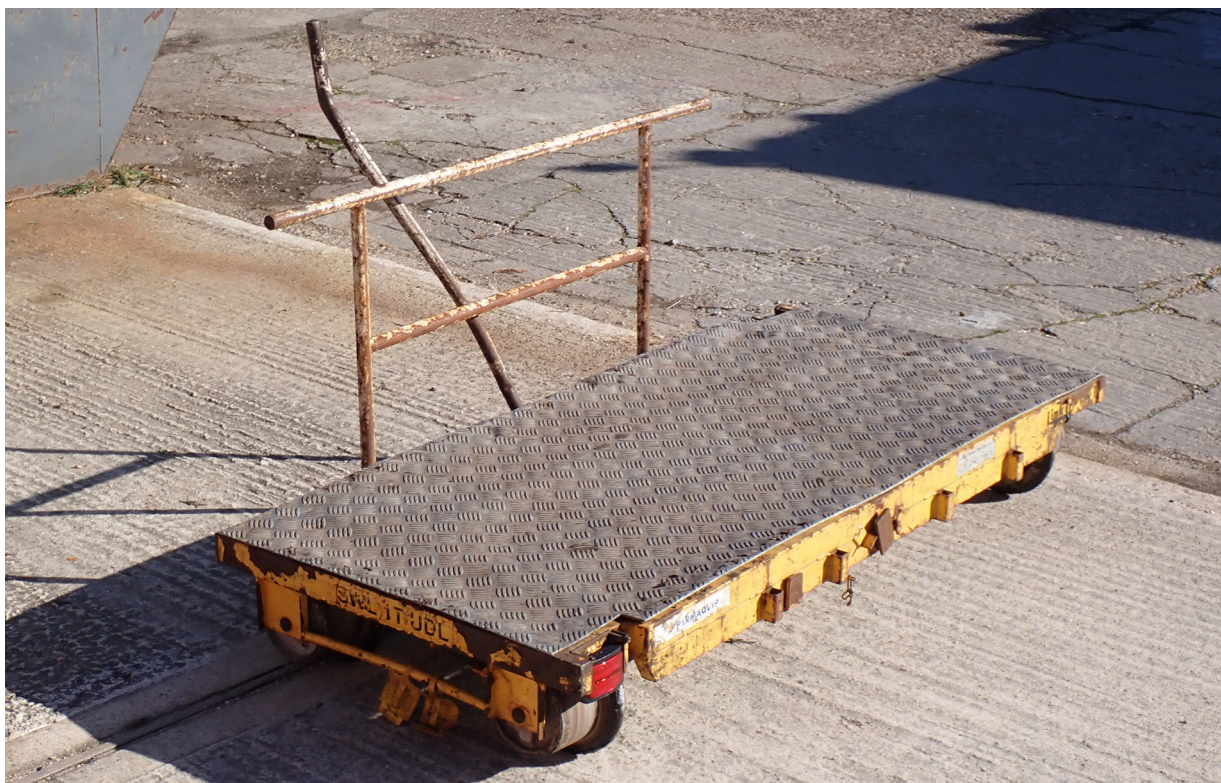
- 18 The hand trolley, which was struck by the RRV, weighs 50 kg unloaded and has a carrying capacity of 1000 kg (figure 4). It had red lights affixed front and back as required by GERT8000 (the Rule Book) HB10, 'Duties of the COSS or SWL [safe work leader] and person in charge when using a hand trolley', issue 4.1, dated November 2022.
- 19 Before the accident, the hand trolley was being used to carry hand-tools, jacks, petrol-driven hand-tamping machines and fuel cans.

Figure 4: Hand trolley used on 21 to 22 November 2023.

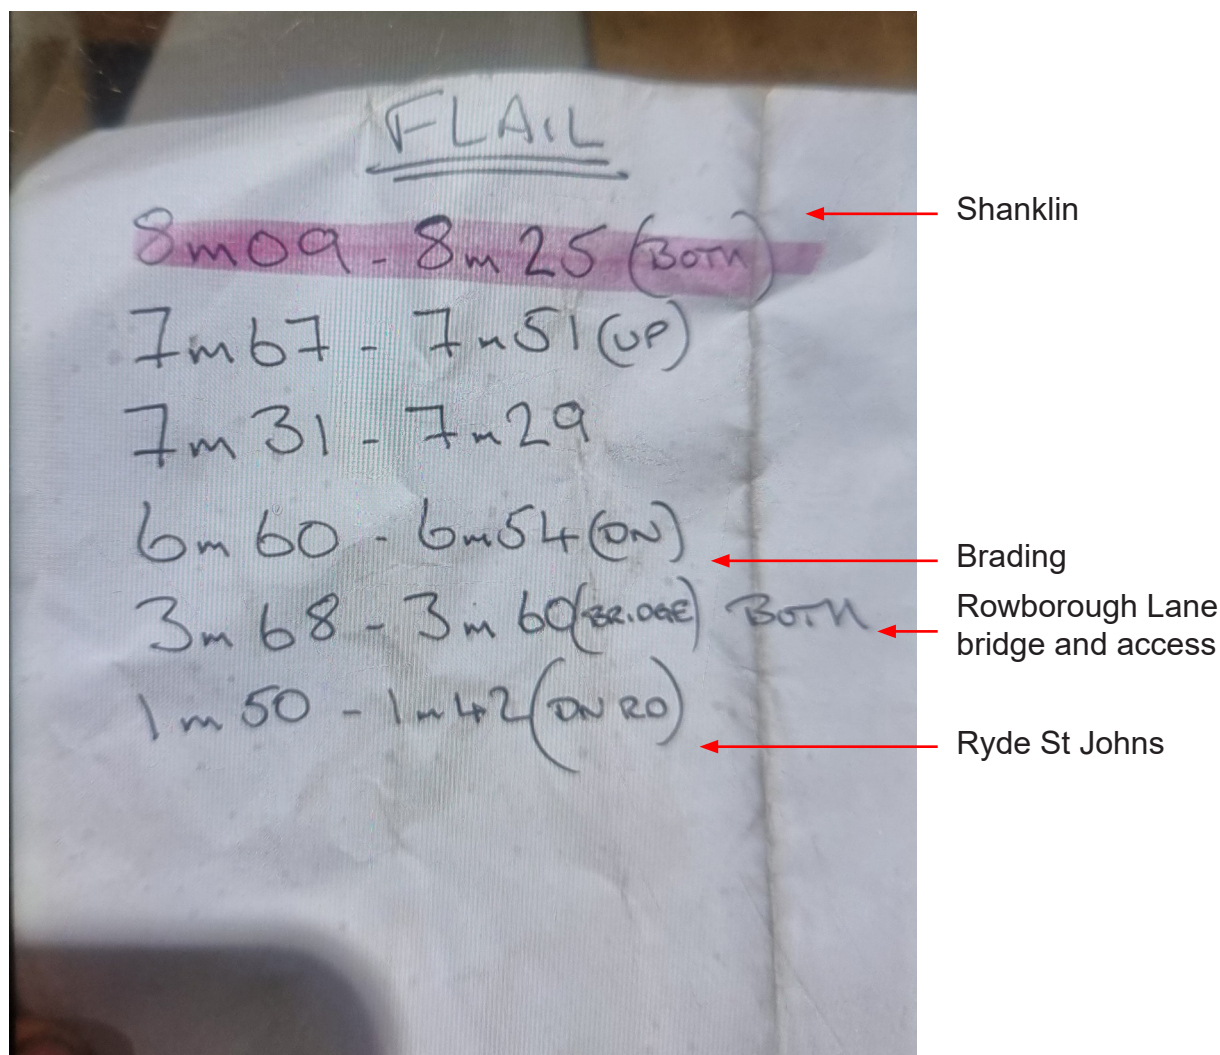
- 44 During the briefing at Sandown yard, the ES gave the MC a handwritten list of six locations where lineside vegetation was to be cut back (figure 8). As the SWP (RRV) did not include details of any tasks or sites of work for the RRV, the ES instructed the MC to start cutting vegetation at 1 mile 42 chains, towards the north end of the line near Ryde St Johns station, and then travel back to the next location at Rowborough Lane bridge (3 miles 60 chains). The MC stated that the ES had told them that the track repair work group would be at Brading station. The first two RRV sites of work were both located north of Brading (figure 9).

Figure 8: Handwritten list of sites of work which the ES gave to the MC.

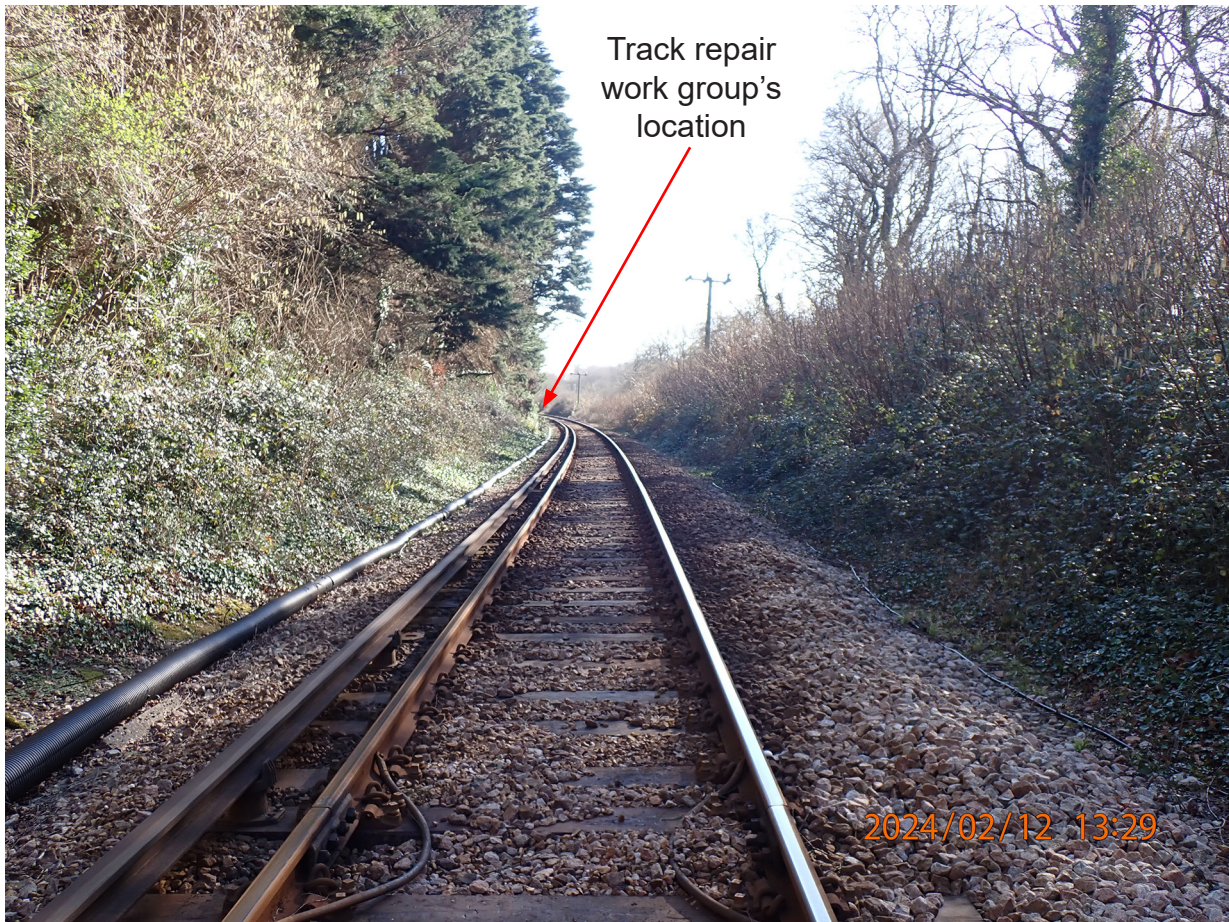
- 53 The RRV, on passing over the summit of the hill, started to descend. Analysis undertaken by RAIB has concluded that the MO would have been able to see the work group from the RRV cab from a maximum of 240 metres away, as sighting was obstructed by trees on the inside of the left-hand curve before this point (figure 10). As they came into view, the MO could see the reflective strips on the work group's protective clothing. The usual procedure when the RRV encountered work groups on the track during possessions was to stop close enough to the work group to allow the MC and COSS to communicate and arrange the safe passage of the RRV. The MO anticipated, therefore, that they would need to stop and wait until the track was clear and they could be waved through.

Figure 10: View looking south from 3 miles 25 chains, with first sighting of the accident location around 240m ahead.

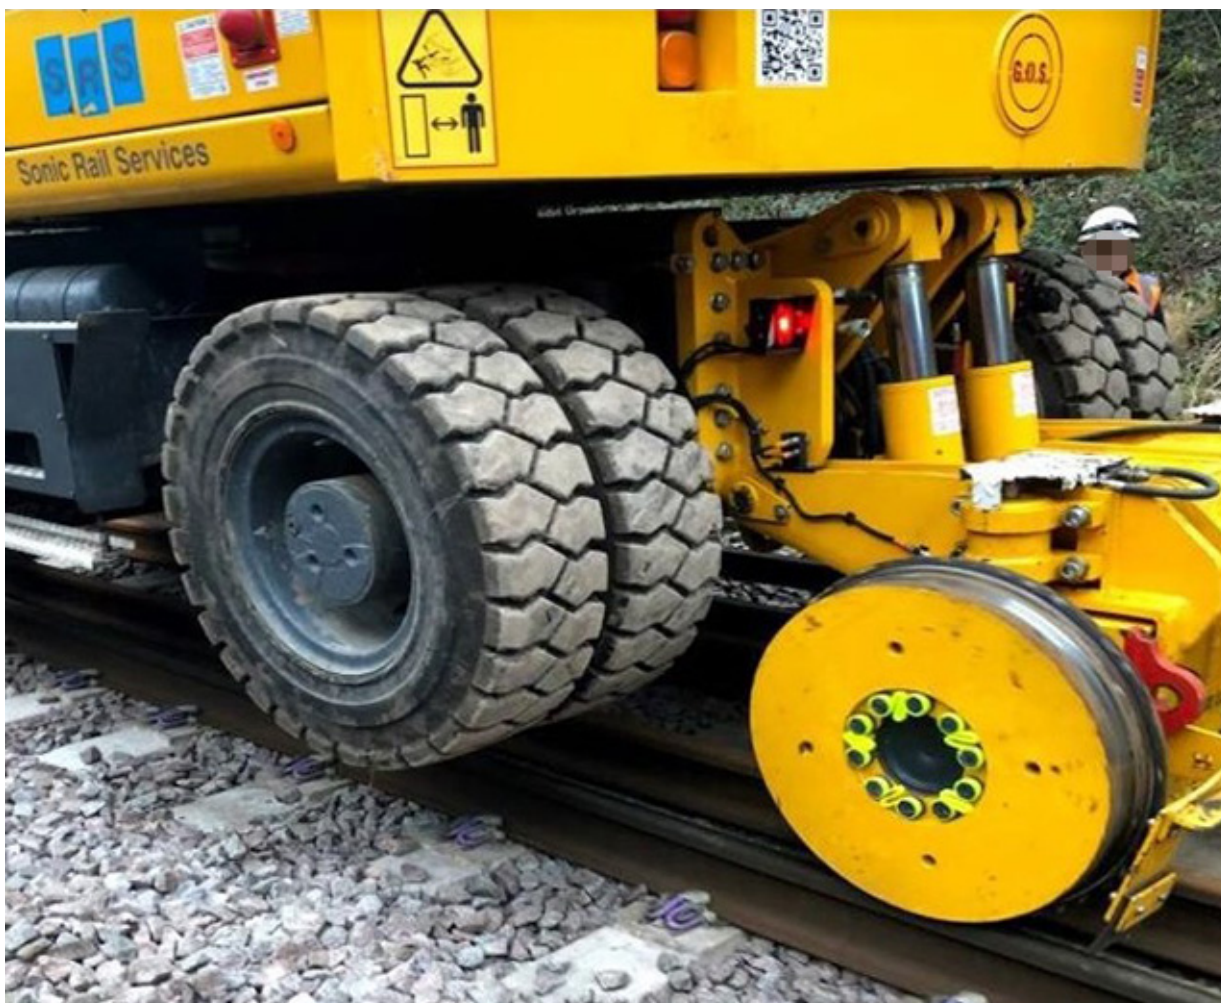
Figure 11: An RRV of the same type showing the overhang of the rubber tyre in relation to the rail (courtesy of Sonic Rail Services).

- 59 The MO and MC believed the group and trolley were clear of the track when they started to pass them. The MO and MC were unaware that the RRV's tyre had struck the corner of the trolley as they did not feel the impact. They were also unable to see the collision due to the view from the RRV's cab being obstructed by part of the machine.
- 60 After the RRV came to a stop, the MC got out via the rear cab door to check the RRV wheels for a possible cause of the RRV's poor stopping performance. They did not find anything of concern.
