AAIB Bulletin

12/2024

Aircraft Type and Registration:	Boeing 737-8K5, G-TAWD	
No & Type of Engines:	2 CFM56-7B27E turbofan engines	
Year of Manufacture:	2011 (Serial no: 37265)	
Date & Time (UTC):	20 October 2023 at 1153 hrs	
Location:	Leeds Bradford Airport	
Type of Flight:	Commercial Air Transport (Passenger)	
Persons on Board:	Crew - 6	Passengers - 195
Injuries:	Crew - None	Passengers - None
Nature of Damage:	Main landing gear tyres and nosewheel tyres damaged. Left nosewheel inner axle bearing destroyed	
Commander's Licence:	Airline Transport Pilot's Licence	
Commander's Age:	41 years	
Commander's Flying Experience:	14,250 hours (2,800 hours on type) Last 90 days - not known Last 28 days - 88 hours	
Information Source:	AAIB Field Investigation

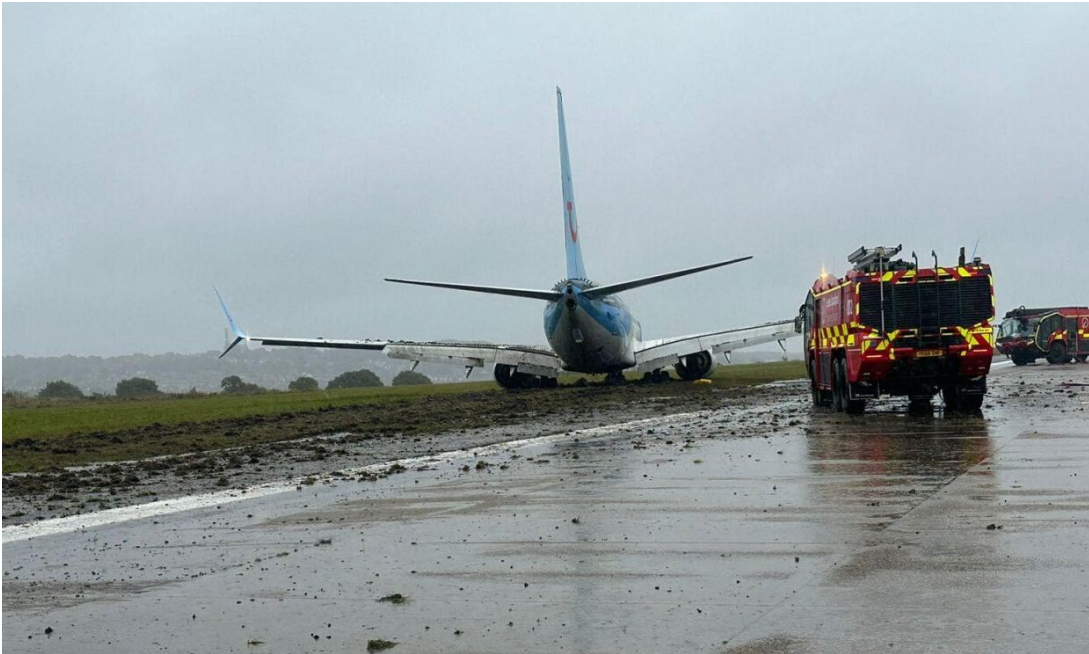
Figure 1
Aircraft final position

The aircraft came to a stop six seconds later in muddy ground approximately 150 m beyond the D taxiway exit (Figures 1 and 2). The crew followed normal shutdown procedures to secure the aircraft. There were no injuries reported by passengers or crew.

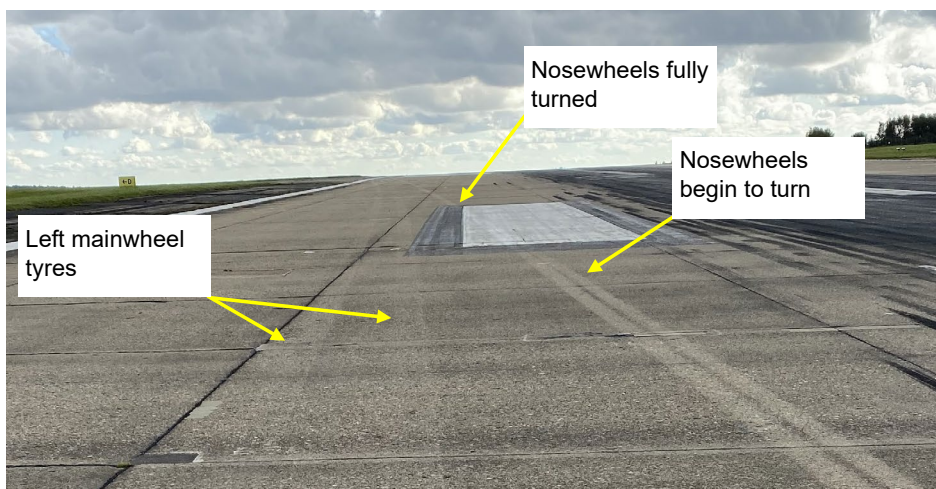
Figure 3
Runway tyre marks in direction of travel

‘Steam-cleaned’ tyre marks can indicate the presence of reverted rubber hydroplaning.

The 'cleaned' runway tyre markings are typically only associated with reverted rubber hydroplaning. However, no evidence of reverted rubber was found on the mainwheel or nosewheel tyres which requires locked wheels to occur, nor were there corresponding 'melted' rubber deposits on the runway. The runway marks suggest that the surface temperature underneath all the tyres was high enough to turn some of the water on the runway's surface into steam but not high enough, nor combined with locked wheels, to cause rubber reversion. The aircraft deceleration rate and braking forces applied confirms that the aircraft was not friction-limited at any point and hydroplaning was not a contributory factor in this event.

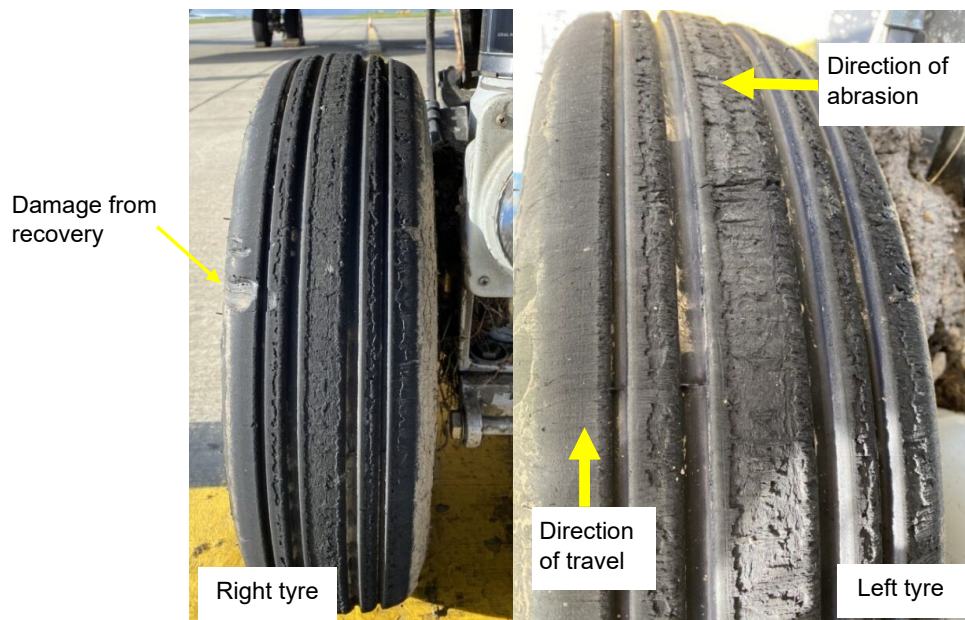
Figure 6
Nosewheel tyre damage

Both nosewheel tyres had abrasion surface damage around their entire circumference. The type, direction and quantity of damage indicates it occurred when the nosewheels were turned nearly perpendicular to the direction of travel (to the right), and that the wheels were still rotating (Figure 6). Neither nosewheel tyre showed damage corresponding to a locked wheel condition or rubber reversion in the un-abraded sections of their surface.

The nosewheel tyre damage is consistent with abrasion scrubbing from being turned to an angle nearly perpendicular to the direction of travel whilst the tyres were rotating and in contact with the runway; also demonstrated by the runway marks left by the nosewheel tyres. The angle of the nosewheels could only be achieved by use of the tiller rather than rudder pedal steering alone, and this corresponds with the commander's account of events.

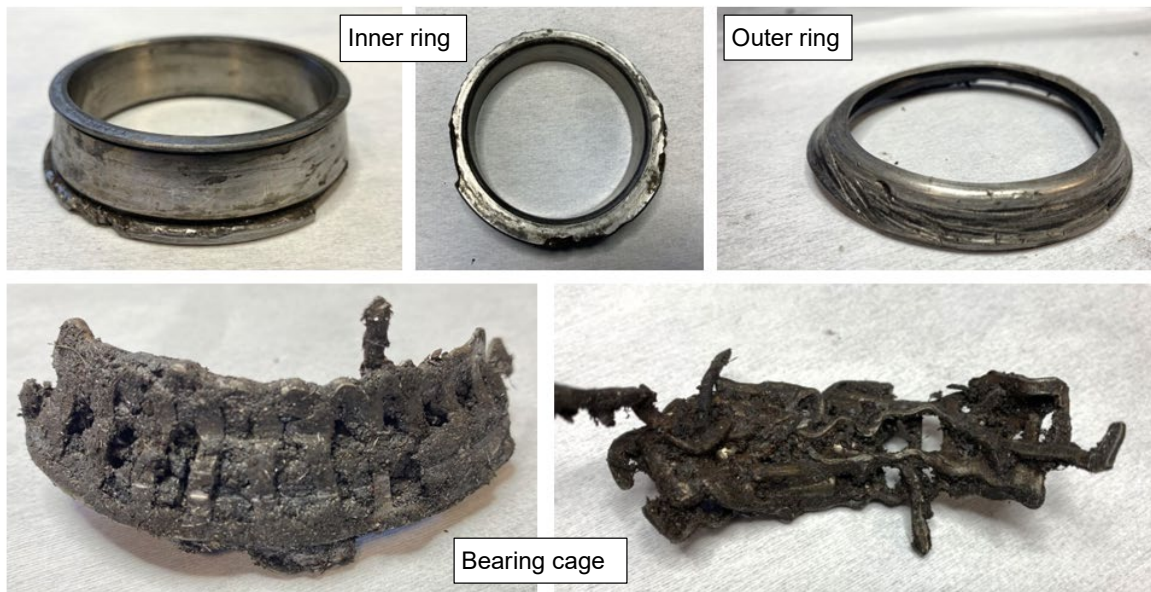
Figure 7

The left nosewheel was removed which revealed that the inner axle bearing had failed (Figure 7), while the outer axle bearing was undamaged. Each nosewheel has an inner and an outer axle bearing which are replaced on condition and do not have a fixed service life. This bearing was fitted during a routine wheel overhaul in September 2022.

Prior to removal, the left nosewheel had significant play on the axle but was free to rotate. It is probable that the play of the nosewheel on the axle occurred during the recovery process as, had it been present during the landing roll, significant damage to the outer bearing and further damage to the wheel and axle would have been expected.

Left inner nosewheel bearing components

It could not be confirmed when the nosewheel bearing began to fail, but it is likely that it suffered catastrophic failure during the rollout at LBA and was contributory to the vibration through the rudder pedals as felt by the commander. The failure of the bearing did not prevent the nosewheel from rotating nor did it affect the ability to steer the nosewheels.

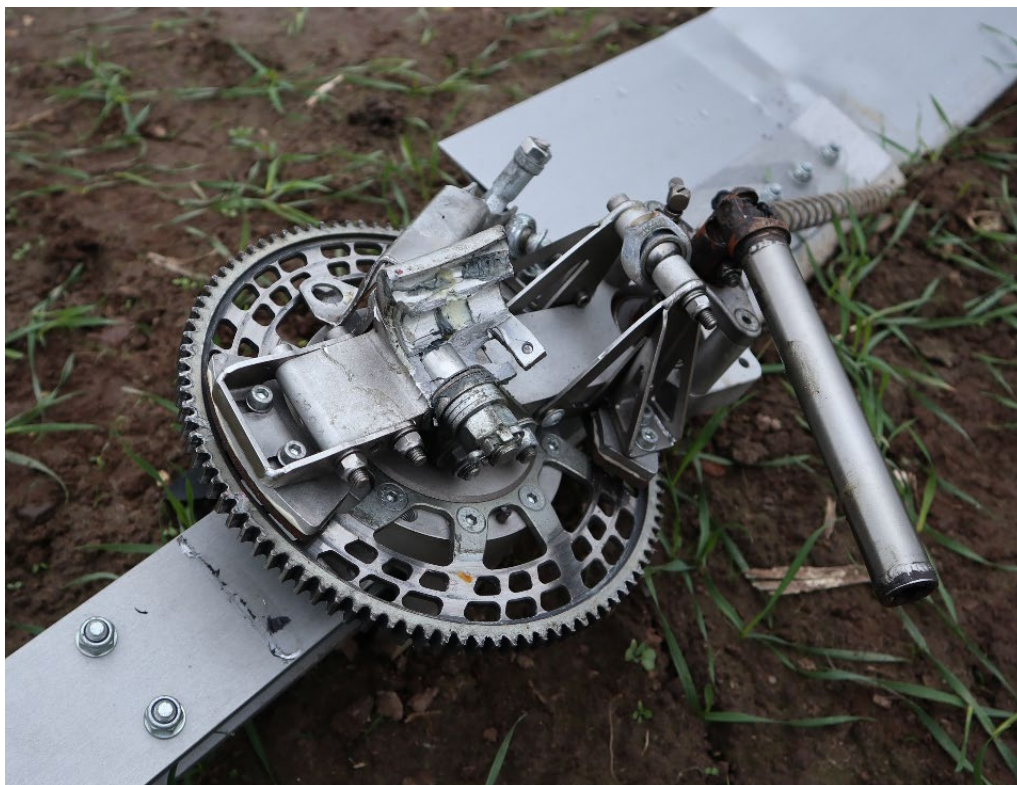
Figure 13

The gimbal block had failed where two cracks joined. One ran vertically through the roll bolt hole and down the length of the block. The other fracture surface ran horizontally through the centre of the pitch bolt hole for half the width of the gimbal block until it met the vertical fracture surface. The pitch bolt was retained in place and secured the largest section of the gimbal block to the rotor head (Figure 13). The other smaller section of gimbal block was missing and despite an extensive search, could not be located on the accident site or the surrounding fields.

Rotor head showing gimbal block failure, rotor blade deformation and teeter stop contact mark

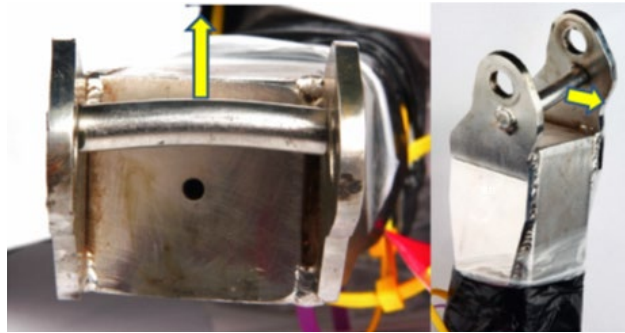
Figure 14

The roll bolt remained fitted to the top of the mast section. The roll stop bar in the mast had deformed to become curved, rather than straight (Figure 14).

Deformation of mast roll stop bar (with roll pivot bolt removed)

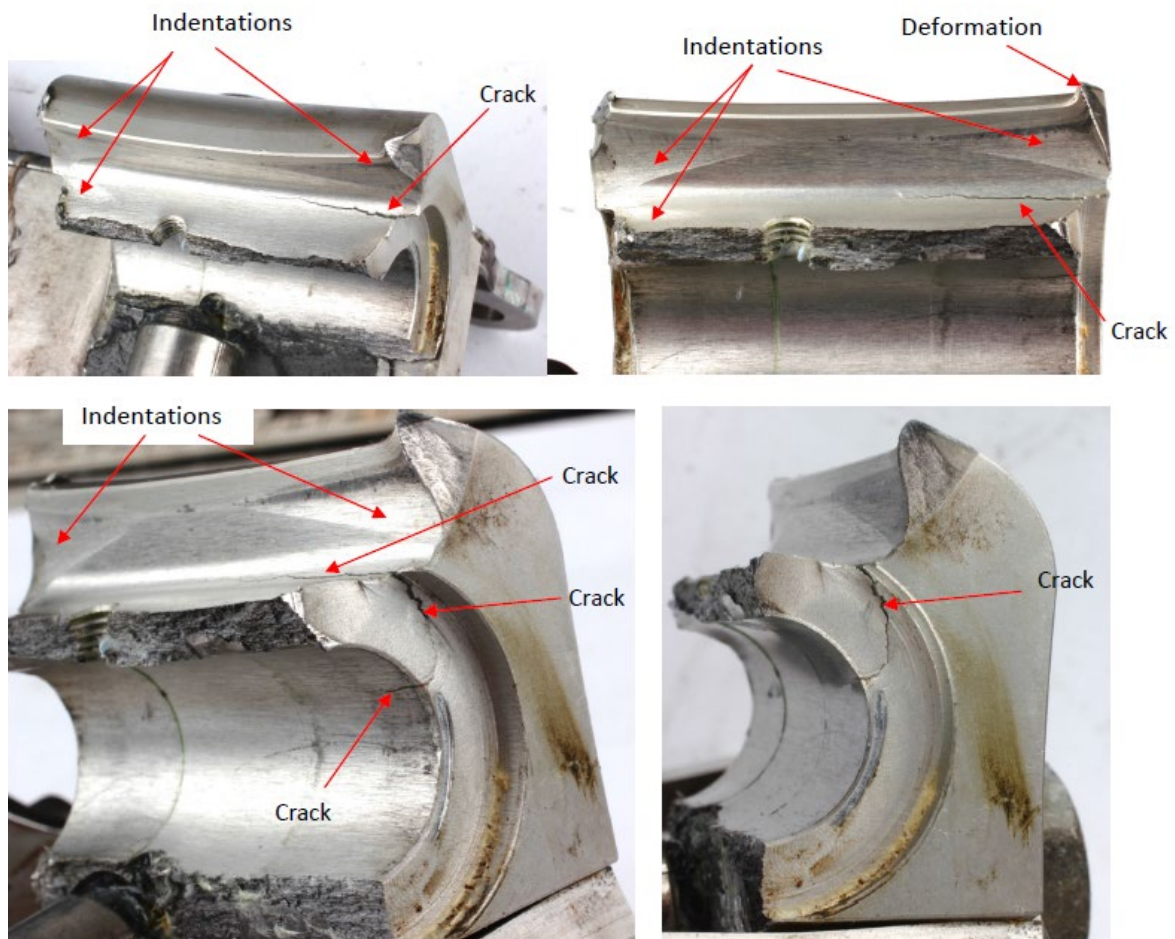
Figure 16

The rotor bridge, gimbal block and mast were removed from the wreckage and sent for metallurgical analysis. Detailed inspection of the gimbal block showed evidence of additional cracks at one end of the block. There was also a curved indentation in the side wall at each end of the channel that acted as a roll stop (Figure 16). The extent of the missing material is shown in Figure 17.

Additional cracks and deformation of the gimbal block

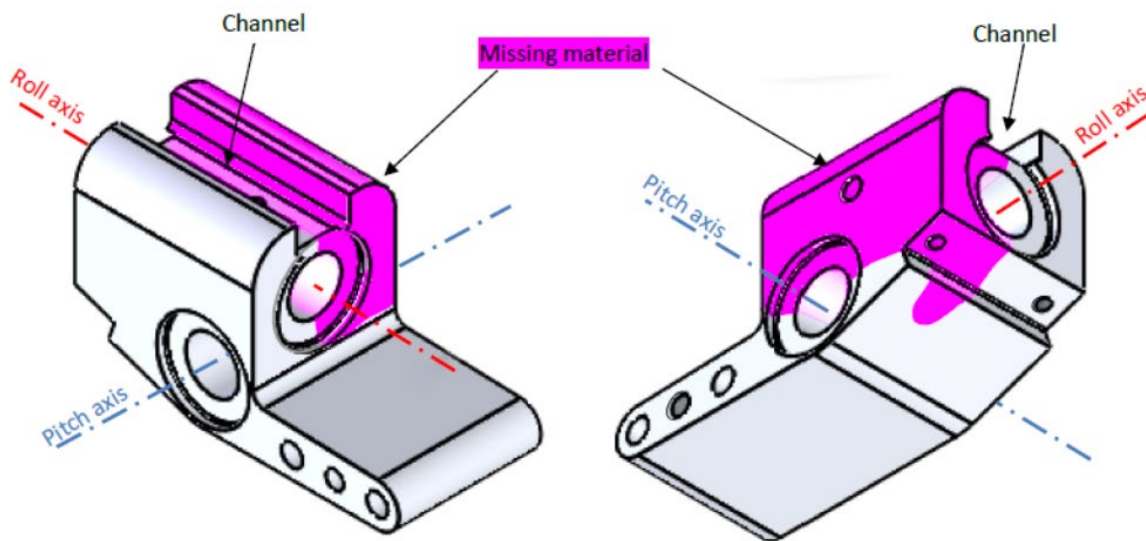
Figure 17

Extent of missing material from the gimbal block
(shown inverted relative to its installed orientation)

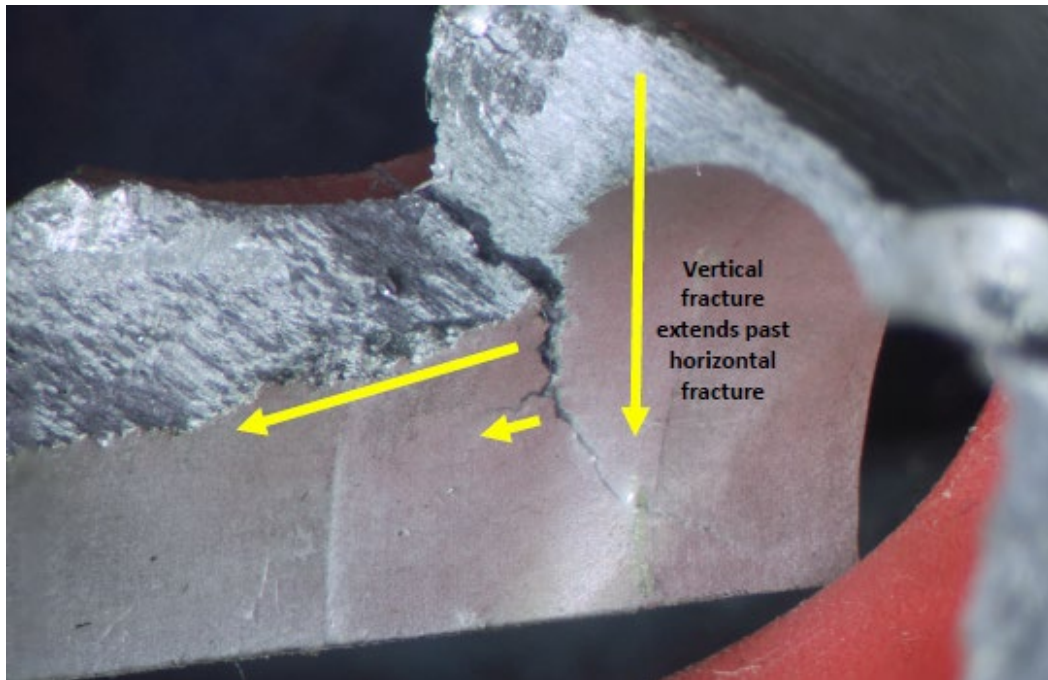
Figure 18

Image showing the vertical fracture surface extending past the horizontal fracture

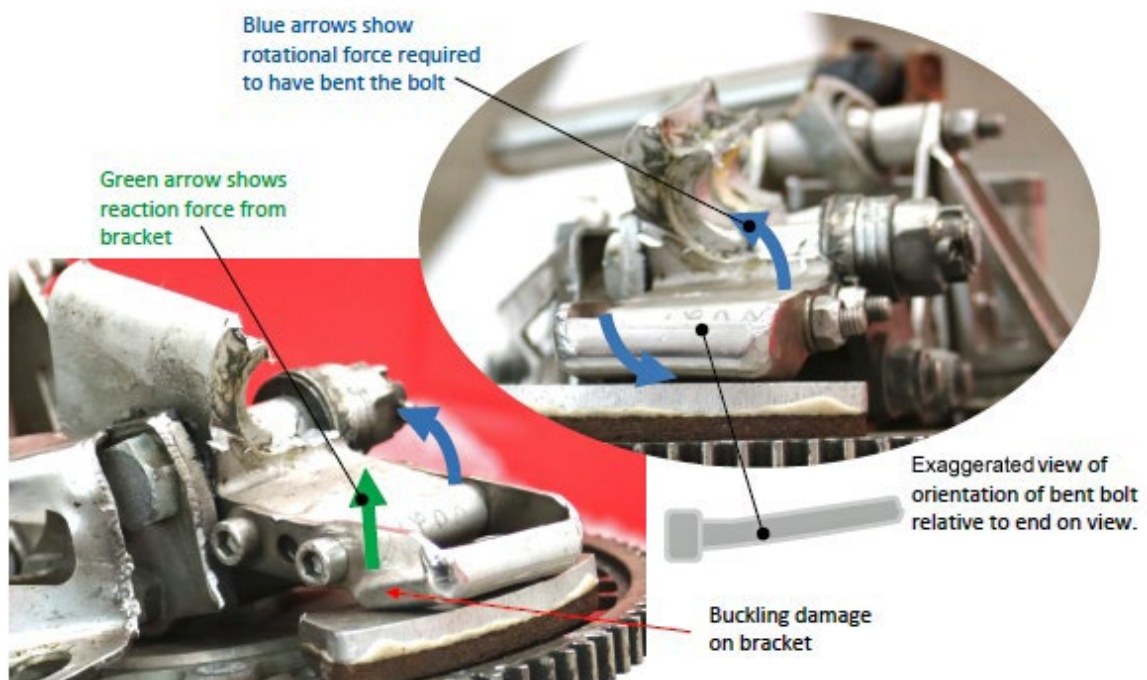
Figure 19

The side plates which attached the gimbal block to the rotor bridge on both sides were significantly distorted and the bolt holes were elongated. The bolts and bracket attaching the front brake pad assembly to the gimbal block were also distorted, indicating a rotational force on the gimbal block (Figure 19).

Images of the distorted brake pad bracket and bolts indicating a rotational force

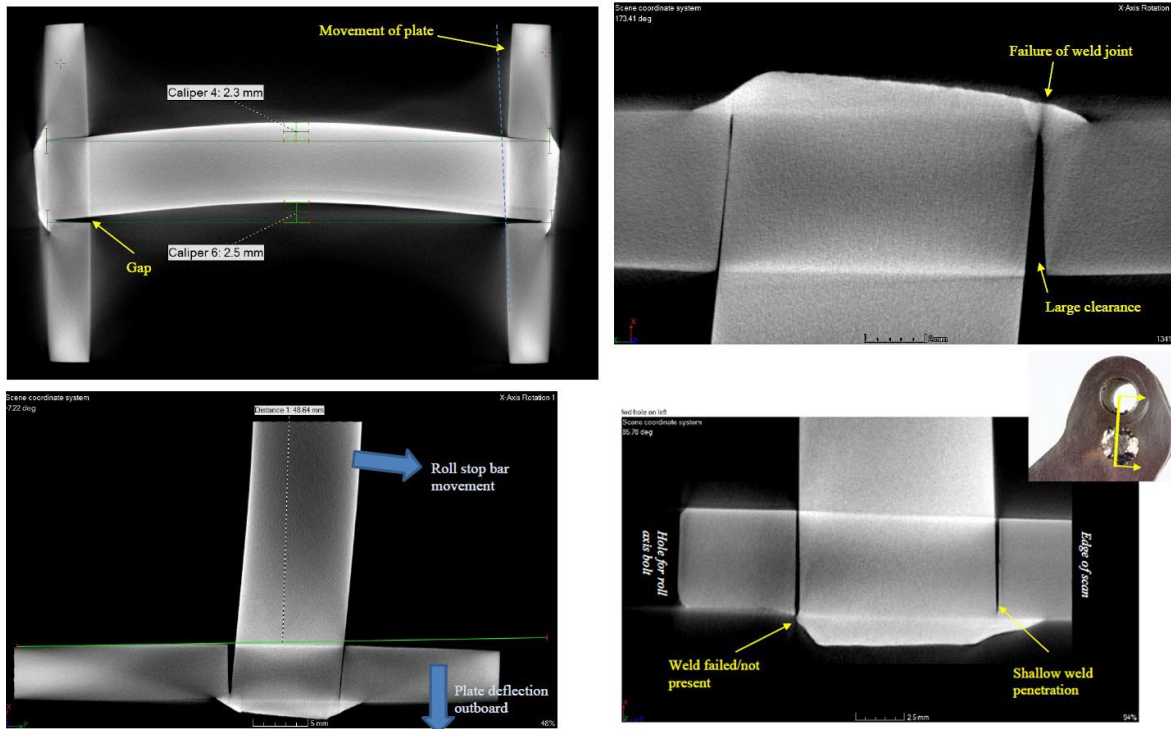
Figure 20

A CT¹¹ scan was carried out on the mast, which confirmed the extent of the roll stop bar distortion and the distortion from vertical of the side plates which supported the bar and the roll pivot bolt. The orientation of the bend in the bar was consistent with the indent marks on the gimbal block. It also showed that the end welds fixing the roll stop bar in the side plates were surface welds on the exterior of the plates, with very little penetration into the plate material. The welds on both sides of the plate had failed or on one side the weld may not have extended across the hole in the plate originally (Figure 20).

CT scan showing the distortion of the bar and side plates, the shallow weld size and weld failure on both sides

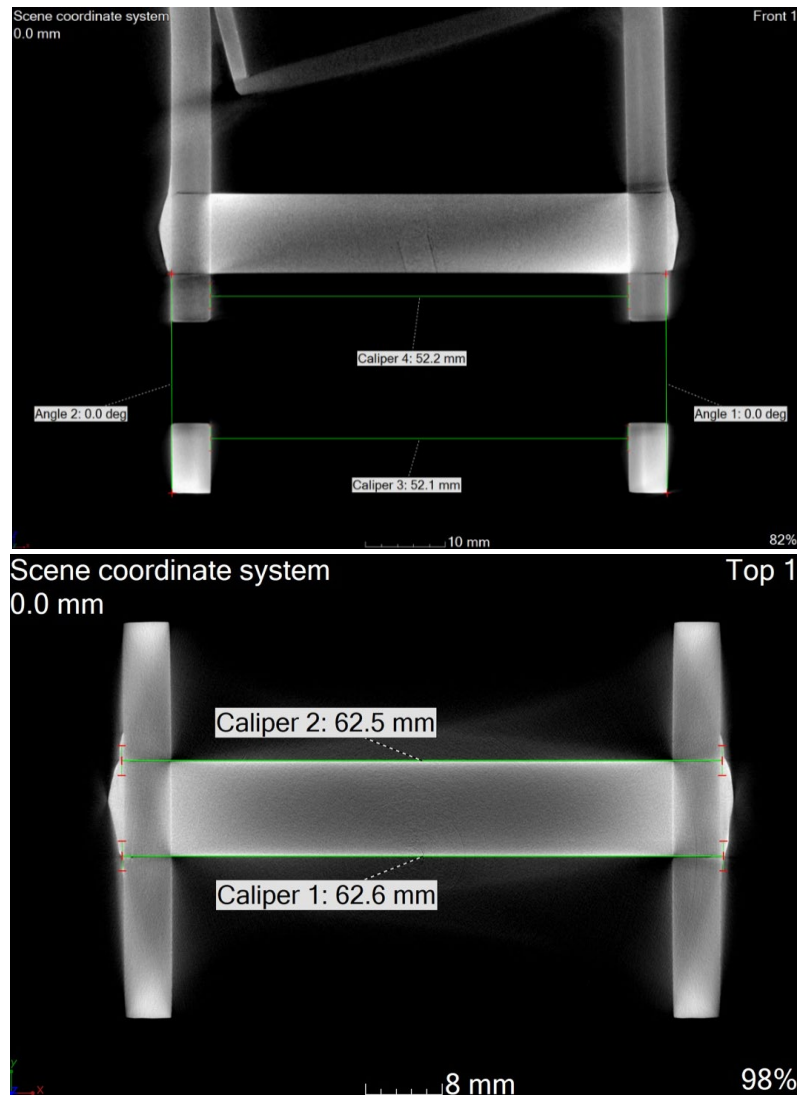
In order to assess the geometry of the mast interface found on G-CKYT, a new production mast was purchased directly from the manufacturer for comparison. This mast had not been used in operation. It was CT scanned to determine the interface dimensions and weld penetration on the roll stop bar. Figure 25 shows that the internal distance between the side plates is 52.2 mm, which was within the drawing tolerance. It also confirmed that the side plates were flat and aligned at 90° to the roll stop bar, which was straight, but the bar measured 62.5 mm, rather than the specified 65 mm.

CT scan of new production mast top

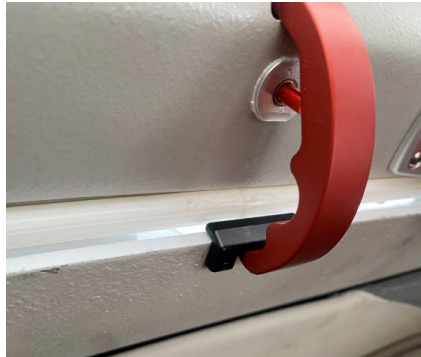
Figure 3

causing a de-activation of the red safety latch and the door separated from the aircraft. The Aircraft Maintenance Manual now requires hinges to be inspected as part of a scheduled maintenance check and this was carried out on G-LDGB on 17 April 2023.

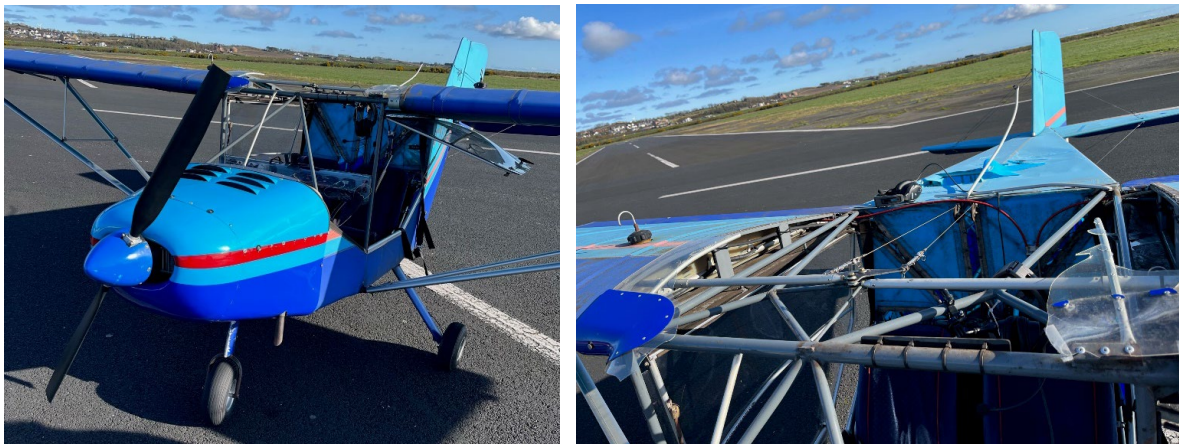
The owner said that the windscreen and skylight broke into numerous pieces and the majority had departed from the aircraft. The right door was damaged, and the Dacron fuselage material was torn in a few areas where it had been hit by broken parts. Figures 1 and 2 show the aircraft and some of the damage after landing.

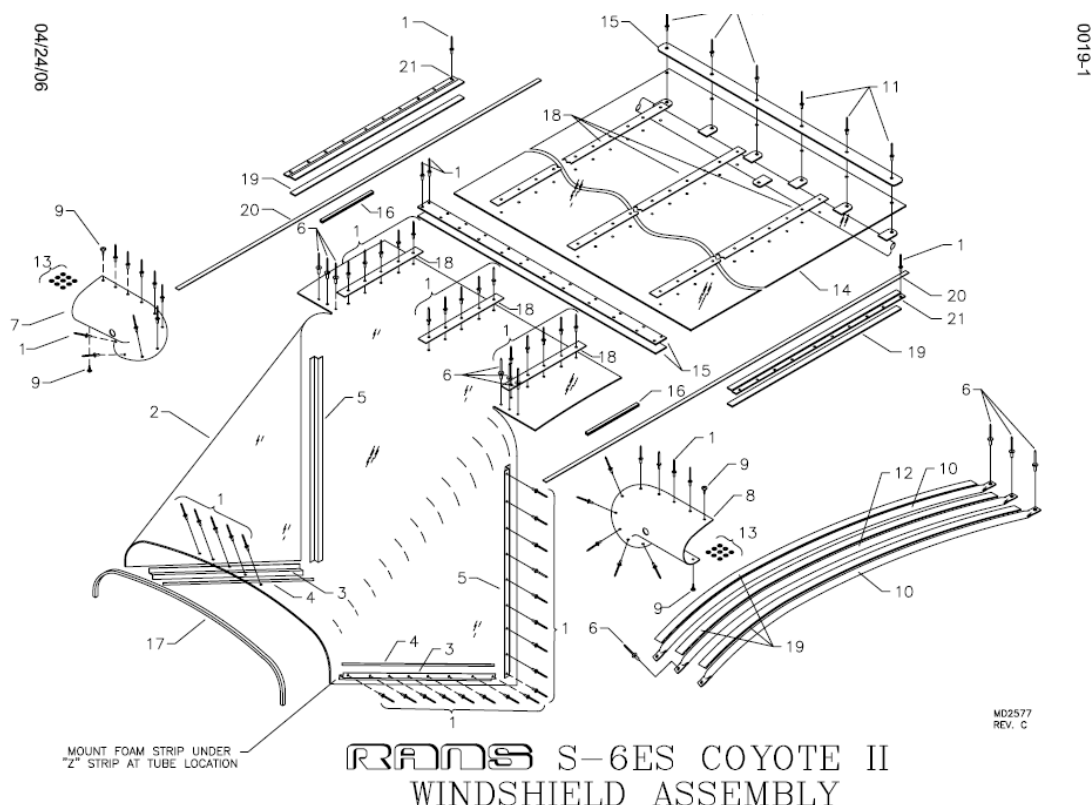
Figure 3

The windscreen and skylight assemblies are made of Lexan¹. The current aircraft parts catalogue and the build manual show the assemblies are rivetted to the aircraft framework, but 'sandwiched' between foam strips and metallic trim strips (Figure 3). The trim strips under the rivet heads spread the loads over a larger surface area, which reduces the risk of the Lexan cracking around the rivet holes. Photographs of G-BZKO after the accident showed that neither the foam strips nor the trim strips were fitted.
