Air Accidents Investigation Branch  
Farnborough House  
Berkshire Copse Road  
Aldershot  
Hants GU11 2HH

Published 13 October 2016

**CONTENTS****SPECIAL BULLETINS / INTERIM REPORTS**

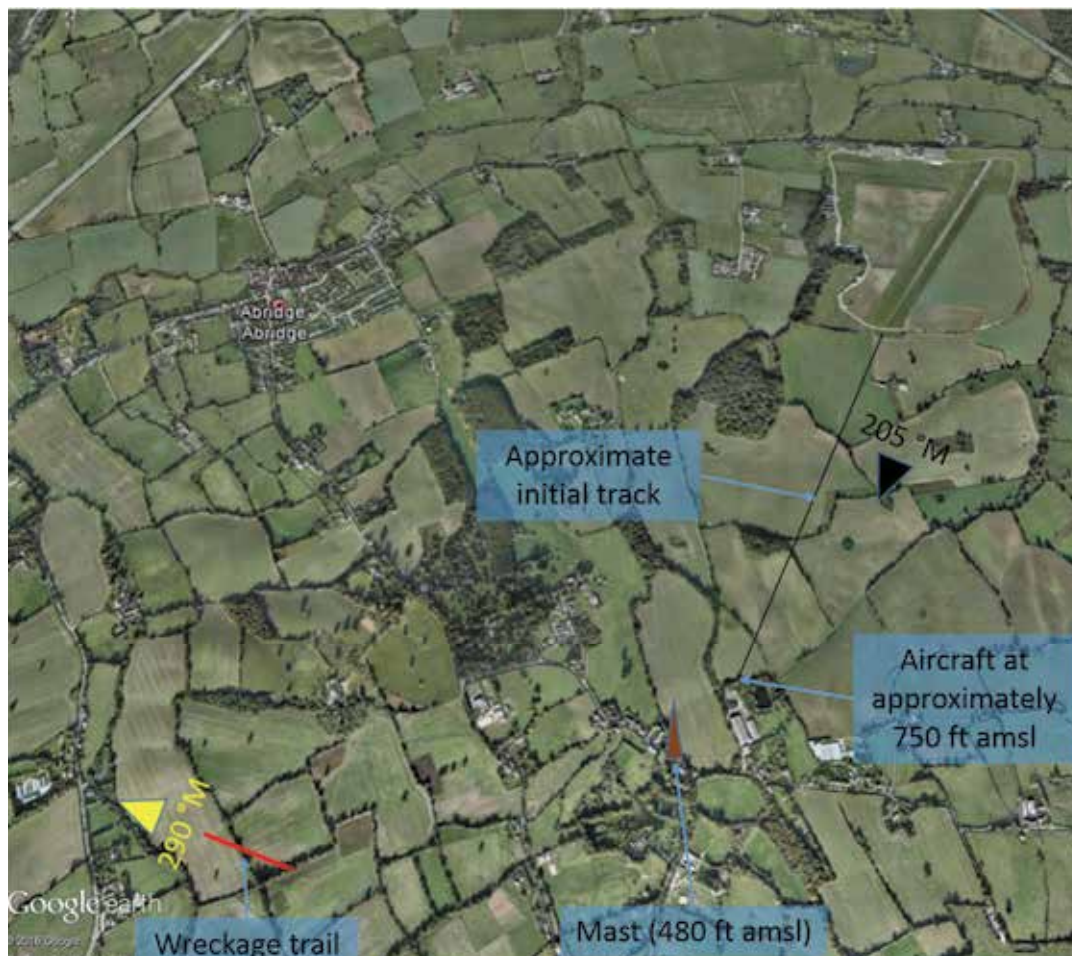
**Figure 3**

Initial track and wreckage trail

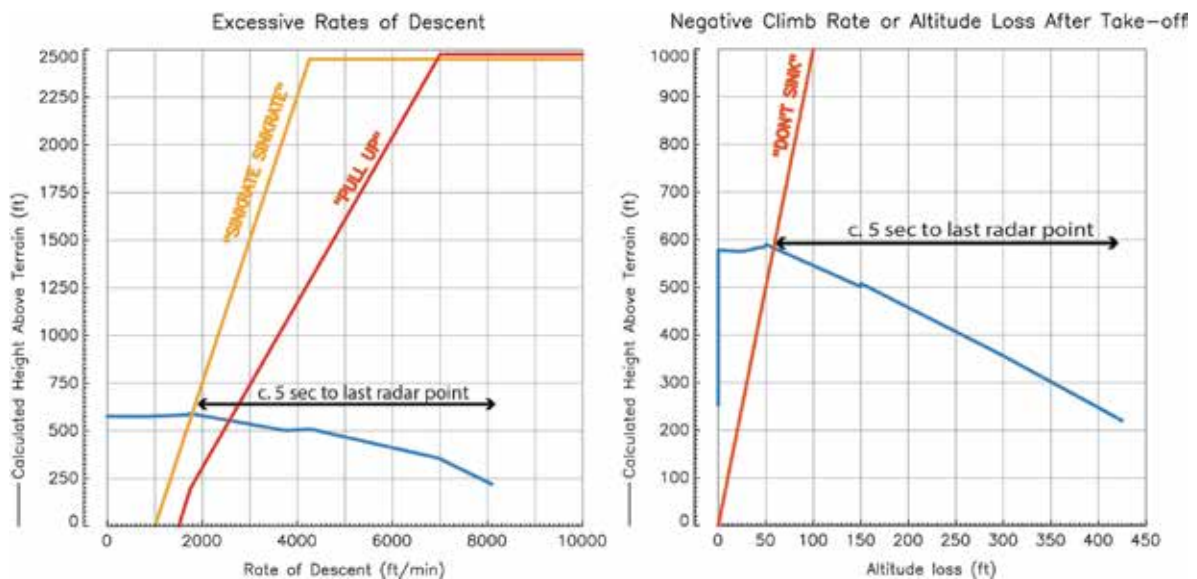
**Figure 7**  
TAWS Simulation

The assessment showed that about five seconds before the last radar point, which itself was an estimated one to two seconds before ground contact, the criteria were met for issuing alerts relating to *Excessive Rates of Descent*, and *Negative Climb Rate or Altitude Loss After Take-off*. Figure 7 illustrates these cases. For the *Excessive Closure Rate to Terrain* function, alerts were generated about four seconds before the last radar point. This suggested that the first alert would have been triggered approximately six to seven seconds before ground contact.

To verify the AAIB's modelling, a manufacturer of TAWS was asked to perform its own simulation which confirmed that the *Excessive Rates of Descent*, and *Negative Climb Rate or Altitude Loss After Take-off* protections would have activated approximately four seconds before the last radar point. However, the precise timing and order of the alerts could not be specified due to the low update rate of the source data. The manufacturer also remarked that, due to the priority which some alerts have, lower priority alerts may have been suppressed in the accident sequence in favour of other higher priority alerts depending on the exact sequence of events. Additionally, the manufacturer commented that, based on G-BYCP's ground track, it was possible that *Bank Angle* alerts, typically an additional function of a Class A system, may have been generated but it was not possible to state this conclusively due to a lack of bank angle information in the radar data.

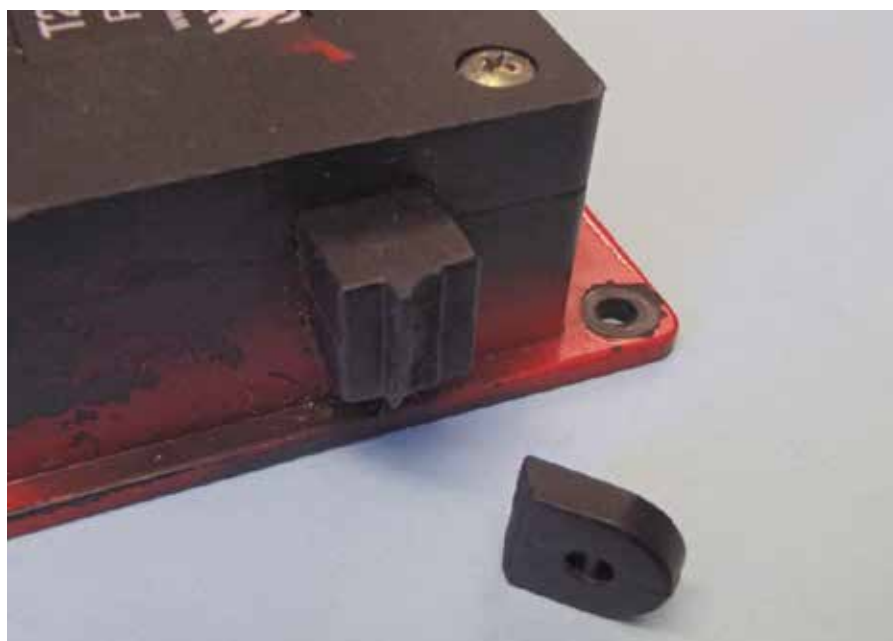
**Figure 2**

The Savannah VG pitch trim system consists of two anti-balance trim tabs, one fitted to the trailing edge of each elevator. Each tab is separately moved for trim by an electric trim servo mounted on the tailplane tip rib, via a system of pushrods and a lever. As the elevator rotates, the anti-balance tab gearing provides an increase in elevator forces. The neutral position of the anti-balance tab is adjusted via the trim servo to provide pitch trim. Figure 1 shows the left elevator anti-balance tab and trim system, following the precautionary landing, with the elevator tip fairing removed for clarity. The electric trim actuator arm, manufactured from a toughened thermoplastic material, had fractured in downward bending overload and there was no evidence of fatigue or progressive failure (Figure 2).

Bending failure of the trim tab servo arm
