Rail Accident Investigation Branch

Rail Accident Report

**Collision between a passenger train and a fallen tree at Broughty Ferry, Dundee
27 December 2023**

Report 13/2024
December 2024

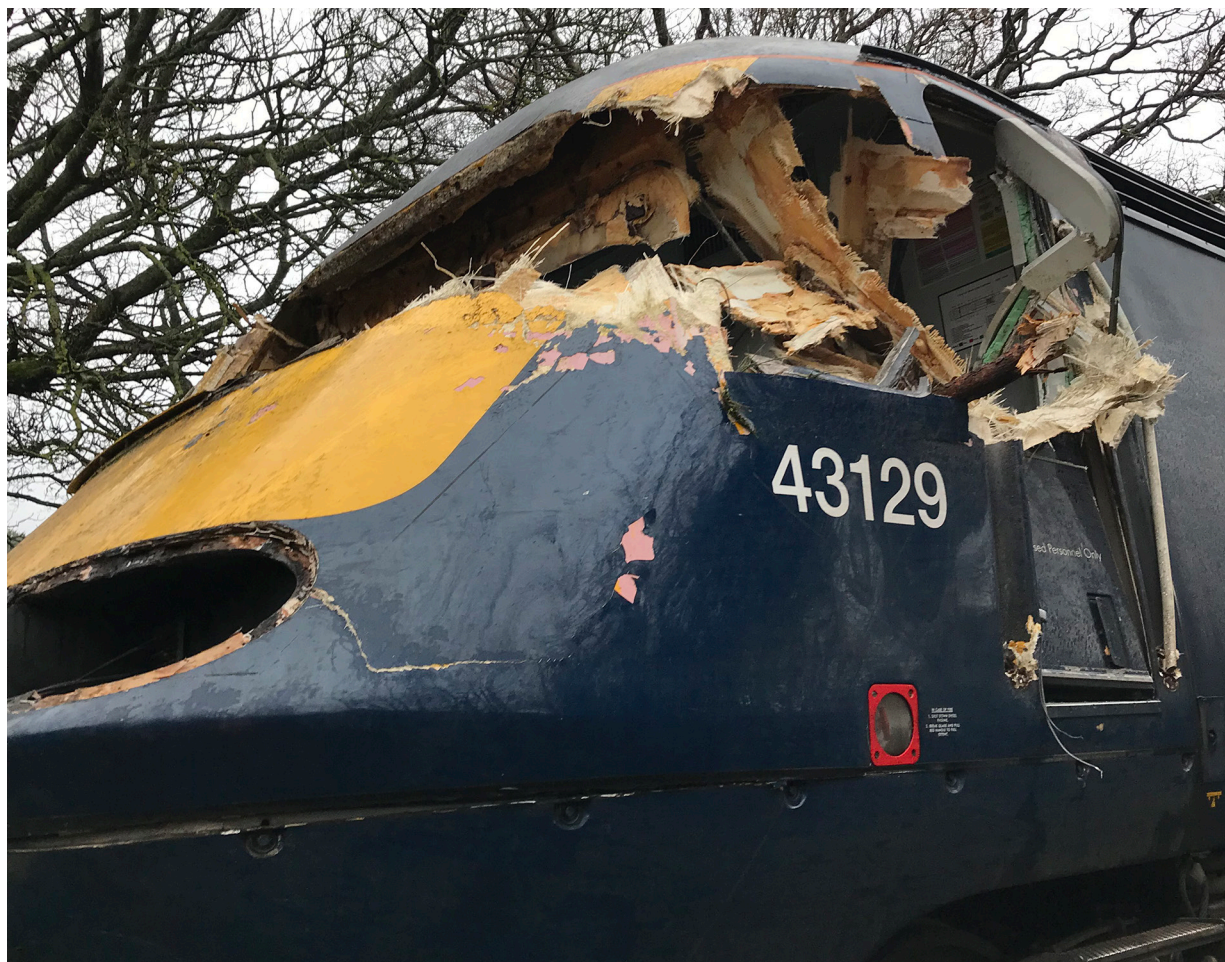
- 33 During the collision, the tree stem entered the cab area around driver's eye level, passing through the cab pillars either side of the windscreen, before cutting through the body of the cab, the quarter light window and the driver's door. The tree stem's progression through the driving cab stopped just above the driver as it reached the bulkhead structure separating the driving cab from the power car equipment compartment behind the cab (figure 6).

Figure 6: Damage sustained to left-hand side of driving cab.

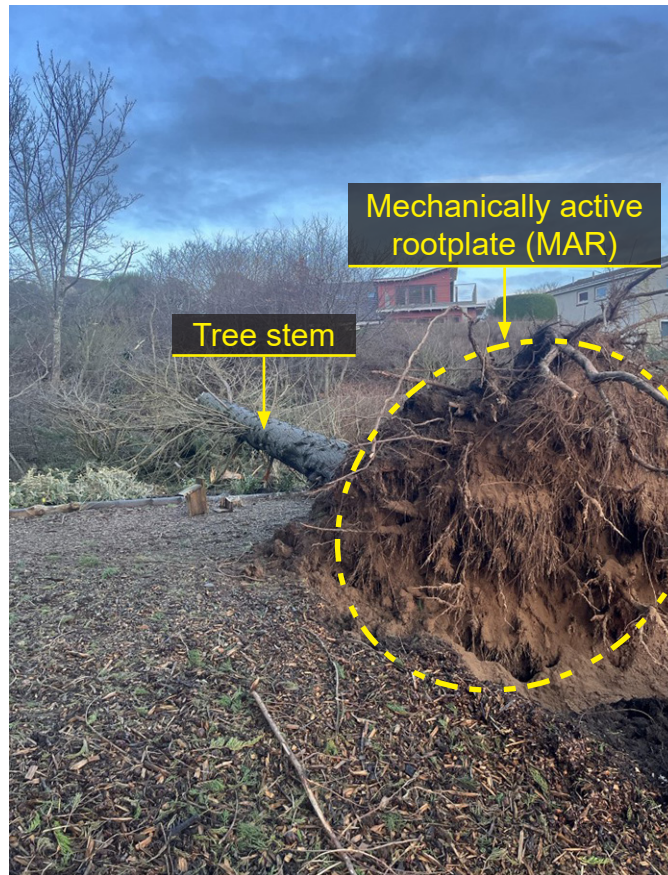
Figure 9: Fallen tree before work to clear the site.

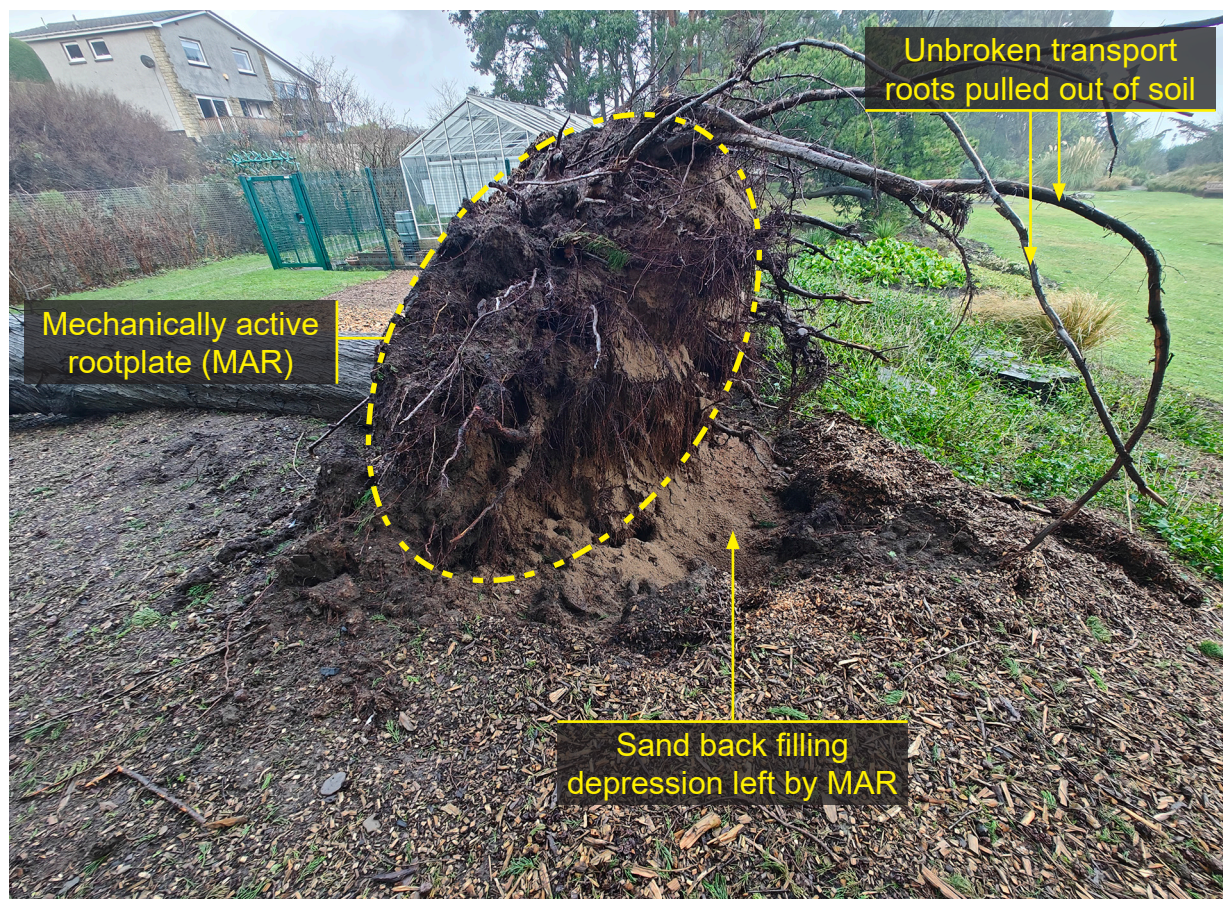
- 54 Breakage of some roots at the edge of the tree's MAR indicated a wind load which had exceeded the shear strength of those roots and the surrounding soil. This loss of the soil shear strength had allowed the rootplate to rotate and apply a greater force on the transport roots extending beyond the MAR. These transport roots remained intact and were pulled through the soil as the rootplate rotated. This is an indication of poor mechanical adhesion within the soil (figure 10).

- 55 Examination of the soil depression left by the uprooted tree showed that the tree was located on soil made predominantly of sand. Sand is an inherently non-cohesive soil with poor mechanical properties for tree root adhesion. Water within the soil can also reduce the mechanical strength of a non-cohesive soil and the ability of a tree root to adhere to it.

Figure 10: Uprooted tree showing MAR, transport roots and sandy soil back fill.

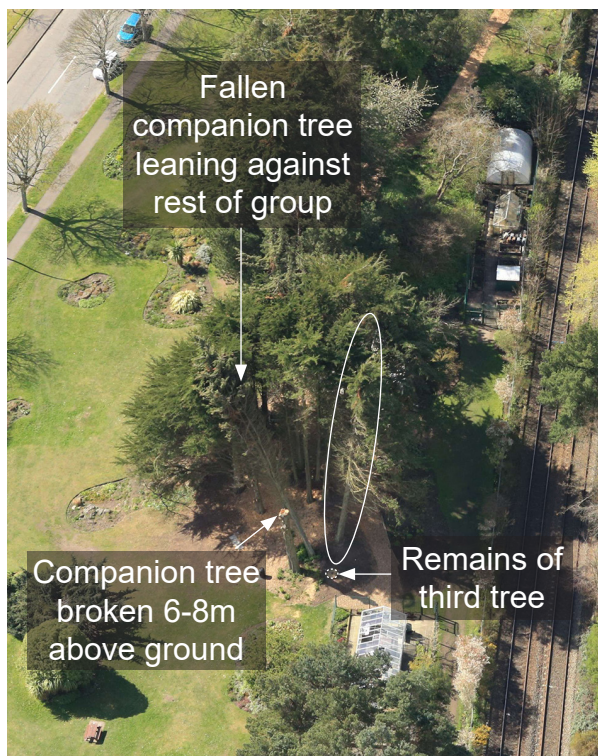
Figure 15: Network Rail aerial image showing the trees in April 2022 (courtesy of Network Rail with RAIB annotations).

- 63 The Network Rail aerial image dated 19 April 2022 (figure 15) shows two of the companion trees and the storm damage they had suffered (paragraph 59). One of the trees had suffered windthrow and fallen into another tree in the group. The other tree suffered stem breakage approximately 6 to 8 metres above ground level. The image taken in May 2023 (figure 16) shows that both trees have been removed and a stump remnant from the third tree providing shelter, which could be seen in the previous year, is no longer visible. DCC stated that it was necessary to fell these trees following damage sustained during Storm Arwen, which occurred in 2021.

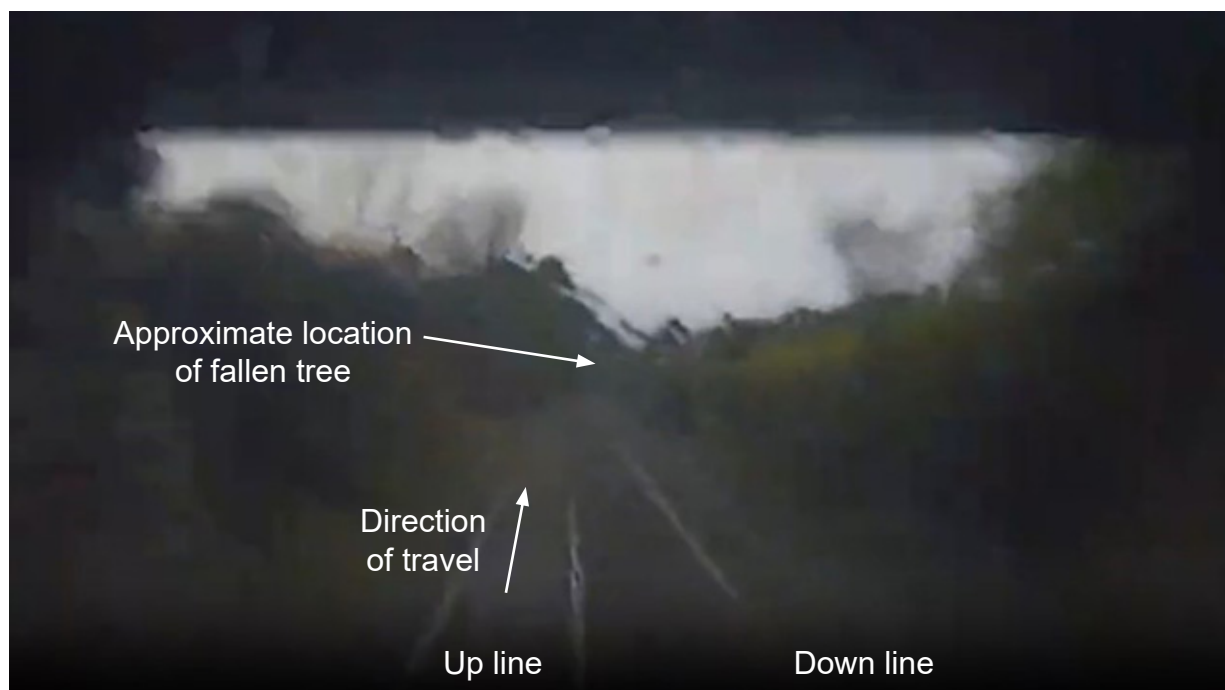
- 92 The curvature of the railway means it is just possible to see the location where the tree fell, some 240 metres (around 6 seconds at the train's speed) beyond the road bridge, but the visibility would have been reduced by the heavy rain and poor sunlight conditions on the day of the accident. The conspicuity of the fallen tree would also have been affected by the motion of the train and a lack of contrast between the tree and lineside vegetation (figure 19).

Figure 19: Image taken from train 1A37 forward-facing CCTV as it passed under the road bridge (courtesy of ScotRail with RAIB annotations).

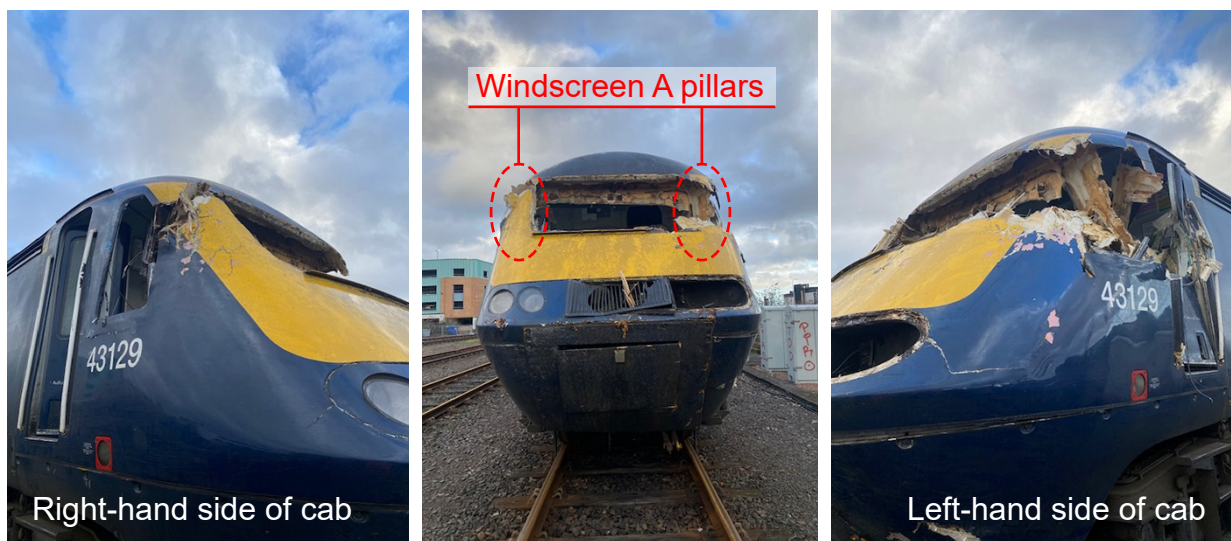
- 119 The tree stem impacted the cab at windscreen height, across the A pillars that support the windscreen at either side of the cab front and the weakest point of the HST cab structure. The energy was greater than the cab structure was intended to withstand and so it did not prevent the tree stem penetrating the cab area previously occupied by the driver. The tree broke through the A pillars and continued to break through the left-hand side of the cab, showering the inside with glass and debris.

Figure 20: External damage sustained to leading power car of 1A37.

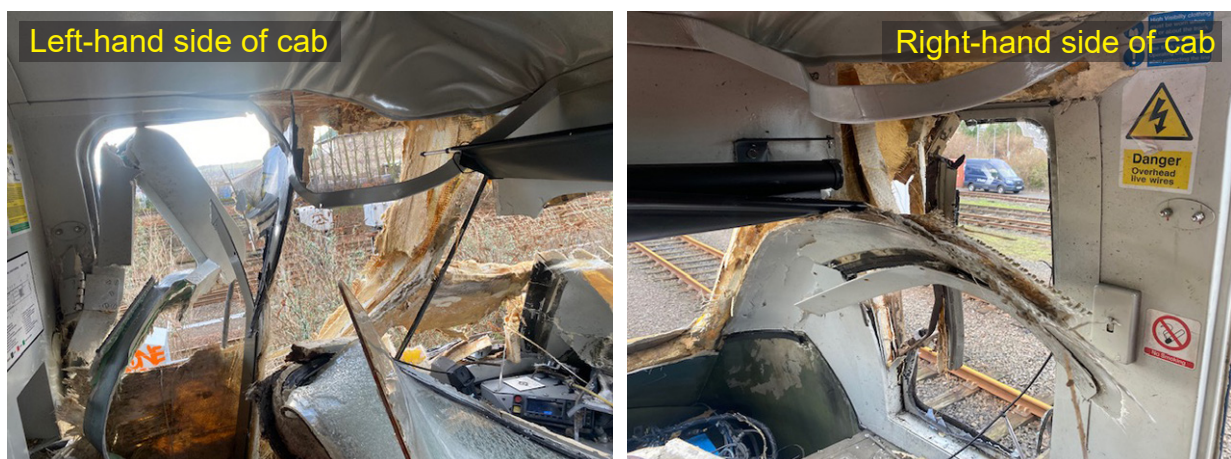
- 120 The rootplate of the tree did not rotate in the ground with the forward motion of the train, with the tree instead beginning to bend until it finally broke into two pieces. This bending motion limited the damage to the right-hand side of the cab, but the tree continued to cut through the left-hand side adjacent to the driver's seat. The structural damage to the left-hand side of the cab extended from the windscreen back to the much stronger bulkhead at the rear, stopping just above where the driver was sheltering (figures 20 and 21).

Figure 21: Internal damage sustained to leading power car of 1A37.

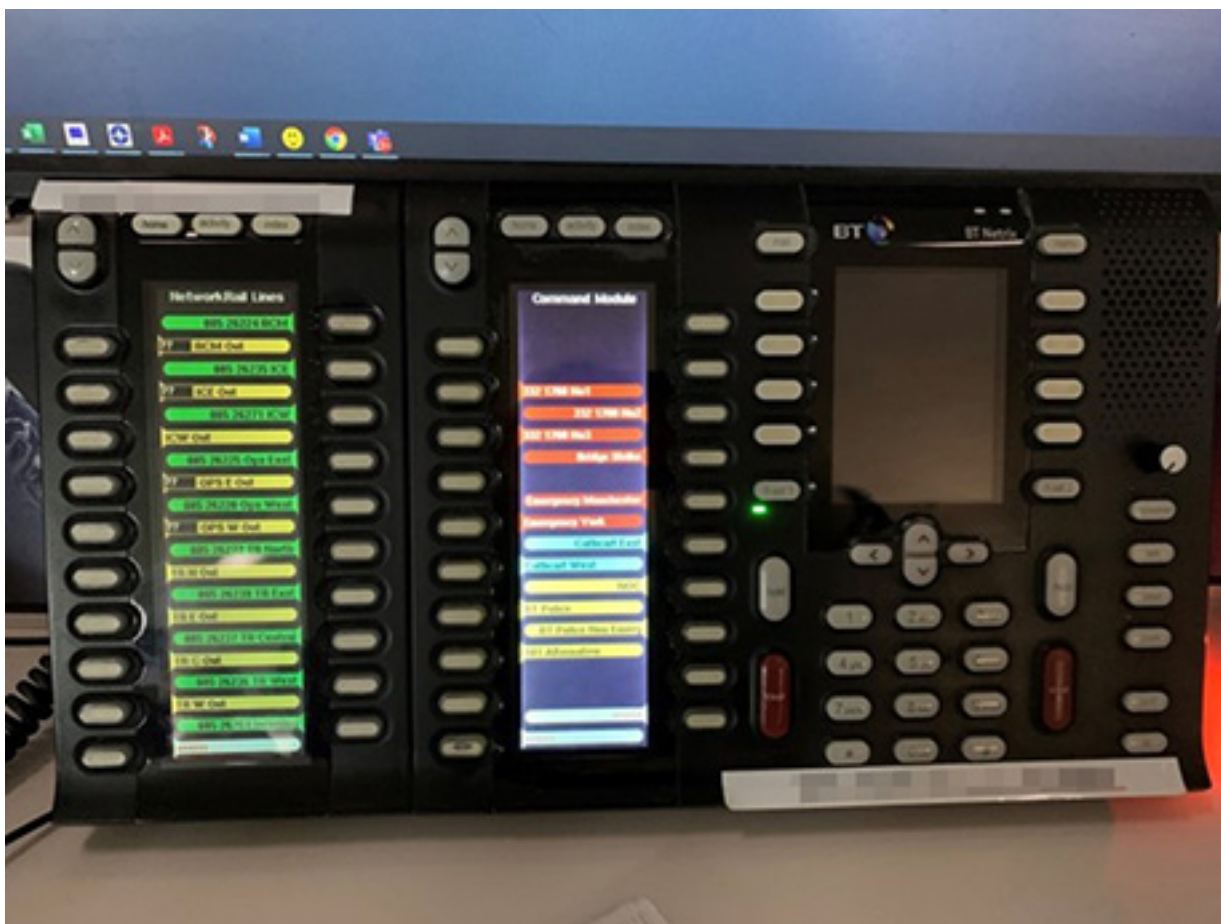
122 The telephone concentrator equipment at Network Rail's Scotland integrated control centre was not able to show the history of multiple missed calls from the public helpline call centre.

Figure 22: Telephone concentrator at the SICC (courtesy of Network Rail).
