Accident

Aircraft Type and Registration:	Piper PA-28-140, G-AWBS	
No & Type of Engines:	1 Lycoming O-320-E2A piston engine	
Year of Manufacture:	1968 (Serial no: 28-24331)	
Date & Time (UTC):	18 June 2024 at 1955 hrs	
Location:	Near Eddsfield Airfield, East Yorkshire	
Type of Flight:	Private	
Persons on Board:	Crew - 1	Passengers - 2
Injuries:	Crew - 1 (Minor)	Passengers - 2 (Minor)
Nature of Damage:	Aircraft destroyed	
Commander's Licence:	Private Pilot's Licence	
Commander's Age:	50 years	
Commander's Flying Experience:	1,475 hours (of which 16 were on type) Last 90 days - 8 hours Last 28 days - 3 hours	
Information Source:	Aircraft Accident Report Form submitted by the pilot

Synopsis

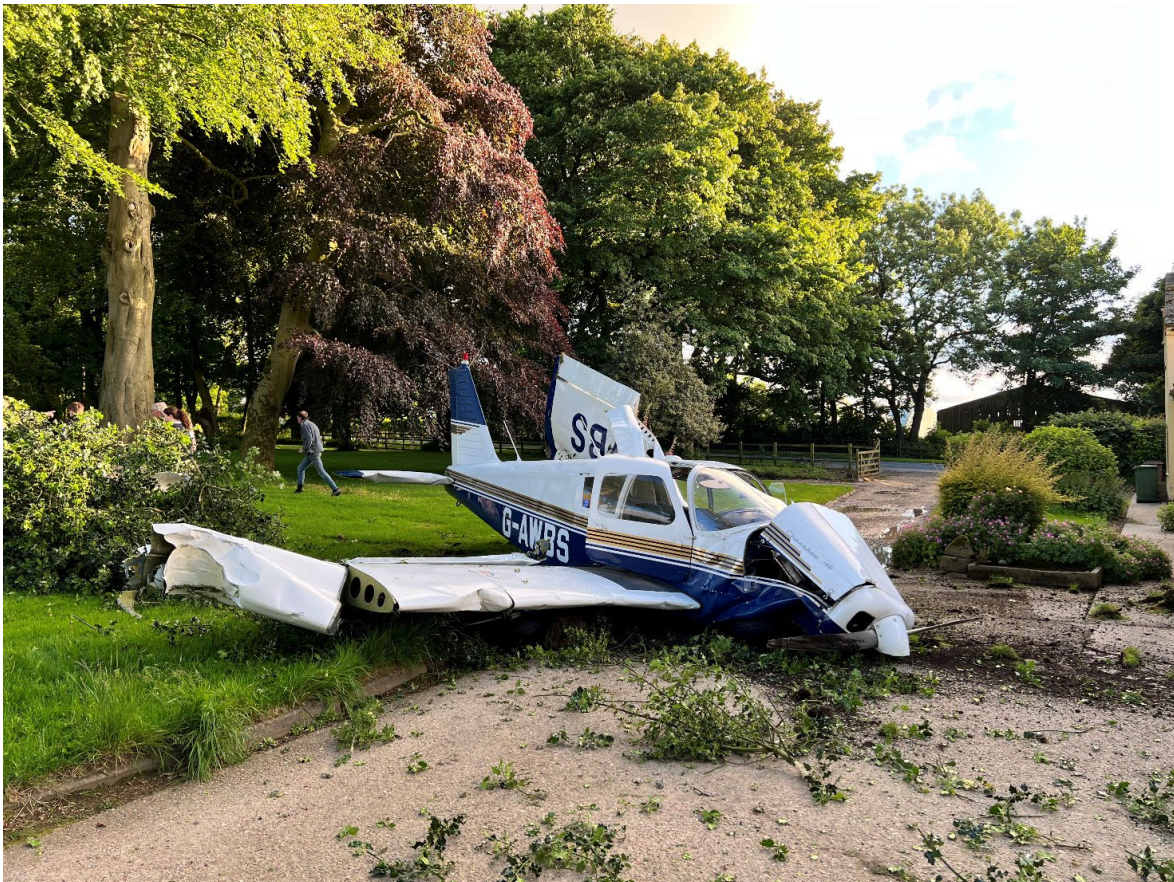
Figure 1

The aircraft came to rest in the garden and on the driveway of a local residence and was destroyed (Figure 1). After completing emergency shutdown procedures, the pilot and passengers were able to exit the aircraft unaided with minor injuries.

G-AWBS at the accident site
