Accident

Aircraft Type and Registration:	Falco F8L, G-HCBW	
No & Type of Engines:	1 Superior XP-IO-320-B2HC2 piston engine	
Year of Manufacture:	2018 (Serial no: PFA 100-12788)	
Date & Time (UTC):	27 August 2024 at 1259 hrs	
Location:	Headcorn Aerodrome, Kent	
Type of Flight:	Training	
Persons on Board:	Crew - 2	Passengers - None
Injuries:	Crew - None	Passengers - N/A
Nature of Damage:	Left landing gear mechanism damaged	
Commander's Licence:	Commercial Pilot's Licence	
Commander's Age:	61 years	
Commander's Flying Experience:	6,033 hours (of which 41 were on type) Last 90 days - 103 hours Last 28 days - 33 hours	
Information Source:	Aircraft Accident Report Form submitted by the pilot

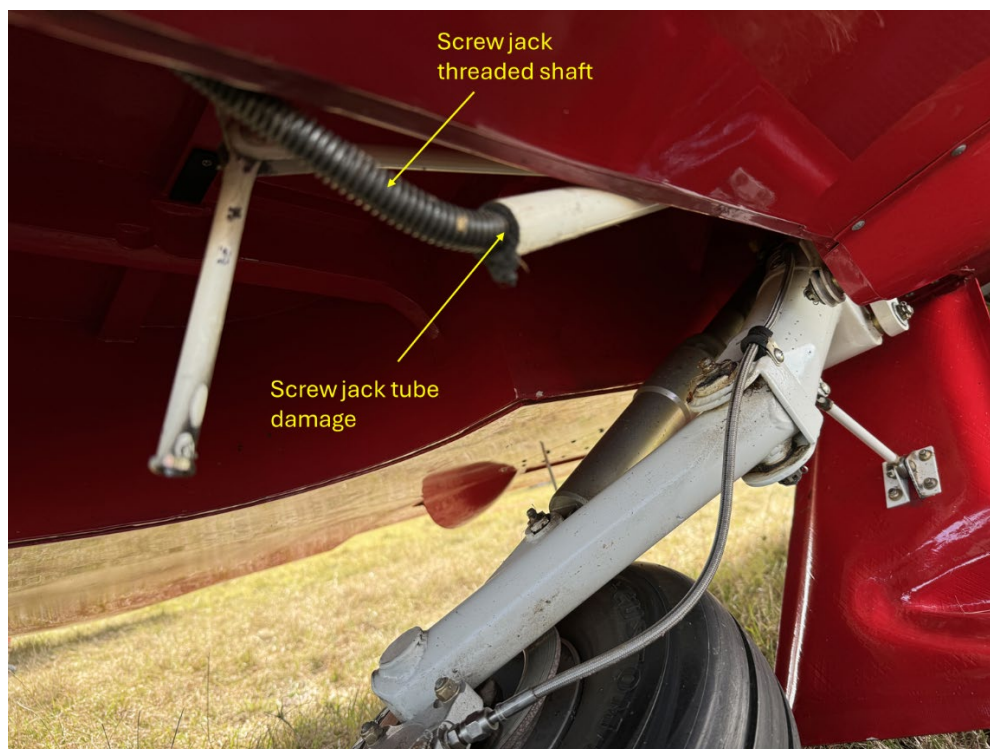
Figure 1

An examination of the aircraft found the retraction screwjack was bent with damage to its drive linkages and tube (Figure 1). In his own analysis, the pilot considers that the bounce on takeoff with a 90° crosswind, albeit low, caused a side drift which overloaded the landing gear retraction linkages.

Damage to screwjack and tube
(picture courtesy of the pilot)

The damage may also have caused overloading of the screwjack motor resulting in the breaker tripping on UP selection. Despite indicating and outwardly appearing to be locked down, the geometric lock in the mechanism had probably been compromised. In this state it is possible that the landing and the loads imparted in the landing gear leg as it rolled along the runway, led to forces then being imparted into the screwjack bending it enough to cause the partial collapse of the left landing gear leg.
