Serious Incident

Aircraft Type and Registration:	Boeing 747-433, G-UNET	
No & Type of Engines:	4 Pratt & Whitney PW4056-3 turbofan engines	
Year of Manufacture:	1991 (Serial no: 25075)	
Date & Time (UTC):	6 January 2024 at 1800 hrs	
Location:	London Heathrow Airport	
Type of Flight:	Commercial Air Transport (Cargo)	
Persons on Board:	Crew - 4	Passengers - None
Injuries:	Crew - None	Passengers - N/A
Nature of Damage:	Left upper wing panel detached	
Commander's Licence:	N/A	
Commander's Age:	N/A	
Commander's Flying Experience:	N/A	
Information Source:	Enquiries by the AAIB

Synopsis

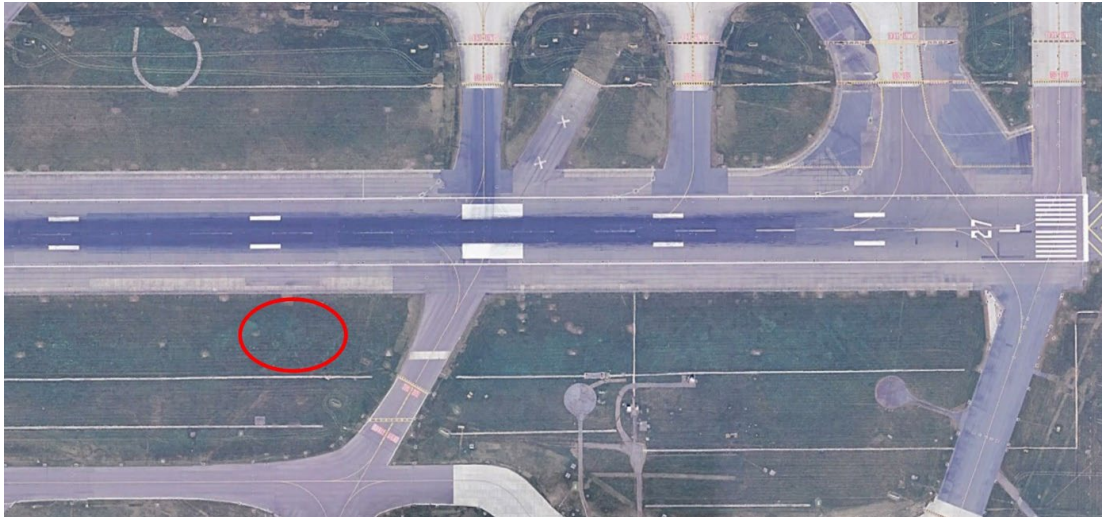
Figure 1

On 7 March 2024 the AAIB received a report from the operator of Heathrow Airport that a large metal panel had been found in the grass area to the south of Runway 27L, about 600 m west of the runway threshold (Figure 1). The panel was sent to the AAIB for examination where it was identified as an upper wing panel from a Boeing 747 aircraft. Subsequent enquiries revealed that a Boeing 747 cargo aircraft (G-UNET) had arrived on stand at Heathrow Airport two months earlier, on 6 January 2024, with this panel missing from its left wing. The flight crew had been unaware that a panel had detached from the aircraft, but it was identified as missing during the subsequent turnaround. The aircraft operator had filed a Mandatory Occurrence Report to the CAA but did not report it to the AAIB as they had not considered it to meet the threshold for an accident or serious incident¹.

Location of metal panel (circled in red) relative to Runway 27

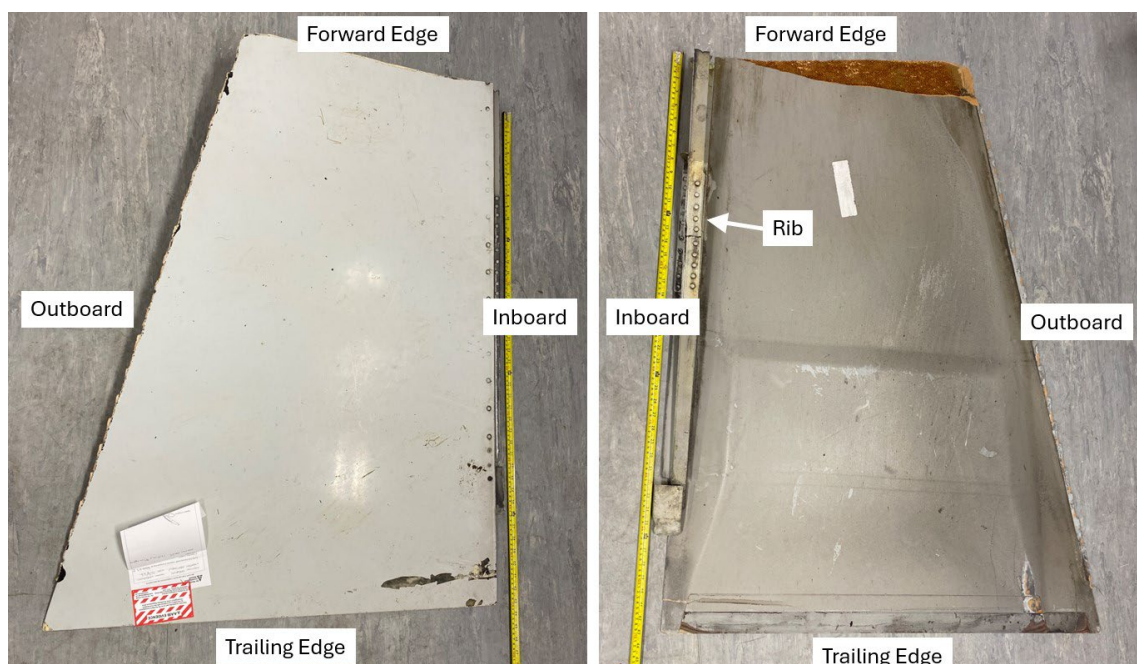
Figure 2

The panel (Figure 2) had maximum dimensions of 1.1 m by 0.9 m. It was identified as having detached from the upper left wing, adjacent to the outboard edge of spoiler 5 (Figure 3). The panel had a structural failure at its forward edge, revealing the internal honeycomb, and a structural failure at its inboard rib. The outboard edge of the panel had detached from a line of rivets. The rib along the inboard edge exhibited evidence of previous repairs.

The panel part number was identified as 65B11629 and the rib part number as 65B10865.

Photos of detached wing panel

The left wing panel was found 600 m beyond the threshold for Runway 27L indicating that it probably detached from the aircraft after touchdown when the spoilers were deployed. The panel most likely cracked and then failed at its supporting rib first, before failing at the leading edge honeycomb structure. The aircraft manufacturer's Service Letter 747-SL-57-101-B indicated that this rib was known to suffer from fatigue cracks and failures, and recommended mitigating action involving adjusting spoiler support rib clearances. There was no documentary evidence that the actions in the SL had been carried out on the incident aircraft; however, when the opposite right wing was checked the clearances were within the limits of the SL.

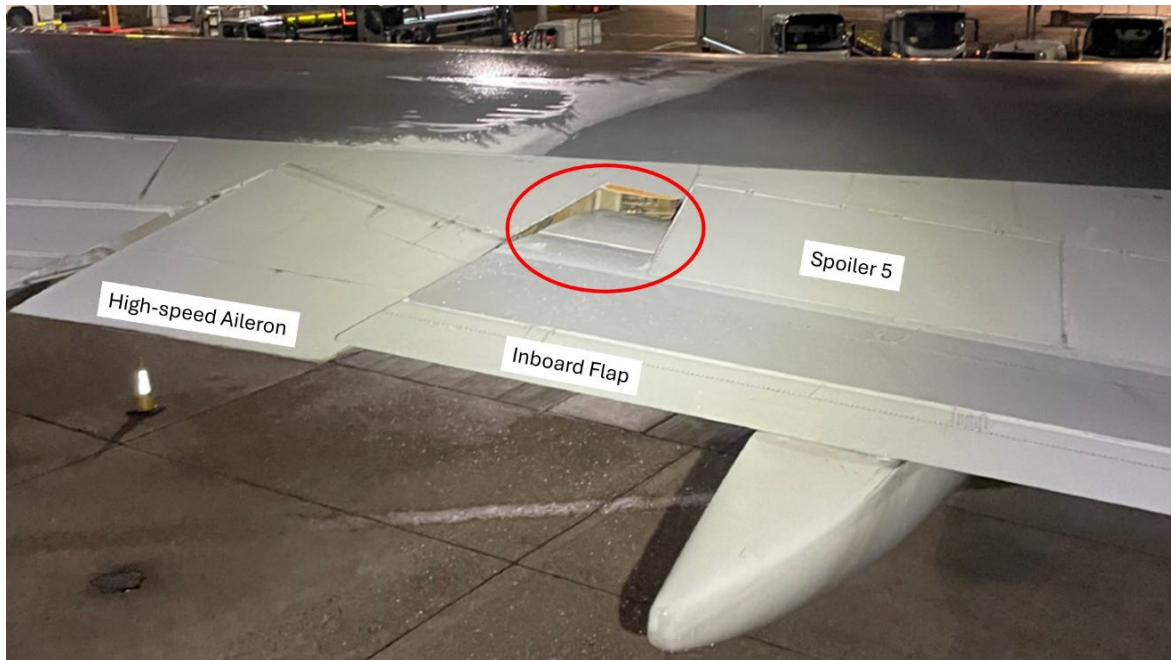
Figure 3

Location of missing wing panel (circled in red)

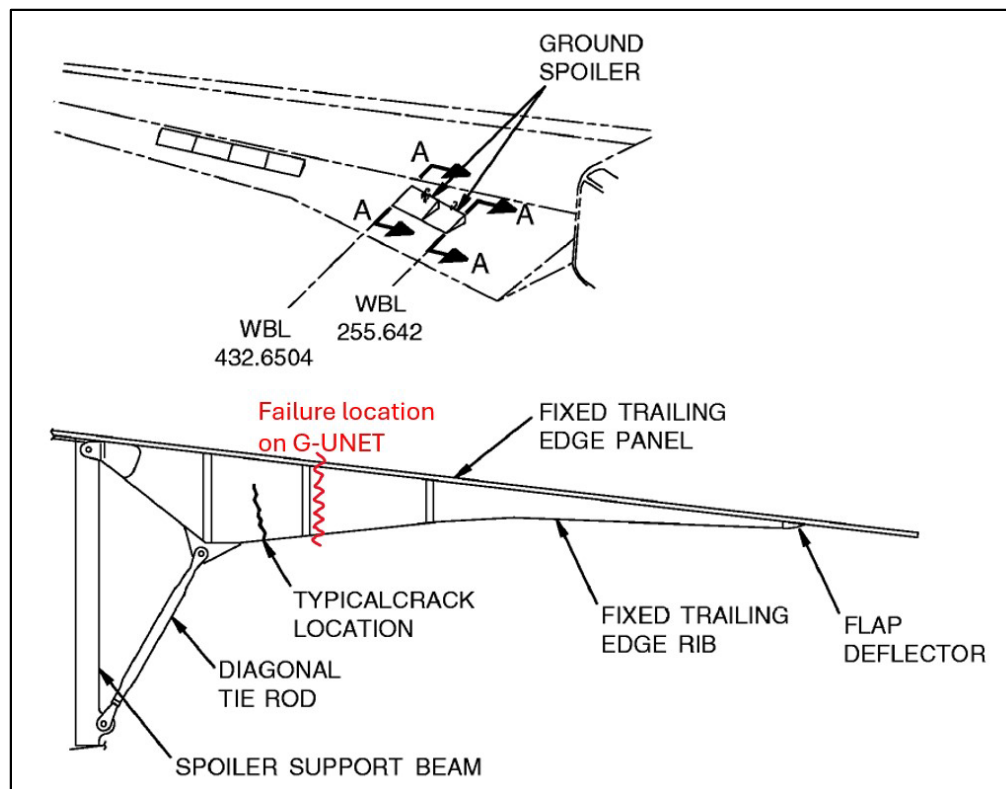
Figure 4

'Operators have reported cracks in the reference e) P/N 65B11544 fixed trailing edge rib located at WBL255.69, and at the reference f) P/N 65B10865 fixed trailing edge rib located at WBL432.65. Cracks typically originate from the rib lower chord just aft of the diagonal tie rod fitting and propagate upwards through the web as shown in the attached illustration. Continued crack growth can cause complete fracture of the rib. In cases of complete rib fracture the reference g) upper fixed TE panel common to the rib at WBL432.65 can also become damaged.'

Illustration from Service Letter 747-SL-57-101-B with location of rib failure on G-UNET shown in red.

'For improved aerodynamic performance the 747-400 wing was designed to flex more than the 747-Classic wing. Greater wing flex of the 747-400 increases the upward movement of the TE flap which may in turn impose higher than expected loads to the reference e) and f) ribs. The magnitude of upward loads imposed by the flap is sensitive to adjustment of the ribs relative to the flap. Investigation of cracked ribs submitted to Boeing by operators show indications of fatigue cracking due to cyclical upward loads acting on the rib over an extended period of time.'

The suggested operator action specified in the SL is to adjust the spoiler support rib clearance between the fixed trailing edge (TE) upper panels and the upper surface of the inboard TE flap as specified in the SL. The SL was originally issued in 2005 but at that time it did not include information about parts departing the aircraft.
