Accident

Aircraft Type and Registration:	1) Piper J3C-65, G-BBLH 2) Bombardier Global 6000, M-SFPL
No & Type of Engines:	1) 1 Continental Motors Corp A65-8F piston engine 2) 2 Rolls Royce BR700-710A2-20 turbofan engines
Year of Manufacture:	1) 1943 (Serial no: 10,549) 2) 1991 (Serial no: 9,692)
Date & Time (UTC):	26 June 2024 at 1230 hrs
Location:	London Biggin Hill Airport
Type of Flight:	1) Private 2) Private
Persons on Board:	1) Crew - 1 Passengers - 1 2) Crew - 2 Passengers - None
Injuries:	1) Crew - None Passengers - None 2) Crew - None Passengers - N/A
Nature of Damage:	1) Damage to left wingtip 2) None
Commander's Licence:	1) Airline Transport Pilot's Licence 2) Airline Transport Pilot's Licence
Commander's Age:	1) 40 years 2) 48 years
Commander's Flying Experience:	1) 11,000 hours (of which 100 were on type) Last 90 days - 240 hours Last 28 days - 80 hours 2) 8,500 hours (of which 4,000 were on type) Last 90 days - 75 hours Last 28 days - 25 hours

Information Source:	Aircraft Accident Report Forms submitted by the pilots and further investigations by the AAIB

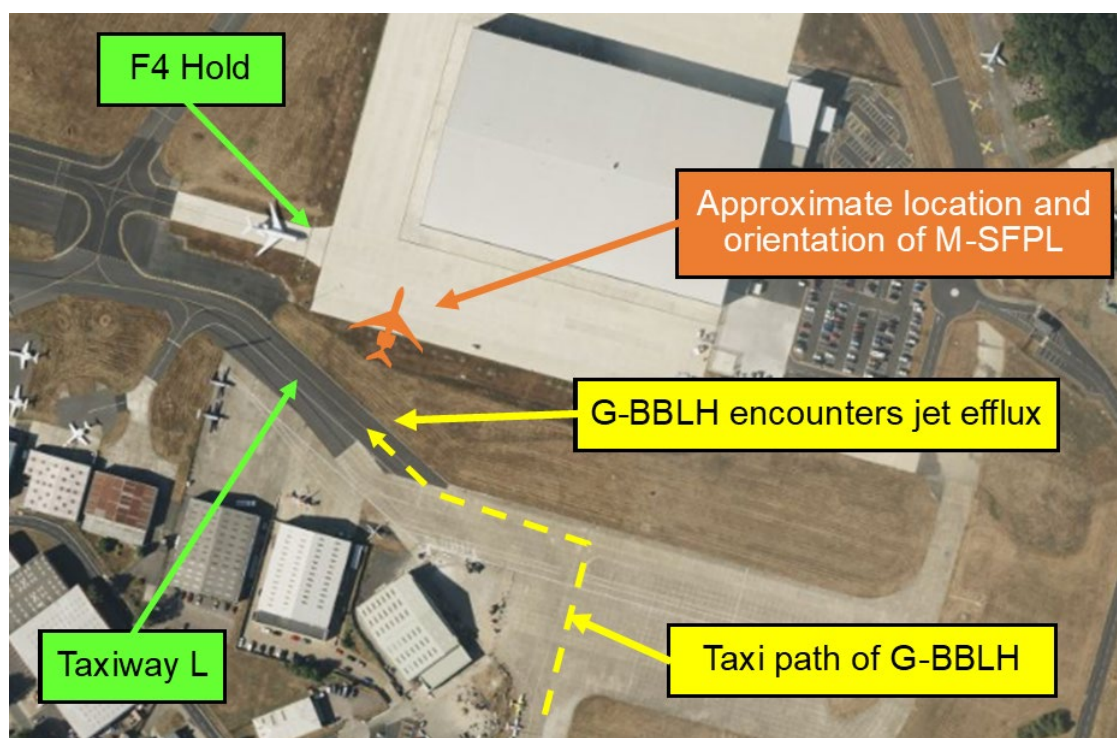
Figure 1

G-BBLH was proceeding along Taxiway L at London Biggin Hill Airport (Biggin Hill) when it got caught in the jet efflux from M-SFPL, a G6000 parked on a northerly heading with its engines running on an adjacent apron (Figure 1). The pilot of G-BBLH was not aware that the G6000 had started its engines before he taxied behind it.

Incident location and respective positions of G-BBLH and M-SFPL
(image ©Vexcel Imaging ©2024 Microsoft)

G-BBLH's pilot reported that, when it got caught in the efflux, their aircraft "aggressively" ground looped and weather cocked "clockwise into the jet blast." For several seconds they experienced "total uncontrollability" which resulted in the aircraft's left wingtip striking the ground on at least two occasions. After declaring an emergency to ATC, they shut down their engine and vacated the aircraft so they could attempt to hold it down to prevent further damage. Onlookers from a nearby hangar assisted the pilot in manoeuvring G-BBLH away from the efflux zone.

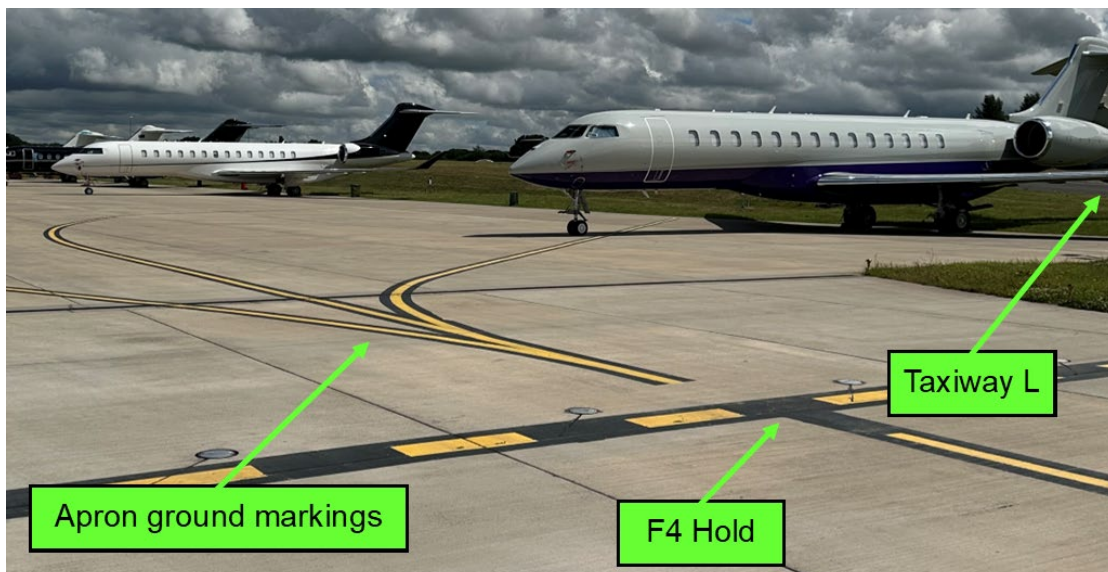
Figure 2

An internal investigation by the maintenance organisation found “a level of normative practise in the positioning of aircraft” where aircraft were parked “along the apron resulting in reduced area to park aircraft in what would be the appropriate positioning in line with the taxi markings” (Figure 2).

F4 Hold and aircraft parked on maintenance organisation’s apron

The conditions for this accident were created when M-SFPL was parked perpendicular to the apron edge for engine start rather than in alignment with yellow ground markings. Had any of the pilots involved been aware of the risk posed at that time to G-BBLH by M-SFPL’s jet efflux the conflict could likely have been avoided by mutual coordination over the radio.

The maintenance organisation publicised this event within its operations team to raise awareness of the circumstances and to highlight the importance of aligning parked aircraft with the apron ground markings before engine start.
