AAIB Bulletin

1/2025

Aircraft Type and Registration:	ATR 72-202, G-NPTF	
No & Type of Engines:	2 Pratt & Whitney Canada PW121 turboprop engines	
Year of Manufacture:	1990 (Serial no: 192)	
Date & Time (UTC):	7 March 2023 at 0138 hrs	
Location:	Belfast International Airport	
Type of Flight:	Commercial Air Transport (Cargo)	
Persons on Board:	Crew - 2	Passengers - None
Injuries:	Crew - None	Passengers - N/A
Nature of Damage:	None reported	
Commander's Licence:	Airline Transport Pilot's Licence	
Commander's Age:	45 years	
Commander's Flying Experience:	6,750 hours (of which 92 were on type) Last 90 days - 65 hours Last 28 days - 25 hours	
Information Source:	AAIB Field Investigation

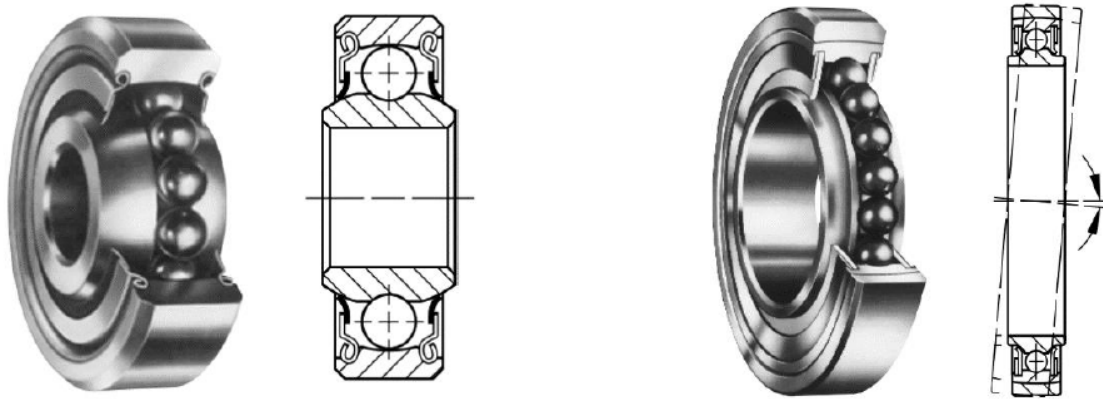
Figure 3

The raceways and balls of both bearings were made from 52100 grade steel which does not have significant corrosion resistance. The exposed surfaces, the bore, cap and seals were cadmium-plated.

Original production standard rear quadrant shaft support bearings fitted to G-NPTF

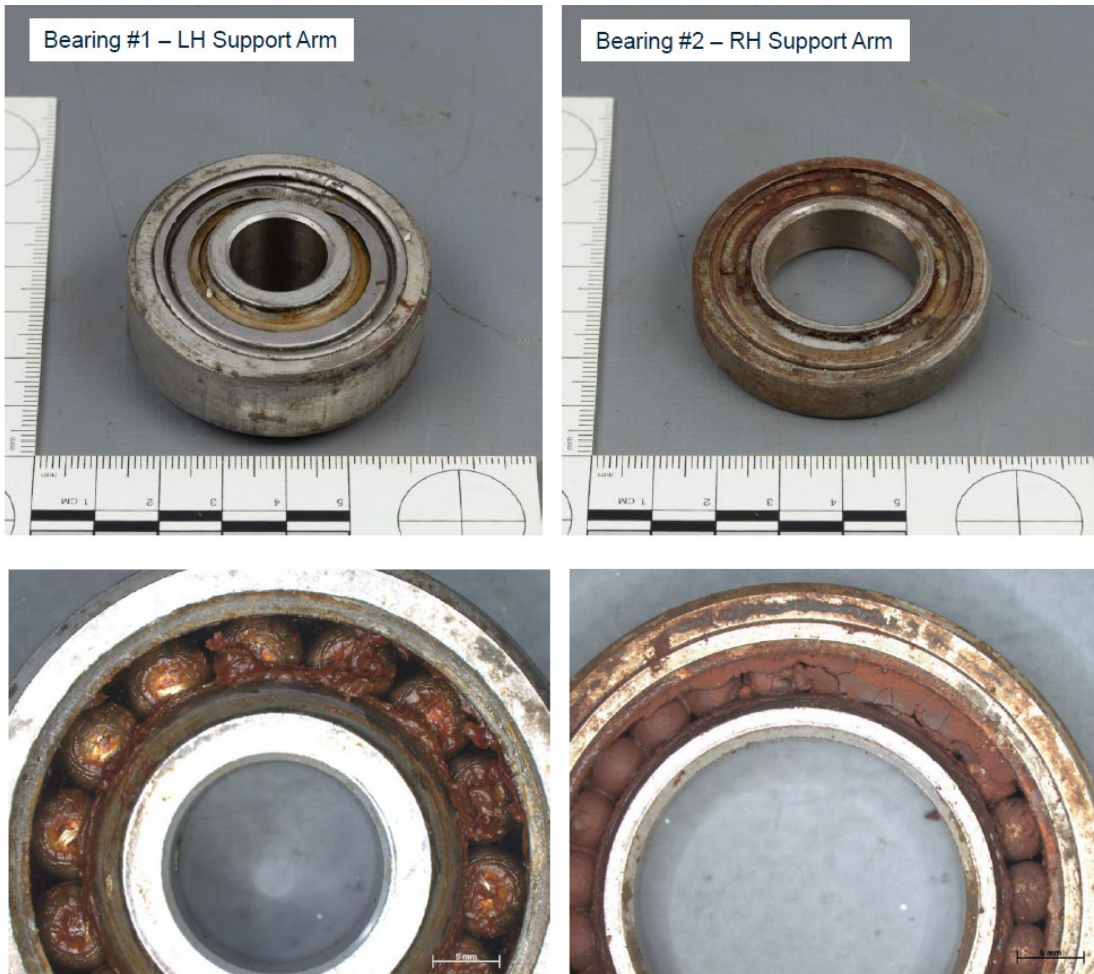
Figure 4

Bearing No 2 displayed corrosion and a brown deposit on the outer surface. It contained a full complement of balls which appeared to be extensively corroded. No grease was present, although there was a thick brown deposit throughout, which appeared to be a combination of corrosion product and dried grease residue (Figure 4).

Rear quadrant support arm bearings from G-NPTF

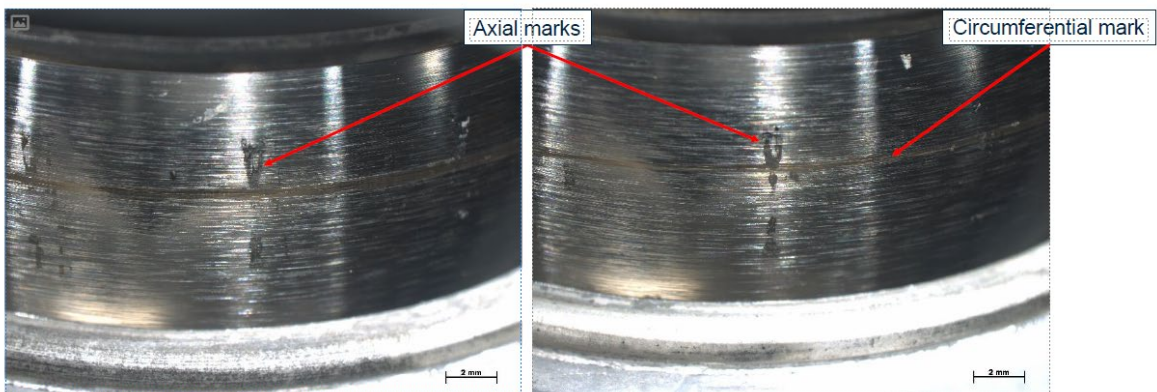
Figure 5

After cleaning, visual examination of the inner surfaces of bearing No1 showed axial marks consistent with the ball positions and circumferential marks around the approximate midpoint of the outer race (Figure 5).

Bearing No 1 axial and circumferential marks

Examination of the bearing No 1 outer race in the scanning electron microscope (SEM) showed that the axial marks had resulted from a combination of corrosion and sliding in the axial direction. The track of circumferential marks had resulted from a combination of corrosion and wear. Within this track was a line where the machining marks on the outer

race had been polished flat. This was considered consistent with the type of wear that occurs with in-service bearings. However, within this track, patches of corrosion were also observed, which is not typical. The corrosion is likely to have contributed to the rough running of the bearing.

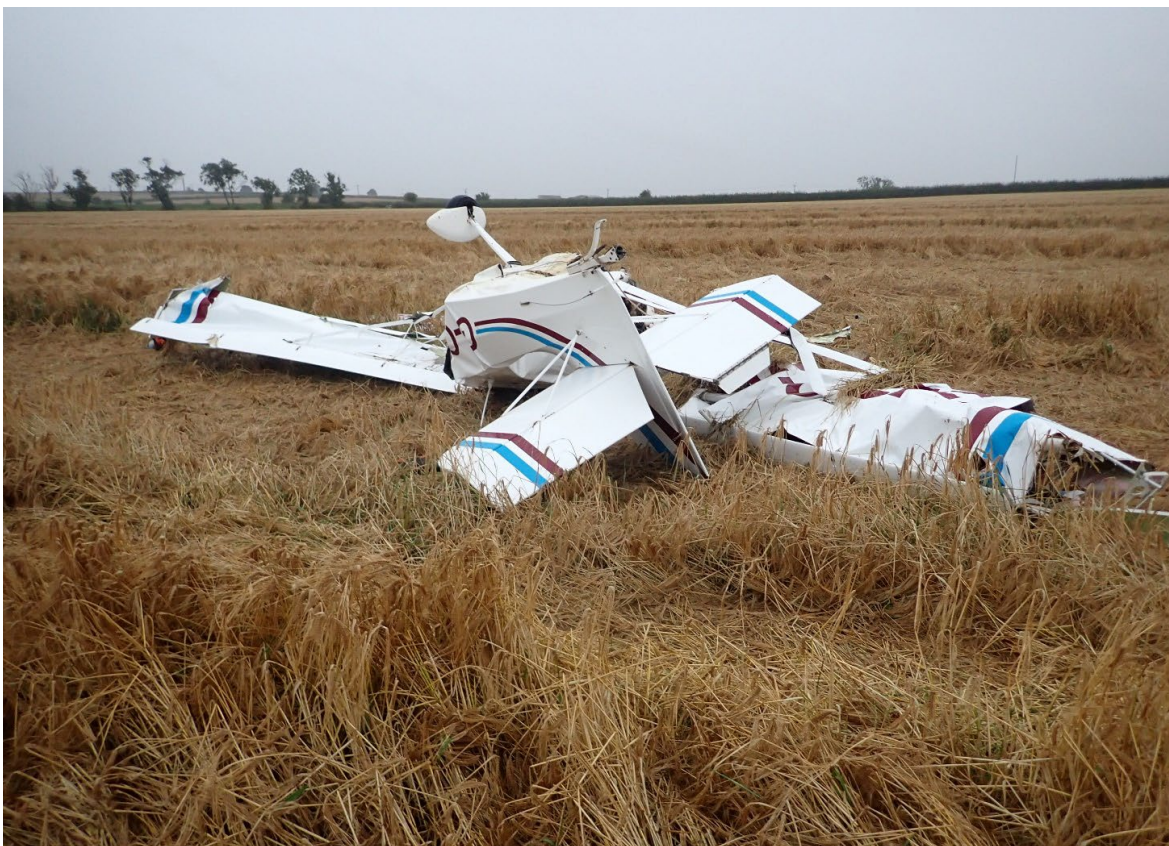
Figure 1
Accident site

The accident site was in a crop field (Figure 1). There was an initial witness mark on the ground which was made by the left wing then a small debris trail which led to the main accident site. Due to the high energy involved, the aircraft suffered structural break up as it hit the ground before finally coming to rest inverted approximately 33 metres from the initial impact point. There was no fire at the scene and fuel was recovered from both wing tanks.

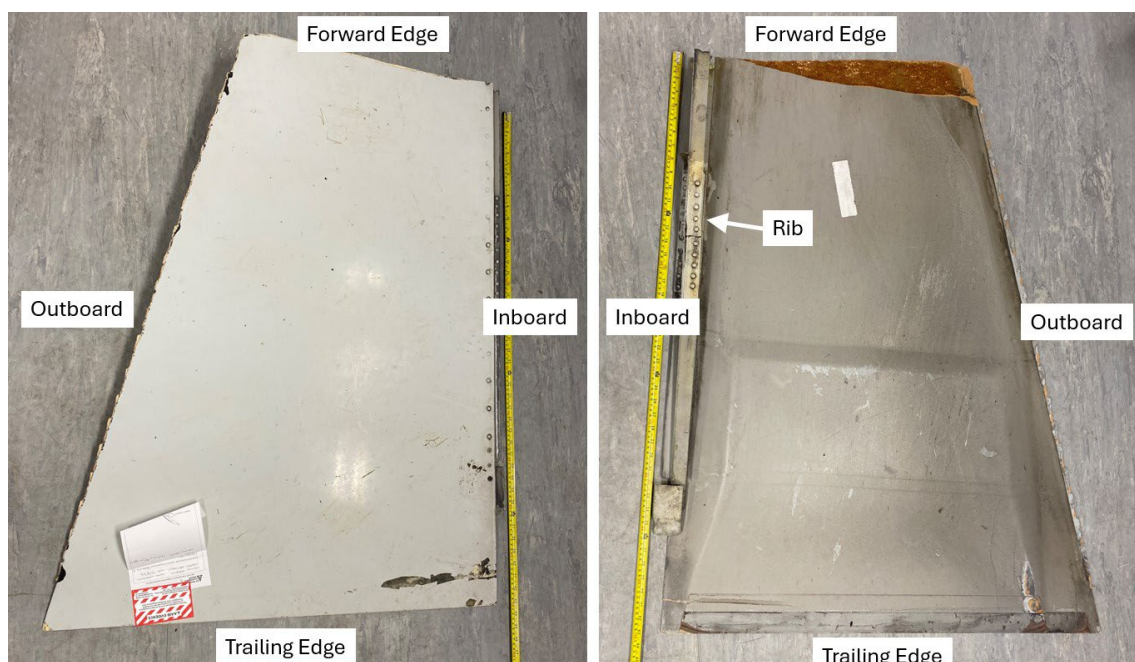
Figure 2

The panel part number was identified as 65B11629 and the rib part number as 65B10865.

Photos of detached wing panel

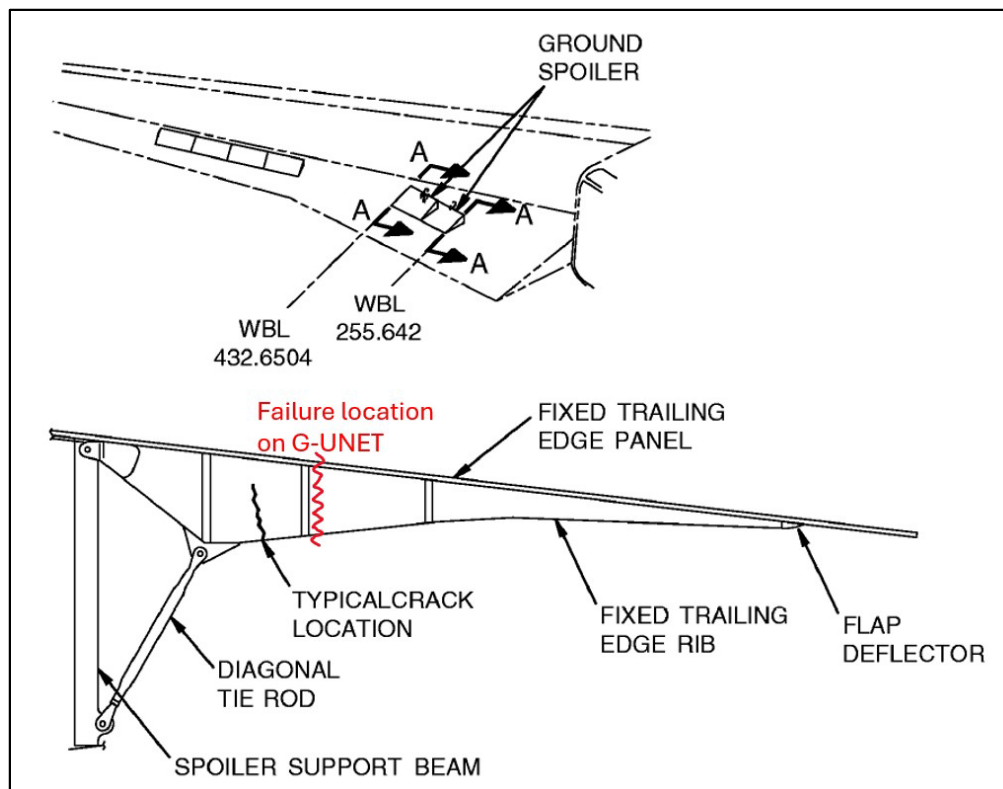
Figure 4

Illustration from Service Letter 747-SL-57-101-B with location of rib failure on G-UNET shown in red.

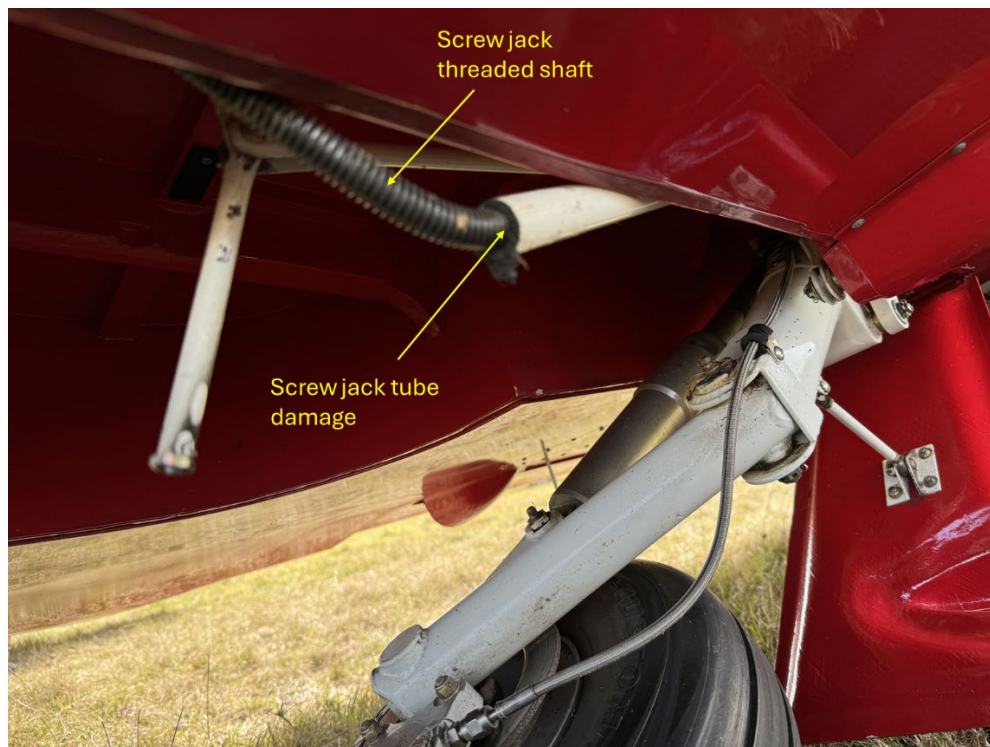
Figure 1

An examination of the aircraft found the retraction screwjack was bent with damage to its drive linkages and tube (Figure 1). In his own analysis, the pilot considers that the bounce on takeoff with a 90° crosswind, albeit low, caused a side drift which overloaded the landing gear retraction linkages.

Damage to screwjack and tube
(picture courtesy of the pilot)

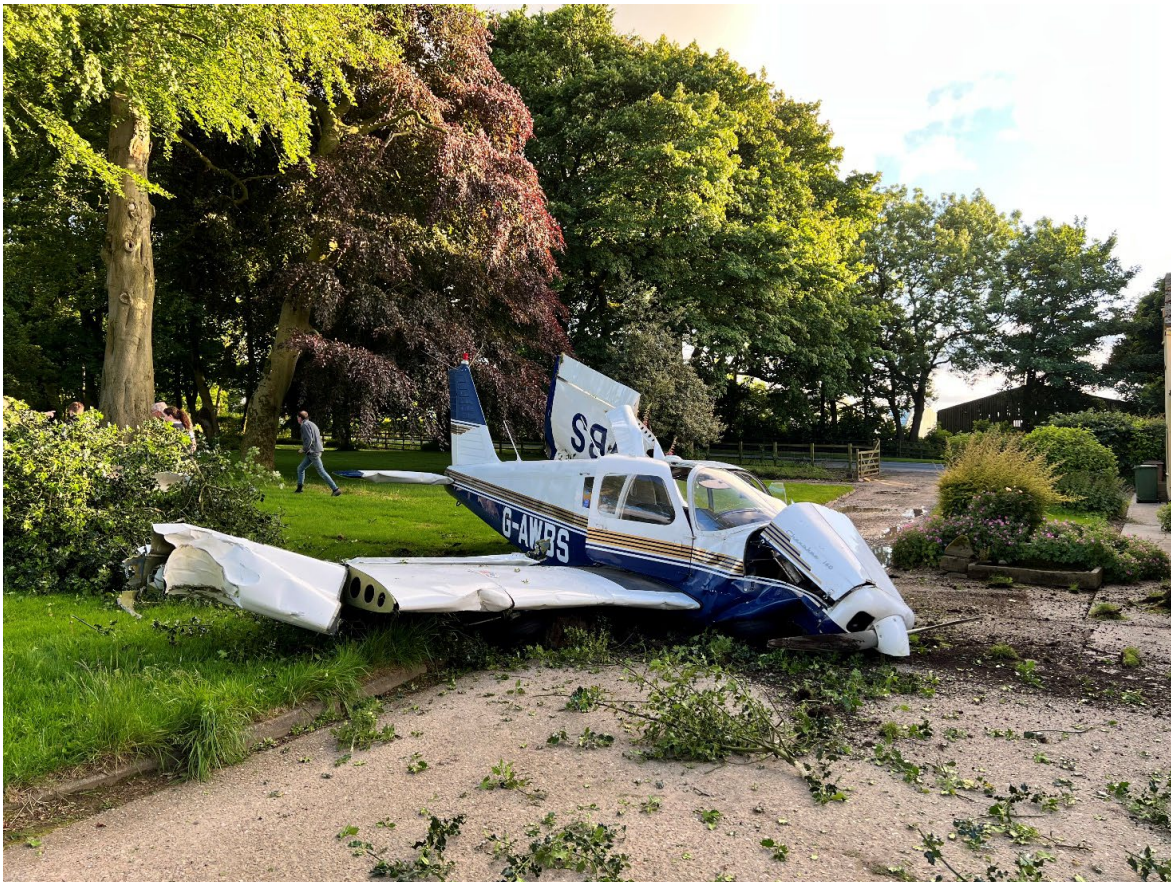
Figure 1

The aircraft came to rest in the garden and on the driveway of a local residence and was destroyed (Figure 1). After completing emergency shutdown procedures, the pilot and passengers were able to exit the aircraft unaided with minor injuries.

G-AWBS at the accident site
