Near miss with a track worker near Fishguard, Pembrokeshire, 4 January 2024

Summary of the incident

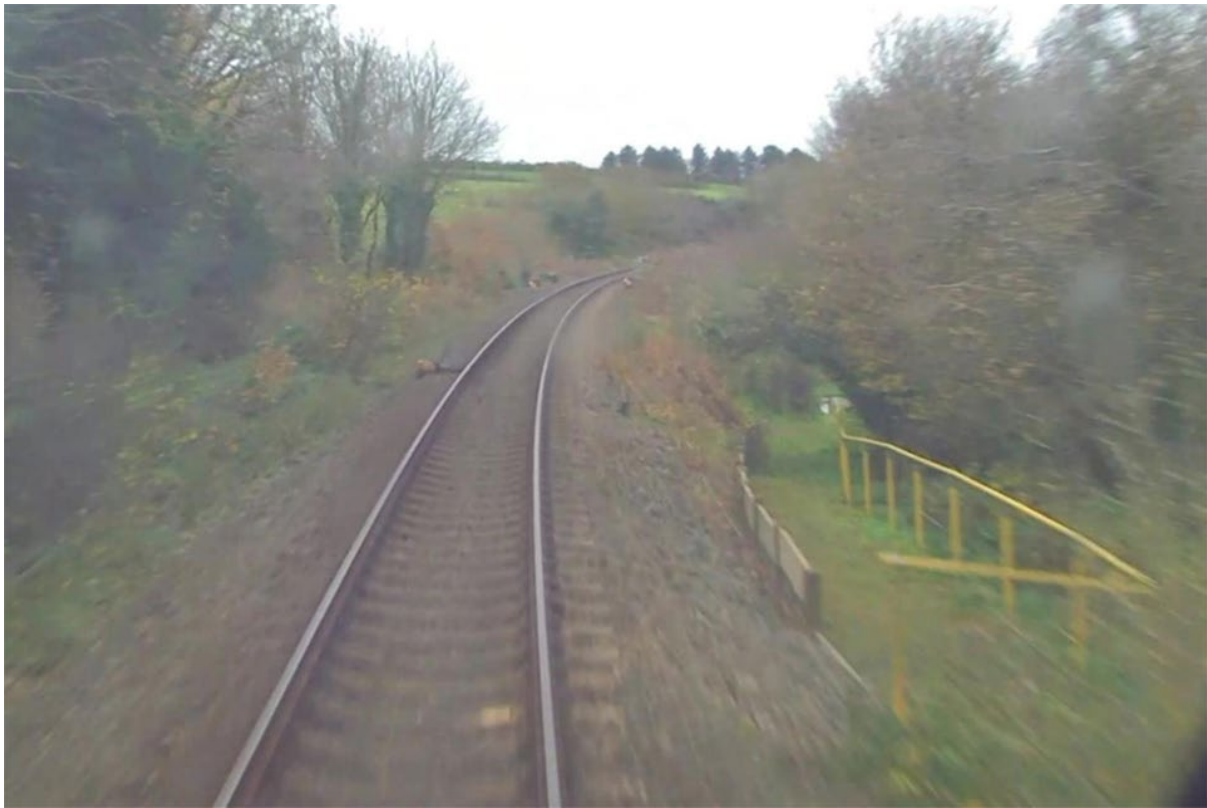
The railway passes over the bridge around 60 metres north of this access point. The track over the bridge is classed as 'limited clearance', meaning that staff do not have a position of safety throughout the length of the structure.

Image from forward-facing CCTV taken from a different train, showing the access point in the foreground and the bridge in the background (courtesy of Network Rail).
