Rail Accident Investigation Branch

Rail Accident Report

Trap and drag accidents at Archway and Chalk Farm stations 18 February and 20 April 2023

Report 06/2024
June 2024

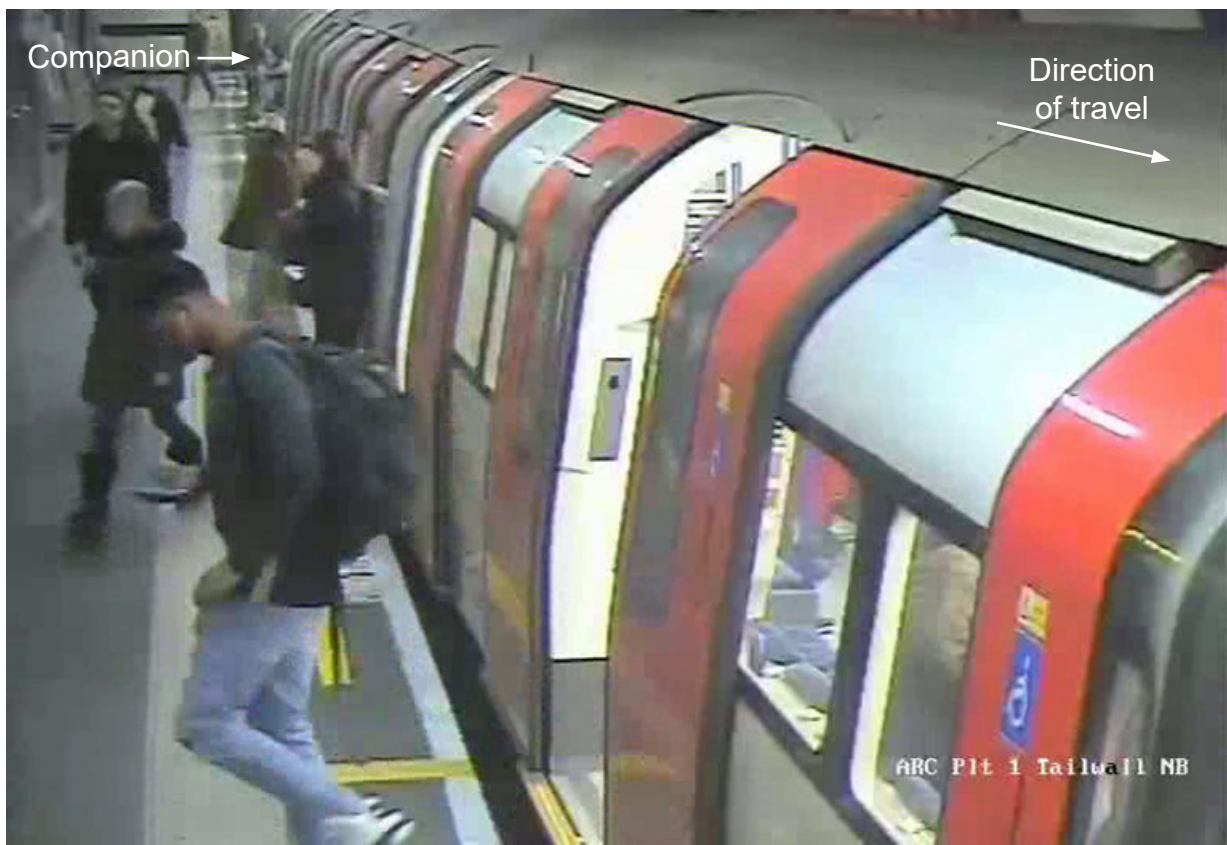
72 When deciding to close the doors, the train operator was unaware of the presence of the passenger in the doorway. At the point that the train operator pressed the doors close button, CCTV footage from a platform camera shows that the passenger's companion had just begun to alight from the train and was in the doorway but had not yet stepped off the train. Platform CCTV images are not necessarily representative of what the train operator could see on the in-cab monitor display, so it is possible that the passenger's companion was not visible in the doorway to the train operator when they viewed the in-cab monitor at this point (see figure 6).

Figure 6: The view of the train at the point the doors close button was pressed.

73 Although the train operator was unaware of the presence of the passenger when they decided to close the doors, they had seen the companion getting off the train. The train operator believed that the companion was clear of the doors and that it was therefore safe to close them. Although the companion was close to the train when this decision was taken, the train operator may have believed that by the time the closing sequence had completed, which takes around five seconds from the doors close buttons being pressed (paragraph 27), the companion would be completely clear of the doors. The train operator was unaware that the companion was waiting to assist the passenger off the train.

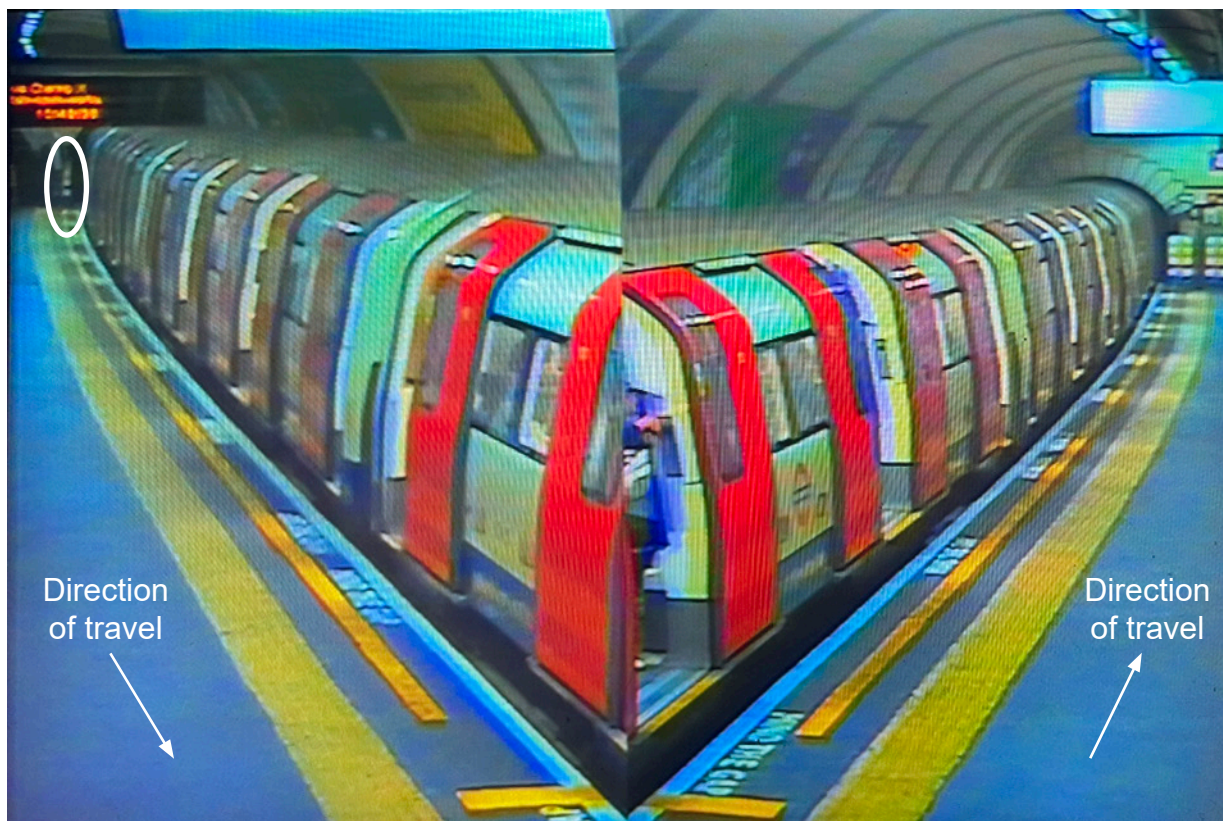
- 122 The size and contrast of an object will also affect whether it is detected or not. A reconstruction carried out by RAIB, placing a person in a similar position to the passenger (without other passengers obscuring them) and viewing from the in-cab monitor, demonstrated that it was difficult to identify a person in that position. In the monitor, the passenger appeared small and there was low contrast in the overall image (figure 9). The passenger's position close to the train also meant that there was not a break in the yellow line on the platform (paragraph 48). This may also have further reassured the train operator that no one was close to the train.

Figure 9: RAIB reconstruction showing person in same position as passenger on Chalk Farm platform.

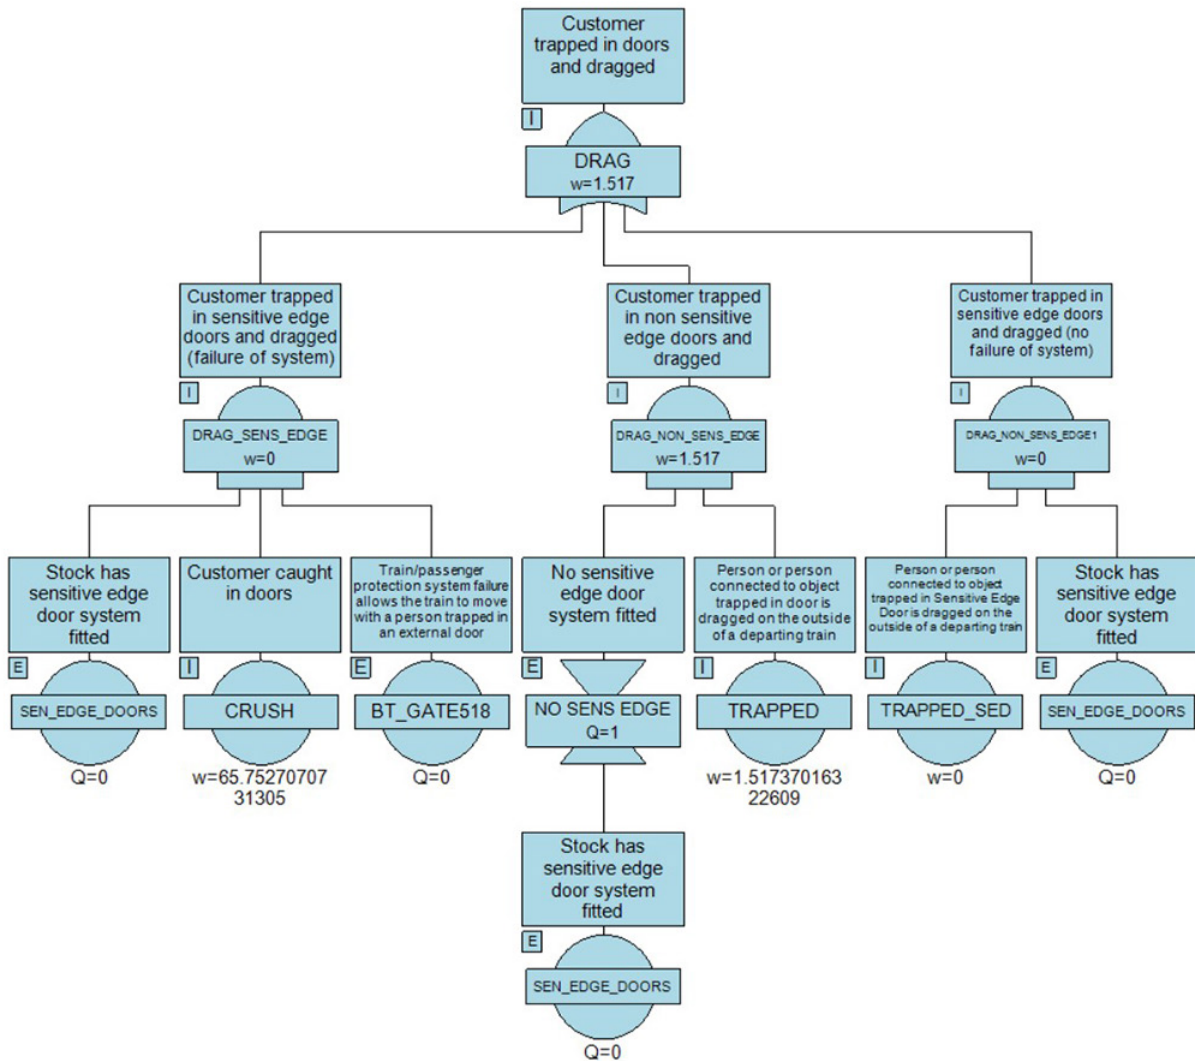
143 The data used in the London Underground Quantified Risk Assessment did not fully reflect the risk of a trap and drag accident.

Figure 10: LUQRA fault tree for passenger trap and drag on the Northern line.

145 The LUQRA includes fault and event trees for ‘passenger trap and drag’ on the Northern line. The fault tree for this event (figure 10) shows that its estimated frequency is approximately 1.5 events/year. Overall, LUL estimates that there are 67.5 events per year where a passenger is trapped in the train doors on the Northern line. Therefore around 1 in 45 events involving a passenger being trapped in a door leads to them remaining being trapped as the train moves off, and therefore being dragged.

Following this review, London Underground Limited should develop a timebound programme to review and update the relevant risk assessments and to identify any additional risk controls which are found to be appropriate.
