Rail Accident Investigation Branch

Rail Accident Report

Fatal accident at Stratford London Underground station **26 December 2023**

Report 01/2025
January 2025

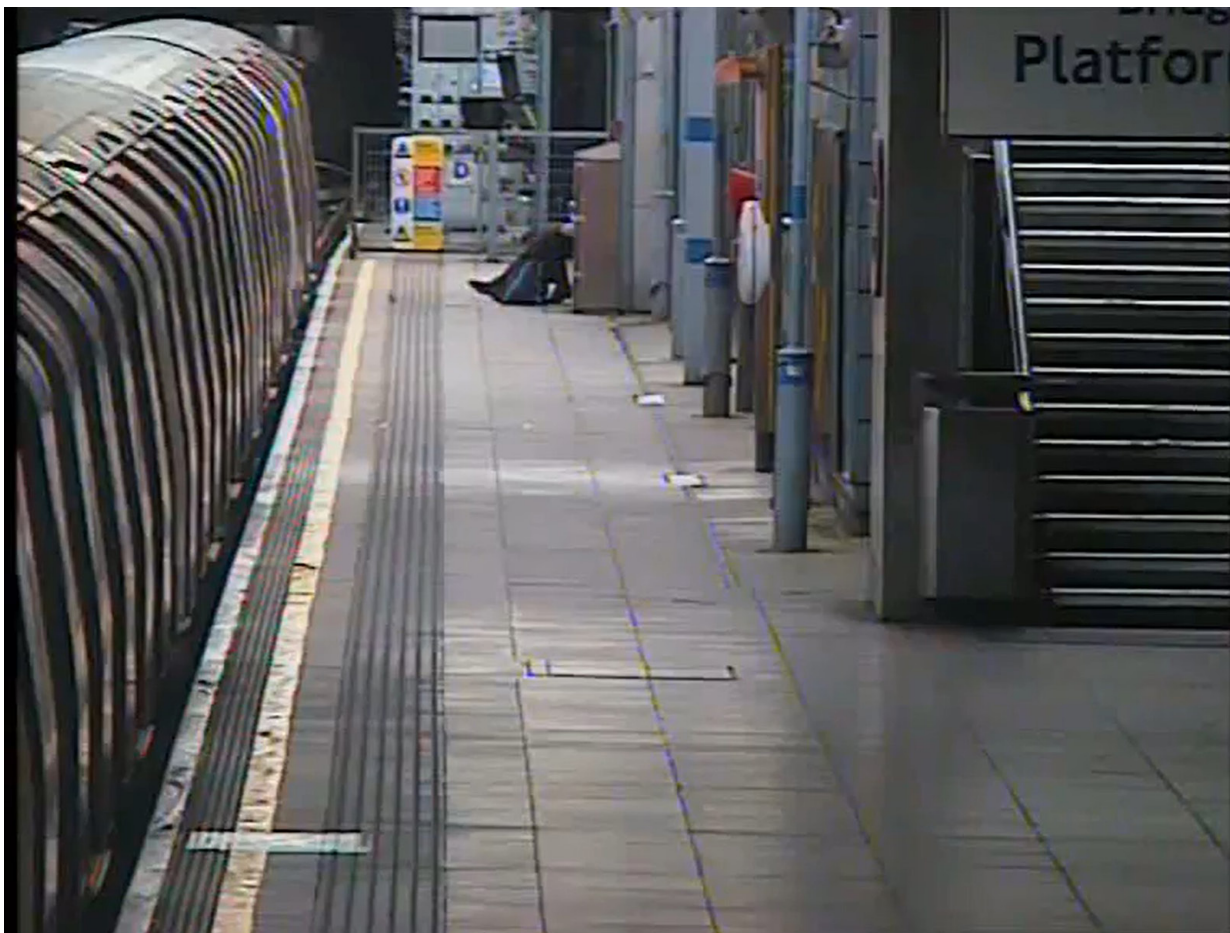
4: 2023/12/26 13:57:02.544

Figure 4: CCTV image of the passenger sat on the bench (courtesy of LUL).

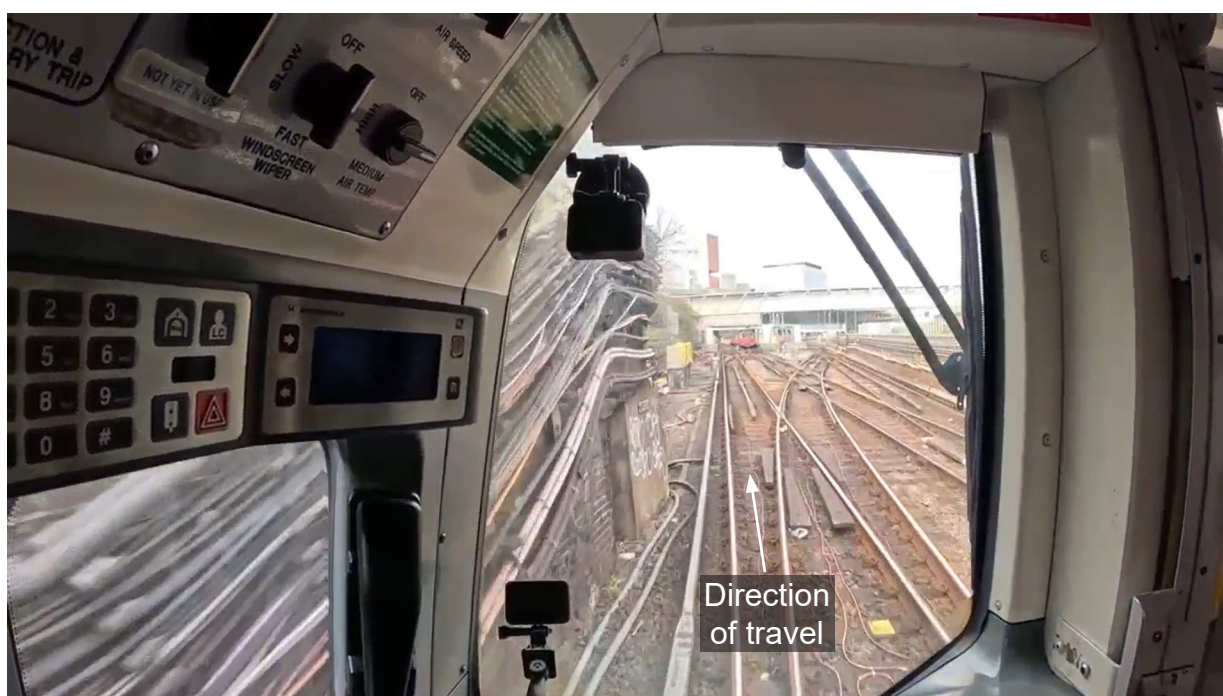
- 72 As the train approached the station during the reconstruction, the TO reported first seeing the test object from approximately 112 metres away (figure 8). For the reconstruction, LUL sprayed a yellow line across the track at a distance of 40 metres on approach to the passenger's location. This yellow line was positioned at what LUL had calculated to have been the latest point at which the emergency brake could have been applied to stop the train before reaching the passenger, taking into account the deceleration rate of the train and the decision time of the TO. When the TO could see this yellow line, they were able to discern the nature of the obstruction on the track, and to judge that there was a clear safety risk. Therefore, RAIB has concluded that the train could have been stopped before reaching the passenger, had the passenger been seen and the brakes applied before or at this point (figure 9).

Figure 8: The moment that the reconstruction TO was able to recognise the reference object on the track, approximately 112 metres from the object.

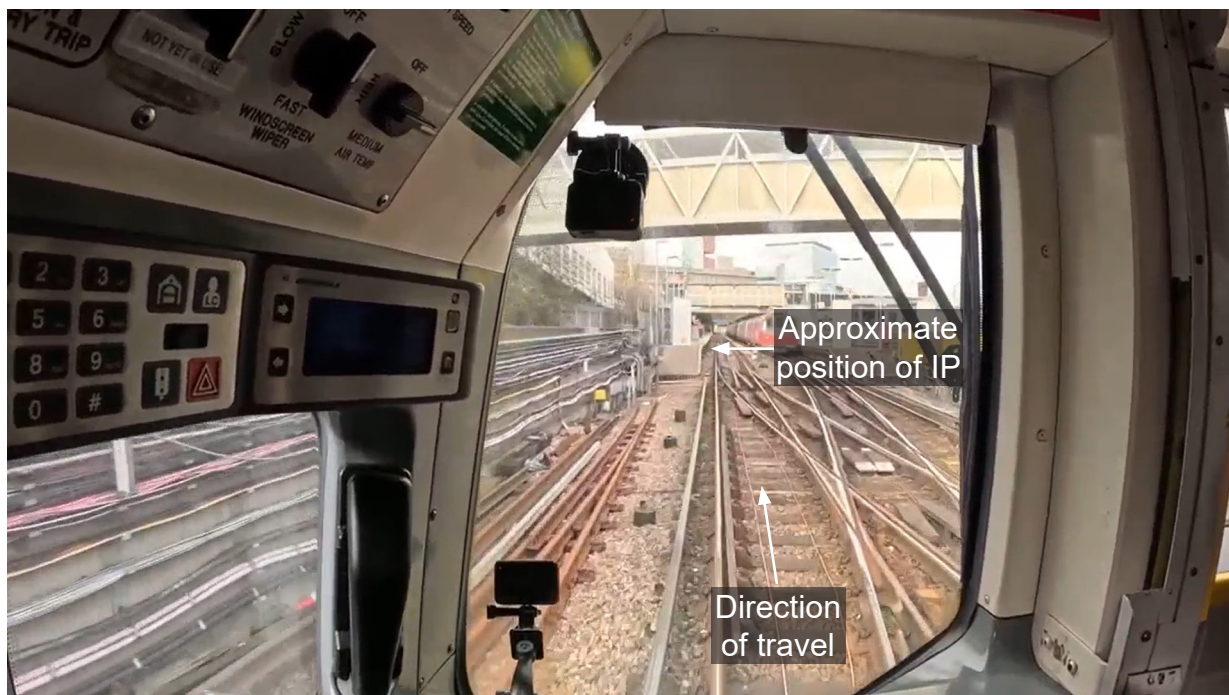
Figure 9: The moment that the reconstruction TO stated they would have recognised the obstruction as a safety risk and applied the emergency brake, approximately 40 metres from the object.
