Rail Accident Investigation Branch

Rail Accident Report

Derailment of a passenger train at Grange-over-Sands, Cumbria 22 March 2024

Report 02/2025
January 2025

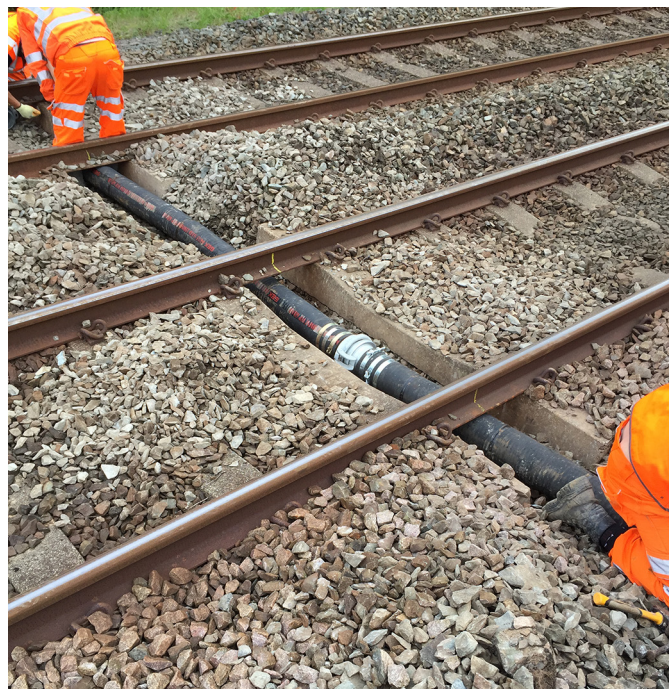
- 32 Before the construction of the railway in the 1850s, the land to the north (now comprising the golf course, cottages, and farmland) formed part of the bed of Morecambe Bay or was marshland. The reclamation of this land formed part of the plan to fund the railway's construction.

Figure 13: Installation of the pipe which was struck by the tamper (courtesy of Network Rail).

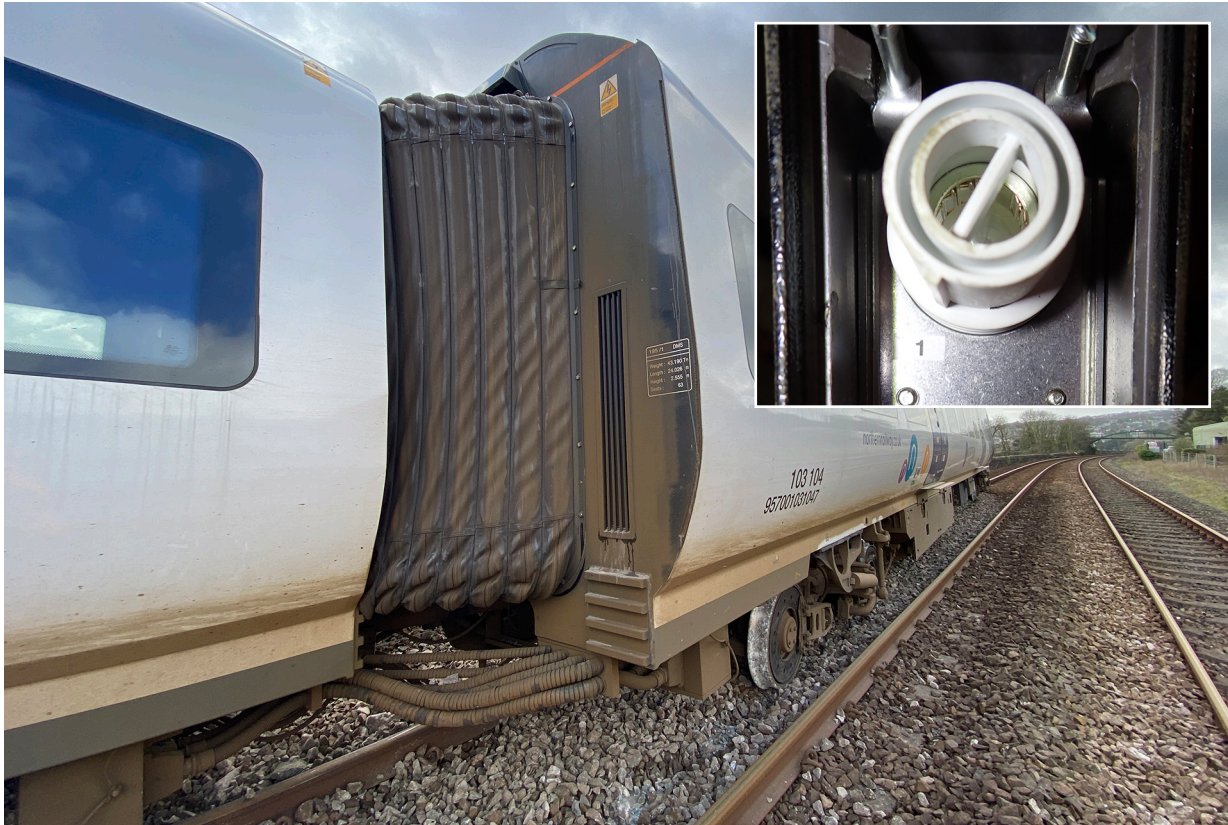
- 71 At 05:27, the SAE called Manchester ROC back and spoke with the ISC, explaining that they had mistakenly left their phone on silent. The ISC had not previously been dealing with the incident, but the SAE explained that they were aware of the pipe and that it was not connected to a pump. The SAE said that they would arrange a repair of the damaged pipe.

Figure 16: The power transfer cable stretched taut following the derailment (main). Damage to the internal fittings of the power cable discovered post derailment (inset).

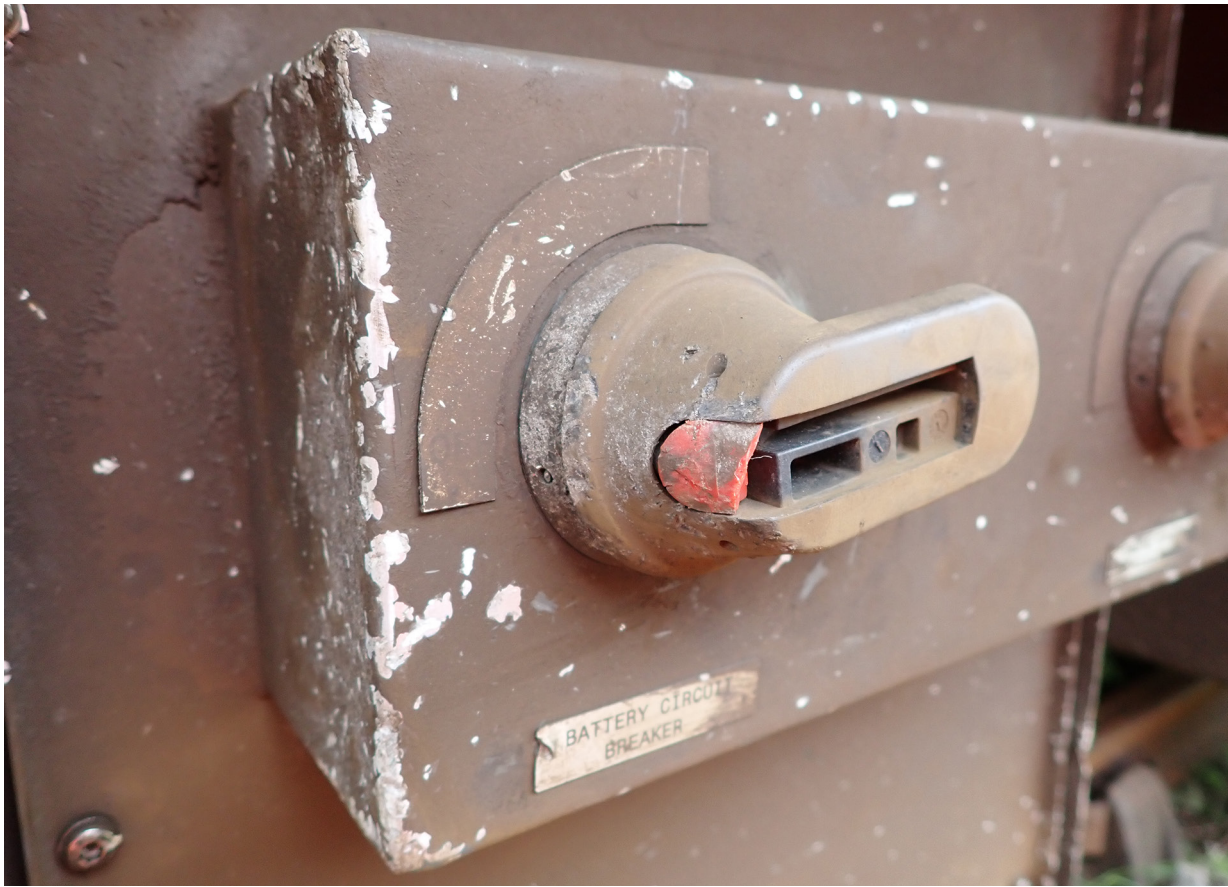
- 72 The following day, Thursday 21 March, at 07:18 the SAE made an internal request to instruct contractors to replace and relay the pipe at a greater depth to prevent it from being struck again.

Figure 17: Damage caused to the battery isolation switch as it was knocked to the isolated position during the derailment.
