Overspeeding near Manor Park, 24 September 2024

Summary of the incident

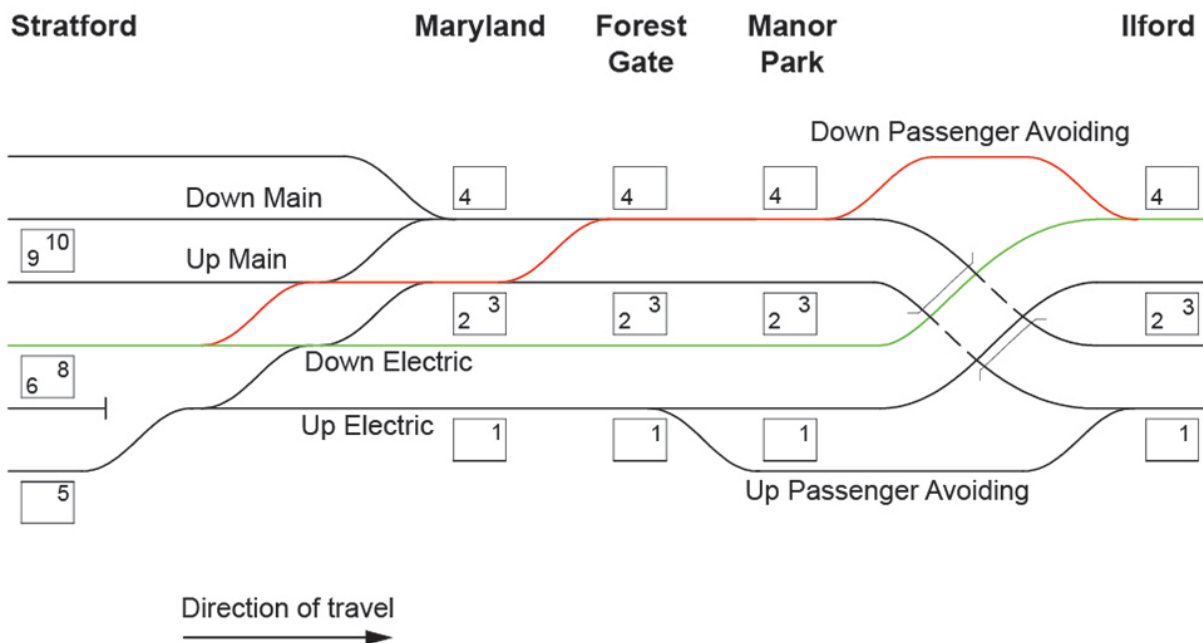
Evidence from the train’s forward-facing CCTV and on-train data recorder (OTDR) shows that train 9W38 was brought to a stand at 07:51 on the approach to Stratford station at the signal protecting platform 8. The driver contacted the signaller and was informed that there was a track circuit failure ahead on the Down Electric line. The train was then routed into platform 8 at Stratford, running about 10 minutes late. Before departing the platform, the signaller informed the driver that the train would be routed onto the Down Main line and then onto the Down Passenger Avoiding line, before rejoining the Down Electric line.

Track diagram from Stratford to Ilford, showing the booked route in green and the route of 9W38 in red. (Not to scale and simplified to remove non-relevant track.)

The train departed Stratford station at around 07:59. On departure, the train crossed onto the Up Main line and stopped at Maryland station. It then crossed onto the Down Main line before stopping at Forest Gate station. At the next station, Manor Park, the driver entered platform 4 on the authority of a single yellow aspect. The train departed Manor Park at approximately 08:09. The next signal it encountered, signal L329, was displaying a red aspect, which cleared to a double yellow aspect as the train approached. The route indicator box displayed the letters ‘DA’ to inform the driver that the train was to be routed onto the Down Passenger Avoiding line ahead.

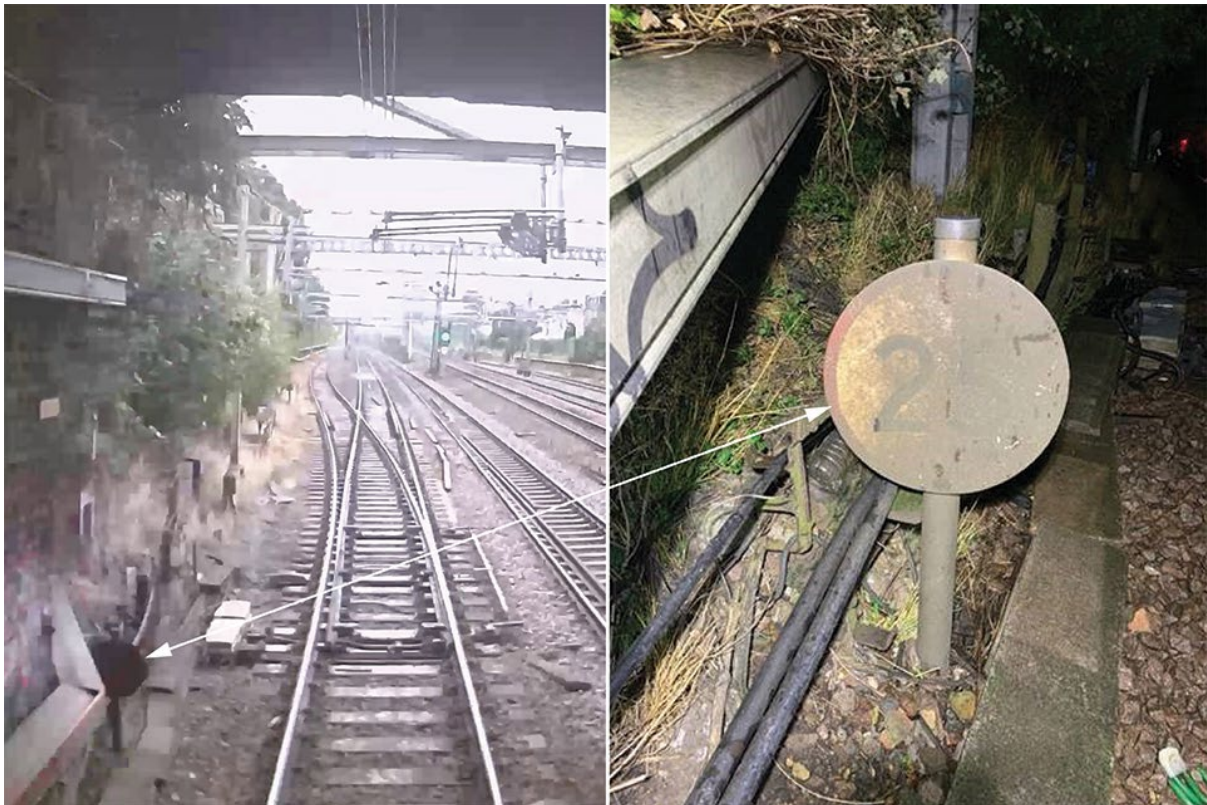
Around 14 seconds after signal L329 cleared to double yellow, while approximately 330 metres on approach to the points, the driver applied power. Around 5 metres before the points, with the OTDR recording that the train was travelling at a speed of approximately 45 mph (72 km/h), the train passed an incorrectly placed, inconspicuous and dirty 25 mph (40 km/h) PSR sign indicating the speed restriction over the points leading to the Down Passenger Avoiding line.

To reinforce drivers' route knowledge (including alternative routes), lineside signs are provided to indicate where train speed restrictions apply and change. RAIB found that the speed restriction sign applicable to train 9W38 as it approached the diverging junction was neither in the position, nor of the design, specified in the approved installation documentation. This shows that it should have been a larger sign with a left-hand direction arrow, positioned on the approach to the bridge before the points. At the time of the incident, the sign was positioned under the bridge, and partially obscured by lineside equipment, which made it difficult to see. It was also covered in dirt, further reducing its conspicuity and legibility.

PSR sign before the diverging points.

Network Rail company standard NR/L3/SIG/11303, 'Signalling installation – signals: signs and boards', issue 2 dated December 2010, states that lineside and operational signs should be positioned in accordance with the installation design. Network Rail Track Work Instruction 2L007, 'How to maintain signs', version 1 dated March 2005, also states that signs should be kept clean and in good repair.
