Rail Accident Investigation Branch

Rail Accident Report

**Collision between a passenger train and a fallen tree at Broughty Ferry, Dundee
27 December 2023**

Report 13/2024
December 2024

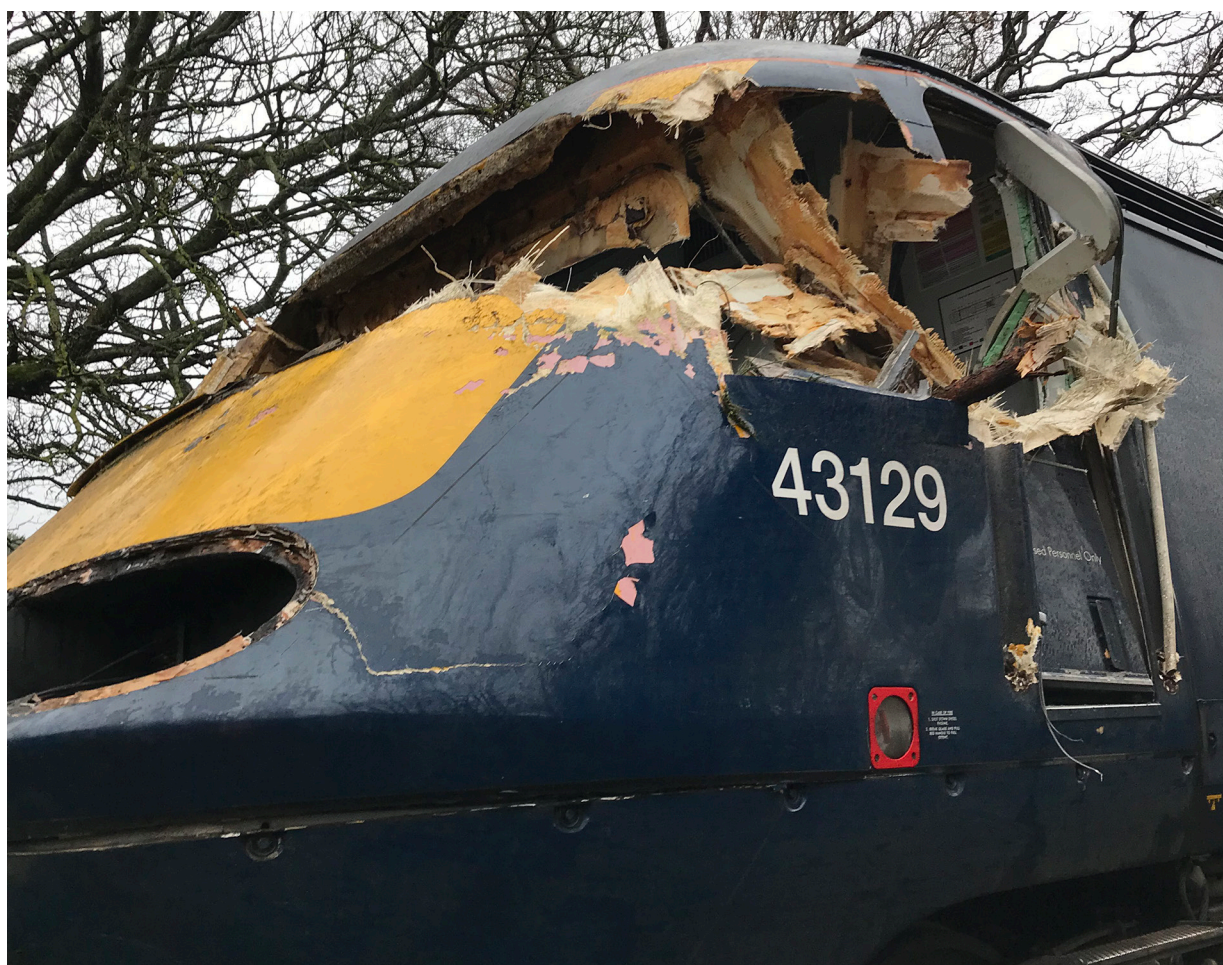
- 33 During the collision, the tree stem entered the cab area around driver's eye level, passing through the cab pillars either side of the windscreen, before cutting through the body of the cab, the quarter light window and the driver's door. The tree stem's progression through the driving cab stopped just above the driver as it reached the bulkhead structure separating the driving cab from the power car equipment compartment behind the cab (figure 6).

Figure 6: Damage sustained to left-hand side of driving cab.

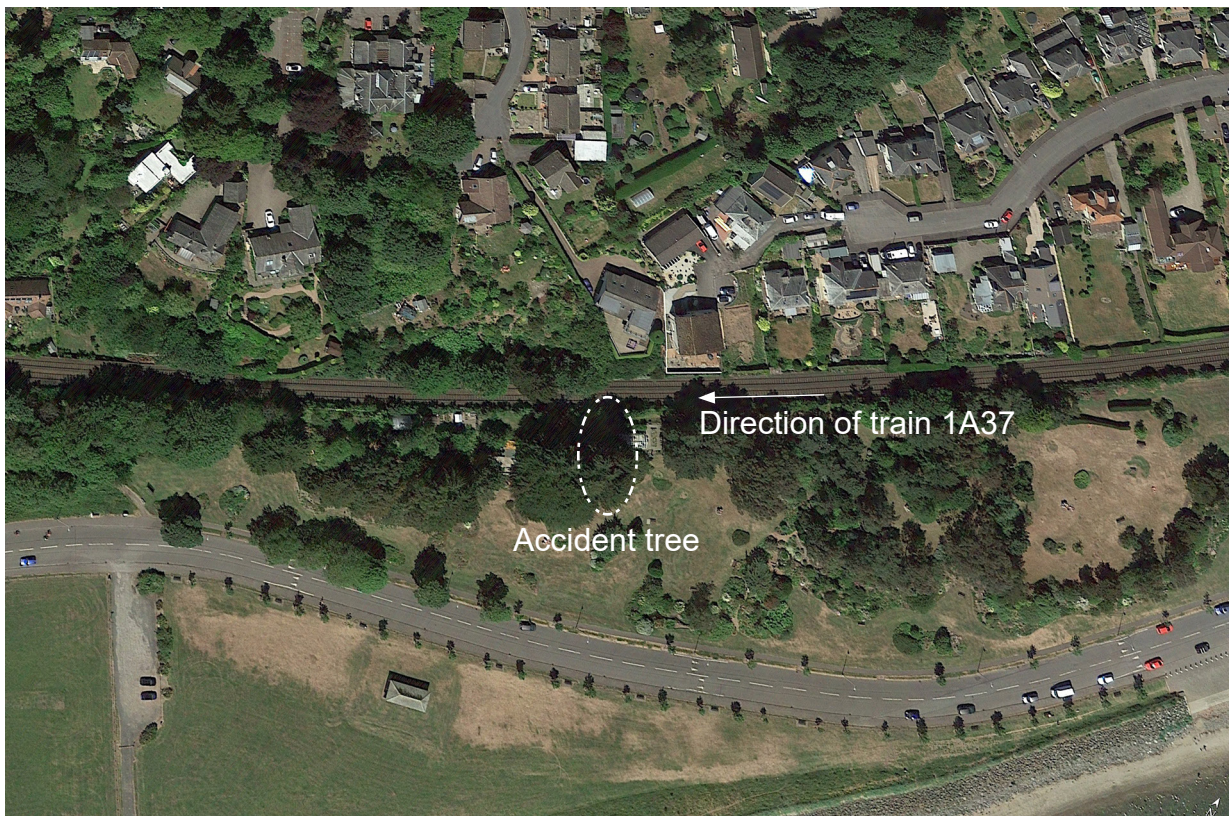
60 Google Earth and Street View images show how this group of trees has changed over a 12-year period. It can be seen in the satellite image taken of the group in June 2018 that the group of trees was well established. By May 2023, Google Earth images show that the group had been much reduced (figures 11 and 12). The Street View images capture this change from ground level and show how the trees on the southern side of the group provide shelter from the ground up to those trees behind (figures 13 and 14).

Figure 11: Google Earth image showing the group of trees in June 2018 (courtesy of Google with RAIB annotations).

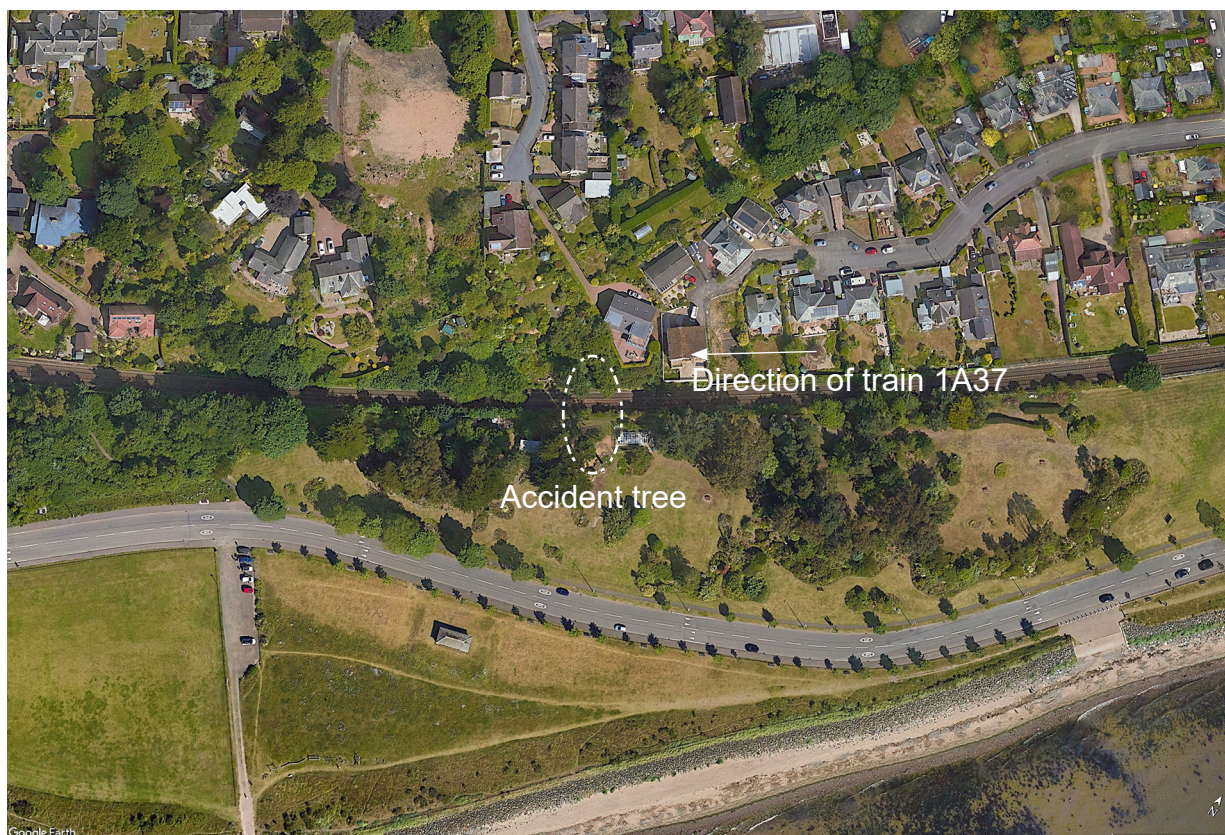
Figure 12: Google Earth image showing the group of trees May 2023 (courtesy of Google with RAIB annotations).

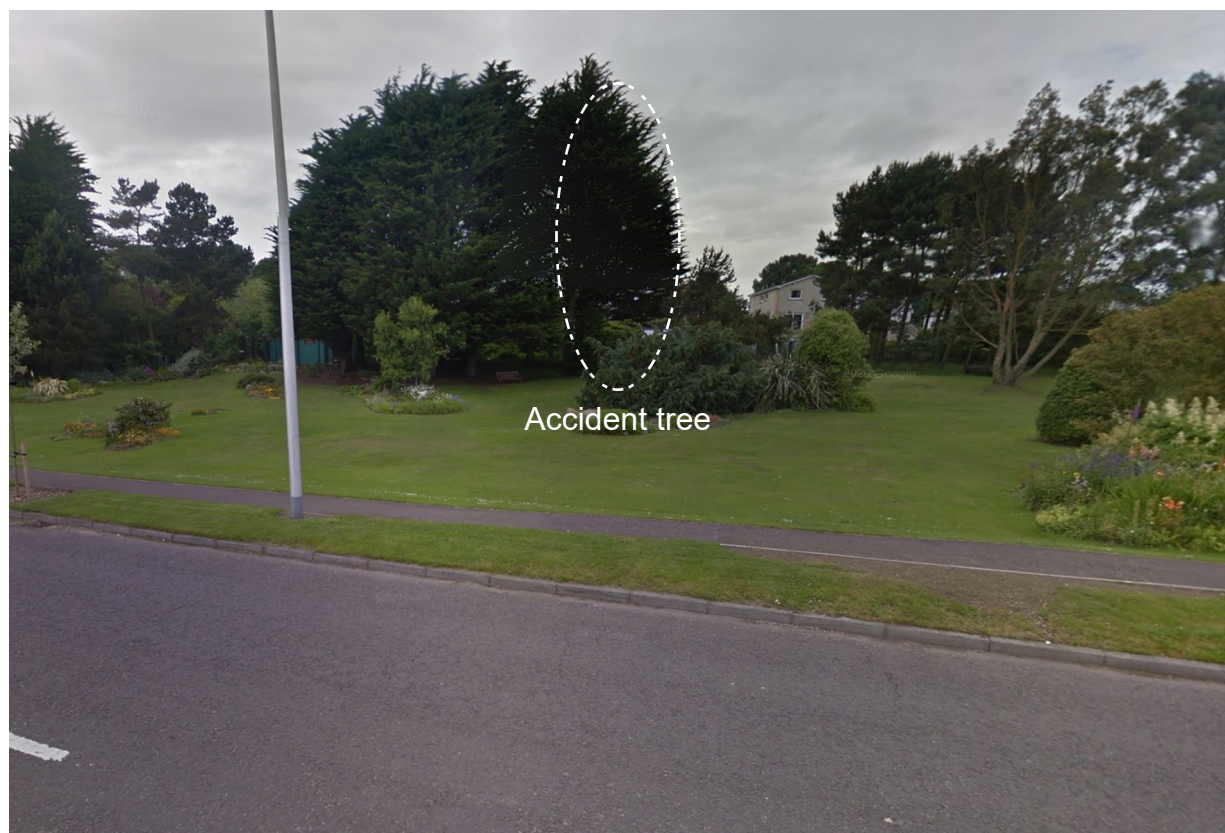
Figure 13: Google Street View image showing the group of trees in July 2012 (courtesy of Google with RAIB annotations).

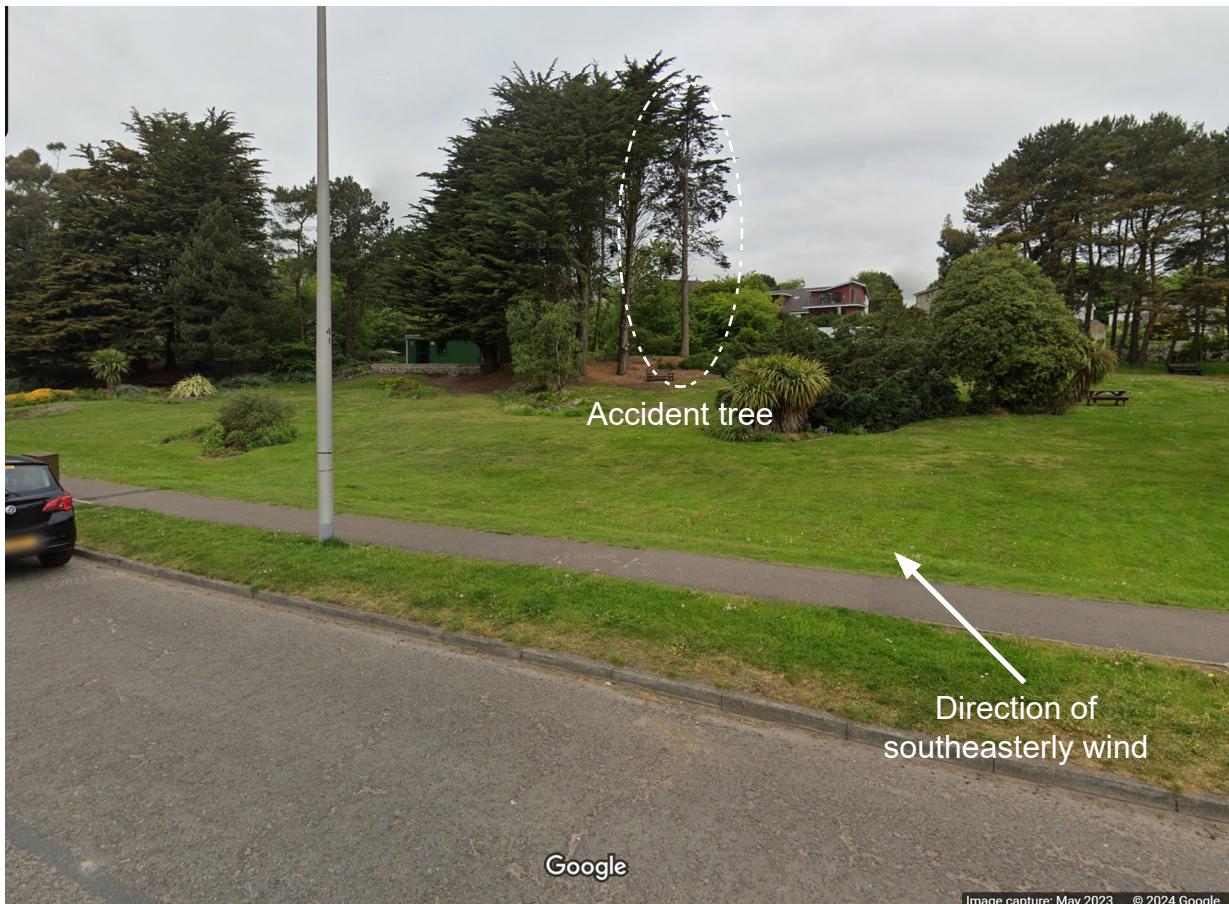
Figure 14: Google Street View image showing the group of trees in May 2023 (courtesy of Google with RAIB annotations).

- 61 These historical images also show that the fallen tree had thicker growth in the upper foliage, but thinner growth further down the stem. This is characteristic of a tree growing in the shelter of companion trees. These images also show how the fallen tree had been left standing apart from the rest of the group following the loss of the companion trees. This loss of shelter meant the tree was no longer receiving shelter from winds blowing from a southeasterly direction over the Firth of Tay.

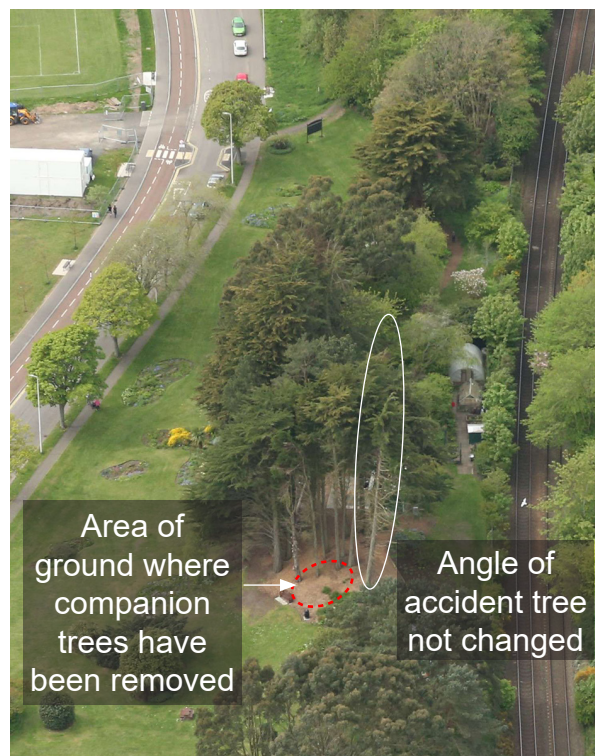
- 62 Network Rail uses aerial images of the railway to assist in its management of the infrastructure. These images extend outside of the railway boundary and, in this case, include images of the tree before it fell. The aerial images show that the tree had been growing with a natural inclination towards the railway, but that the angle of inclination had remained unchanged between April 2022 and May 2023 (figures 15 and 16). A tree to the north of a group such as this will naturally grow away from trees to its south and towards the better light.

Figure 16: Network Rail aerial image showing the trees in May 2023 (courtesy of Network Rail with RAIB annotations).

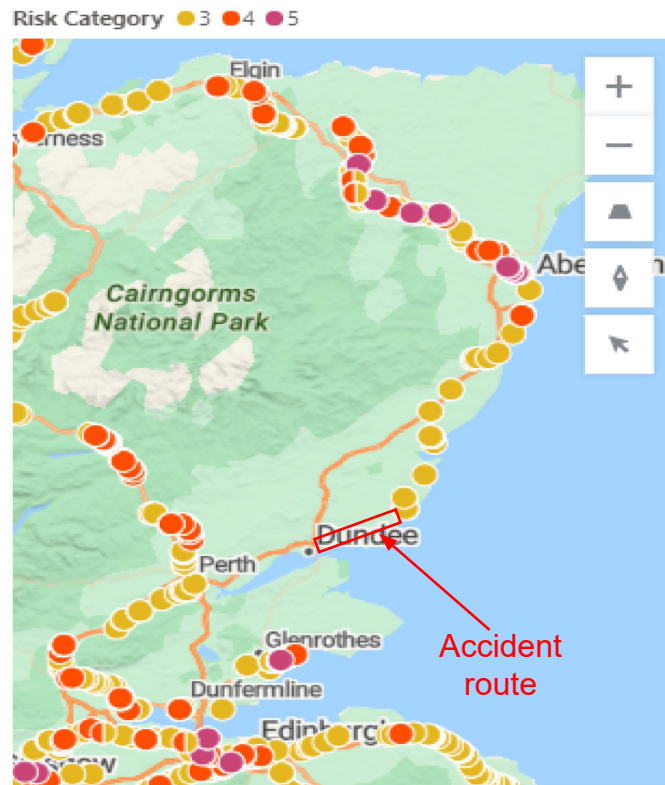
- 90 Network Rail had identified trees at risk of falling along the coastal section north of Arbroath but found that there were no trees of concern to the south (figure 18). With this information, the EWAT conference attendees concluded it was not necessary to recommend a BSR for high winds on the section alongside the Firth of Tay on which the accident occurred.

Figure 18: Network Rail database of hazardous trees north of Dundee.

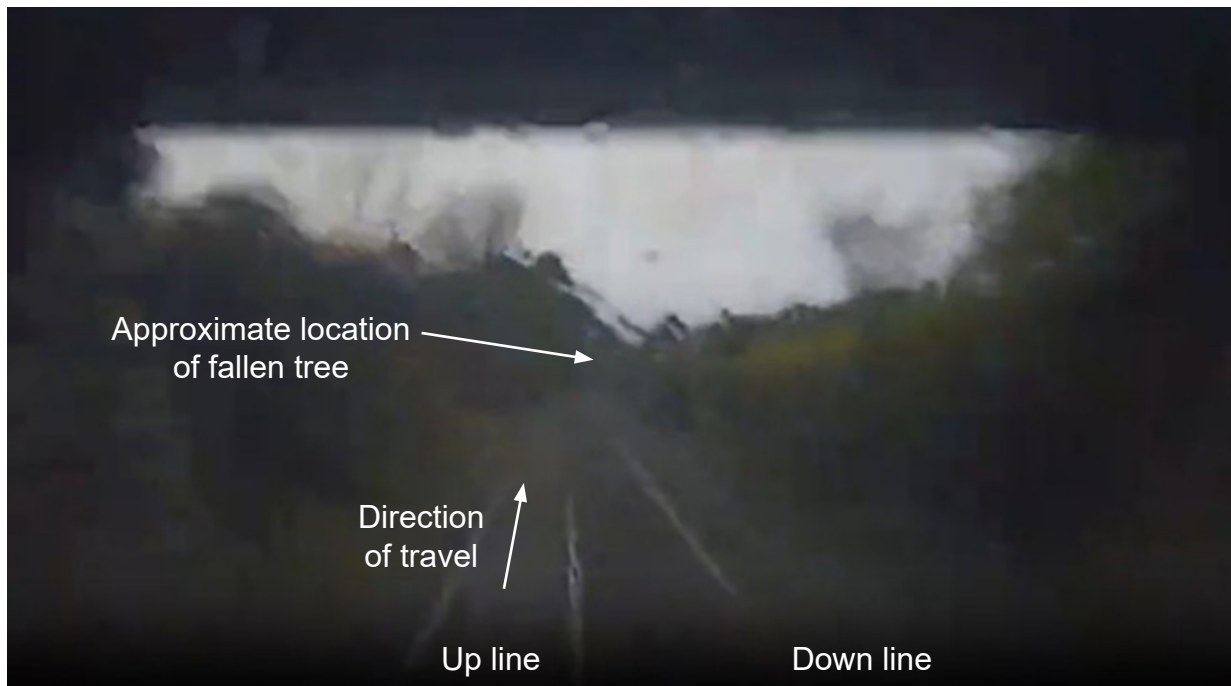
- 92 The curvature of the railway means it is just possible to see the location where the tree fell, some 240 metres (around 6 seconds at the train's speed) beyond the road bridge, but the visibility would have been reduced by the heavy rain and poor sunlight conditions on the day of the accident. The conspicuity of the fallen tree would also have been affected by the motion of the train and a lack of contrast between the tree and lineside vegetation (figure 19).

Figure 19: Image taken from train 1A37 forward-facing CCTV as it passed under the road bridge (courtesy of ScotRail with RAIB annotations).

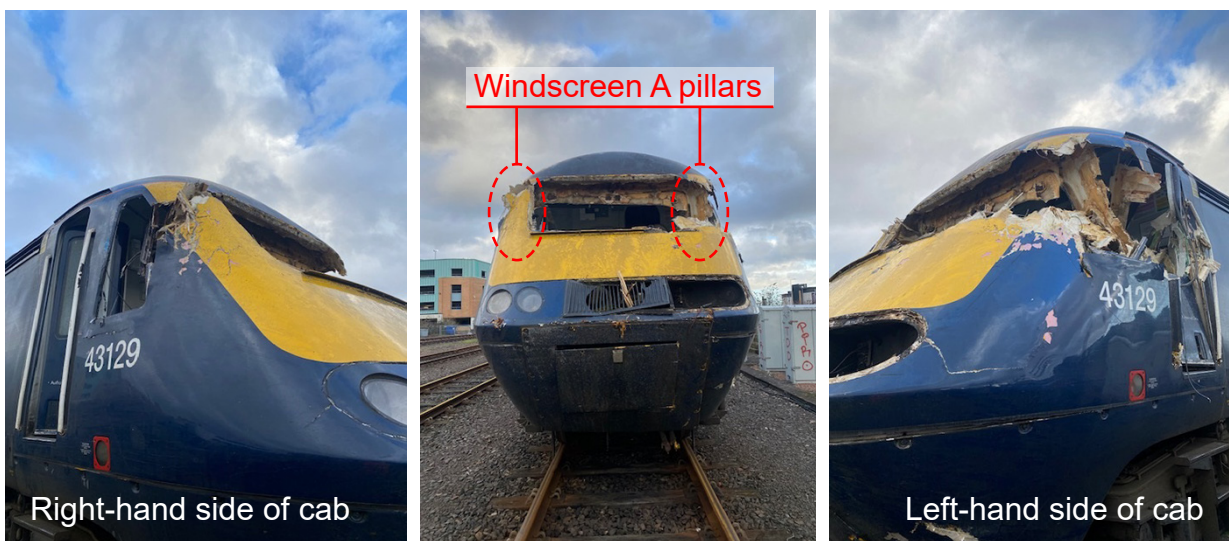
- 119 The tree stem impacted the cab at windscreen height, across the A pillars that support the windscreen at either side of the cab front and the weakest point of the HST cab structure. The energy was greater than the cab structure was intended to withstand and so it did not prevent the tree stem penetrating the cab area previously occupied by the driver. The tree broke through the A pillars and continued to break through the left-hand side of the cab, showering the inside with glass and debris.

- 120 The rootplate of the tree did not rotate in the ground with the forward motion of the train, with the tree instead beginning to bend until it finally broke into two pieces. This bending motion limited the damage to the right-hand side of the cab, but the tree continued to cut through the left-hand side adjacent to the driver's seat. The structural damage to the left-hand side of the cab extended from the windscreen back to the much stronger bulkhead at the rear, stopping just above where the driver was sheltering (figures 20 and 21).

Figure 20: External damage sustained to leading power car of 1A37.

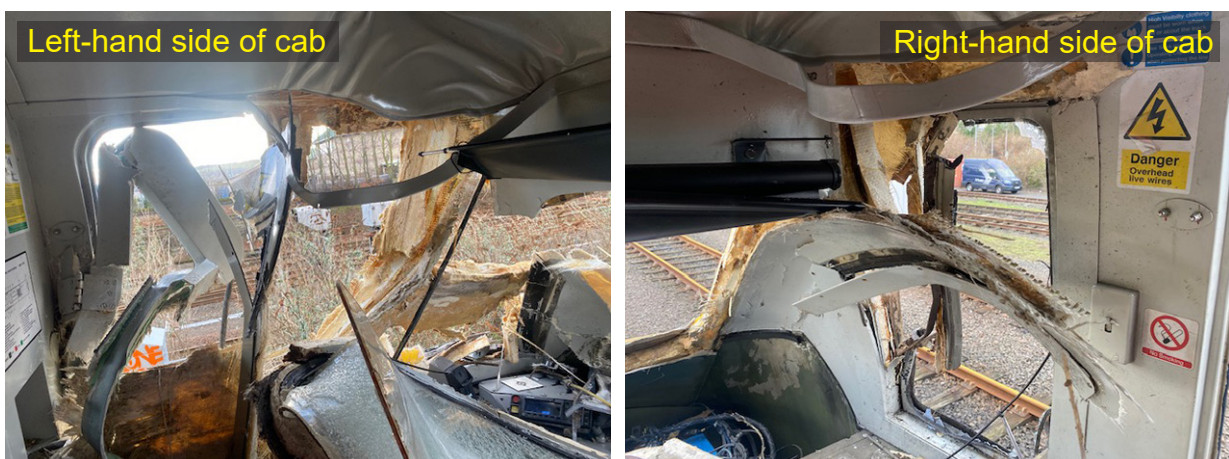
Figure 21: Internal damage sustained to leading power car of 1A37.
