Rail Accident Investigation Branch

Rail Accident Report

Derailment of a passenger train at Roudham Heath, Norfolk 6 February 2024

Report 03/2025
February 2025

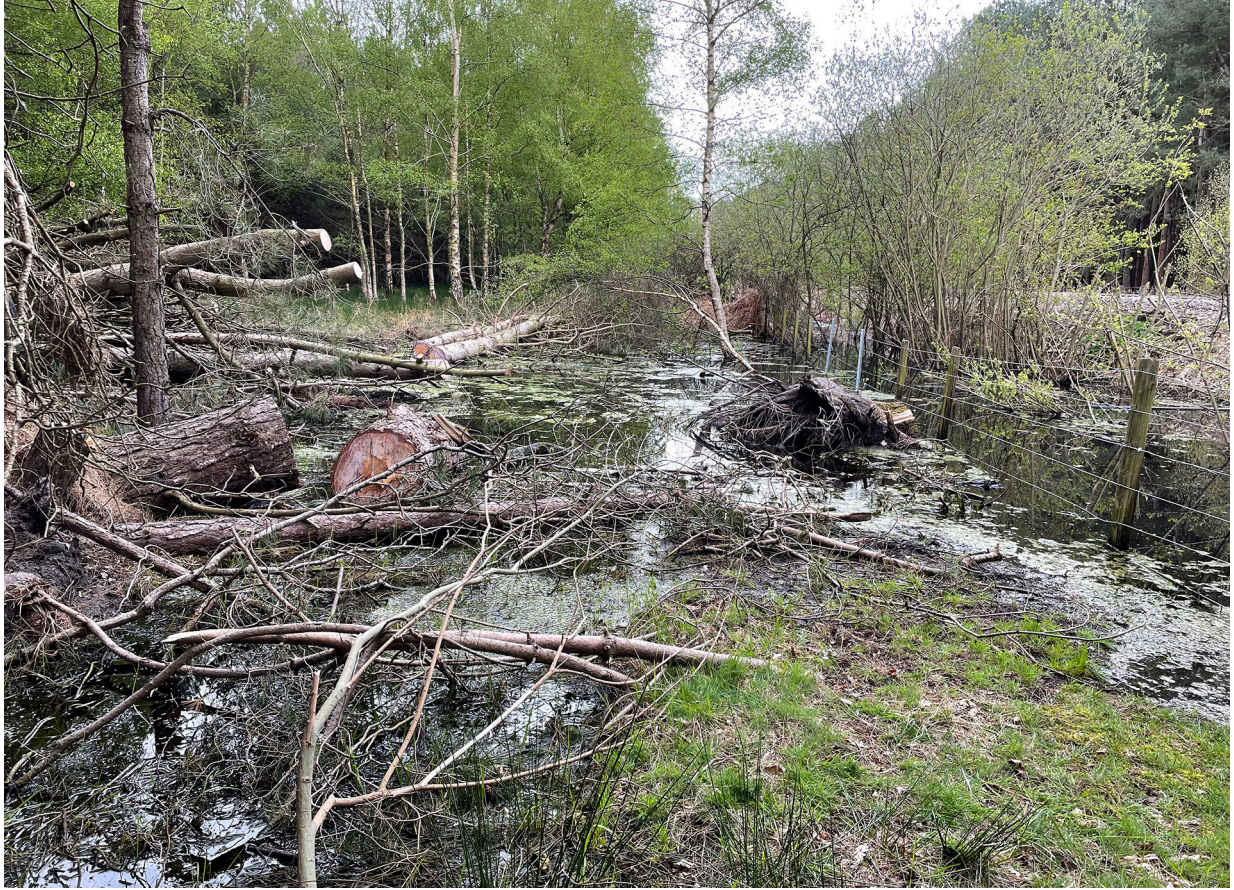
- 54 Further evidence of floodwater being a feature of this site, and in various areas in the neighbouring plantations, was found during the post-accident inspection by the arboriculturist in April 2024 (paragraph 45 and figure 6). The plantation between the site of the fallen trees and Shadwell level crossing remained flooded for at least a month after this inspection as shown by aerial images taken by Network Rail in May 2024 (figure 7). Local residents also recalled a similar flood event around February 2021 and many other occasions of localised high water levels. There have been various small-scale projects to install attenuation ponds and pumps to protect the local houses from such events indicating that there is a history of high groundwater levels in the area.

Figure 6: Site conditions during the post-accident inspection in April 2024.

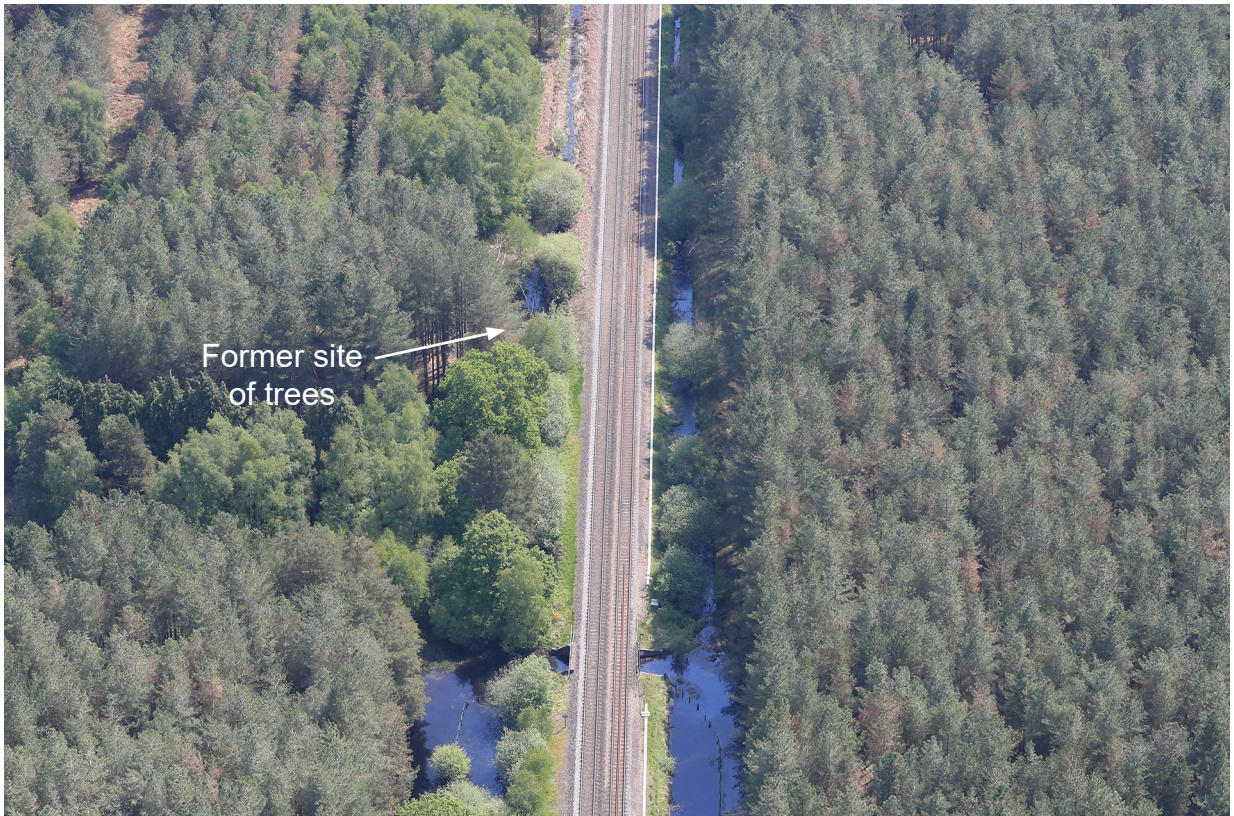
- 53 While the site was not flooded on the day of the accident, it had been raining extensively for around 3 hours before the collision occurred. The area where the tree was located is almost entirely flat, so there is little surface runoff during or following rain. Water is usually dispersed from the site by seepage through the soil to the level of the local water table. While there is a drainage ditch between the railway and the site of the two trees, this has a low flow rate due to the local topography.

Figure 7: The extent of flooding at the site in May 2024, just over 3 months after the accident. The previous location of the pine and oak trees is indicated (courtesy of Network Rail, with RAIB annotations).

- 55 The windspeed at the time the trees fell was not overly high and should not have been sufficient to blow over the pine tree in normal circumstances. The history of high groundwater, together with the onset of heavy rain before the collision, and the failure mode of the pine tree, suggest the primary reason for failure was the saturated nature of the soil the tree was standing in. As the adhesion between the roots and the soil decreased, the available root anchorage of the tree was reduced to a point that the wind load and self-mass of the tree were sufficient to overcome the tree's ability to remain standing.

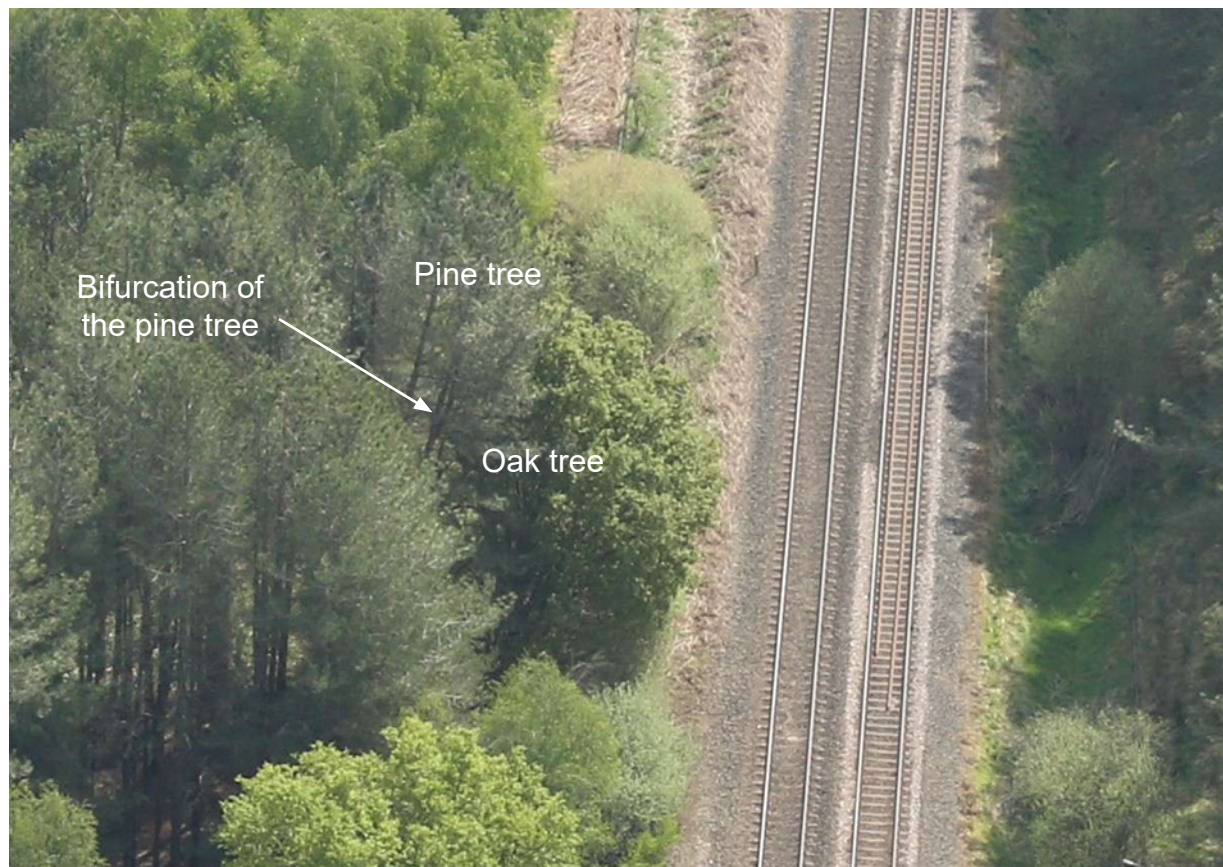
- 58 An aerial image, taken by Network Rail in May 2022, shows the pine tree with its bifurcated stem growing with a bias towards the railway (figure 8). Based on the post-accident inspection of sections of the pine tree, it is believed that this was a characteristic of its growth, and not rotation of the tree about the MAR. Trees will naturally grow to seek out as much light as possible, and the railway corridor offered a clear space for the pine tree to grow towards, away from the proximity of its immediate neighbours.

Figure 8: Aerial view taken in May 2022 showing the bias in the growth of the pine tree. The bifurcation of the pine tree is highlighted (courtesy of Network Rail, with RAIB annotations).

59 This bias meant that when the tree fell it was more likely to fall towards the railway, regardless of the direction of any wind load which was applied, especially in moderate wind speeds such as those on the day of the accident (paragraph 55).
