## Accident

<b>Aircraft Type and Registration:</b>	Socata TB-20 Trinidad, N33NW	
<b>No &amp; Type of Engines:</b>	Lycoming IO-540 SER piston engine	
<b>Year of Manufacture:</b>	1990 (Serial no: 1073)	
<b>Date &amp; Time (UTC):</b>	10 October 2023 at 1535 hrs	
<b>Location:</b>	Langham Airfield, Norfolk	
<b>Type of Flight:</b>	Private	
<b>Persons on Board:</b>	Crew - 1	Passengers - 2
<b>Injuries:</b>	Crew - 1 (Serious)	Passengers - 2 (Serious)
<b>Nature of Damage:</b>	Aircraft destroyed	
<b>Commander's Licence:</b>	Private Pilot's Licence	
<b>Commander's Age:</b>	47 years	
<b>Commander's Flying Experience:</b>	121 hours (of which 27 were on type) Last 90 days - 3 hours Last 28 days - 1 hour	
<b>Information Source:</b>	Aircraft Accident Report Form submitted by the pilot and further enquiries by AAIB

## Synopsis

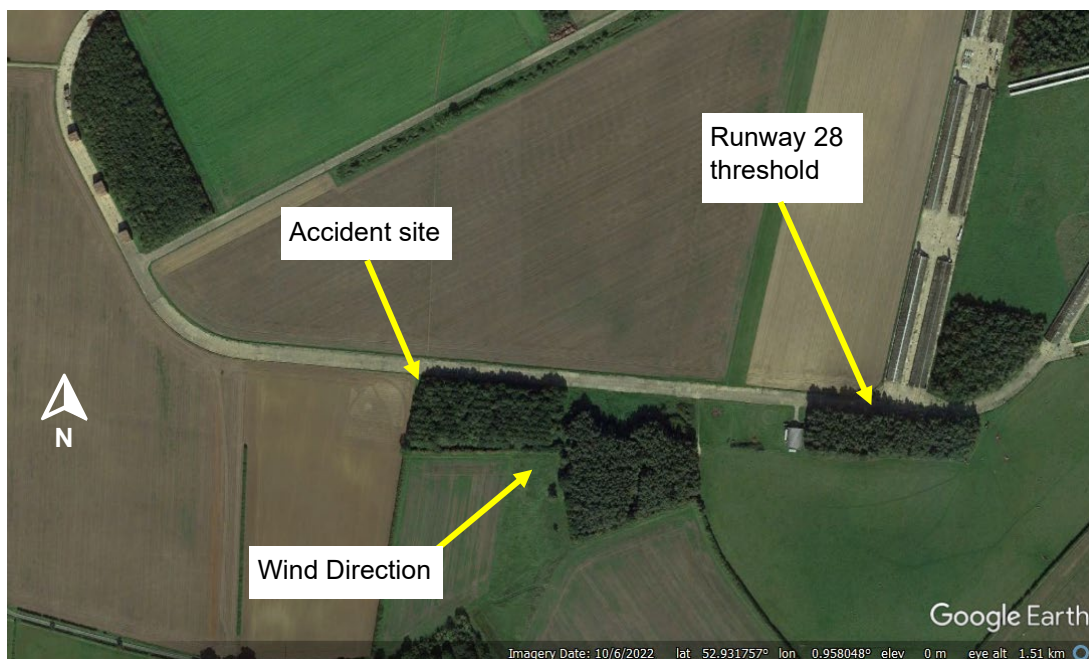
**Figure 1**

N33NW came to rest just inside the far edge of a wood, approximately 460 m from the threshold of Runway 28 (Figure 1). The left wing and engine had separated from the fuselage, causing a fuel leak. The aircraft’s tail section including horizontal stabiliser and fin was attached but had been severely damaged in the accident sequence. The passenger cabin remained largely intact.

Accident site location

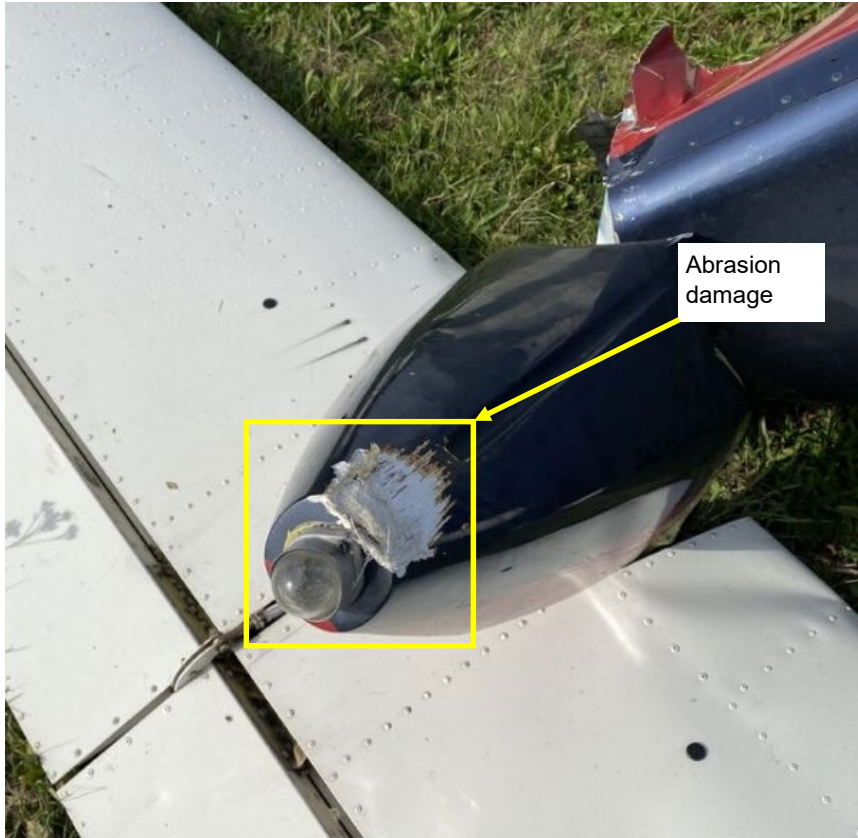
**Figure 3**

The underside of the tail cone had abrasion damage consistent with the tailcone being in contact with the runway during a tailstrike rather than impact damage with trees. (Figure 3) The pilot confirmed the damage was not present prior to the flight.

Tailstrike damage to the underside of the tailcone

During the takeoff or the early climb it is likely that the tail struck the concrete runway as the pilot did not recall having seen the damage prior to flight. The pilot subsequently disagreed with this analysis, but the evidence still suggests this is a contributory factor to the accident. The passengers remembered feeling as if the aircraft had hit something or been caught by a gust of wind as it took off, but neither the passengers or pilot were aware of a tailstrike. It is probable that as the aircraft became airborne it encountered some form of turbulent air in the lee of the trees from the crosswind. As the pilot applied corrective control inputs, the combination of encountering turbulent air and a tailstrike is likely to have led to the aircraft entering an unstable climb.

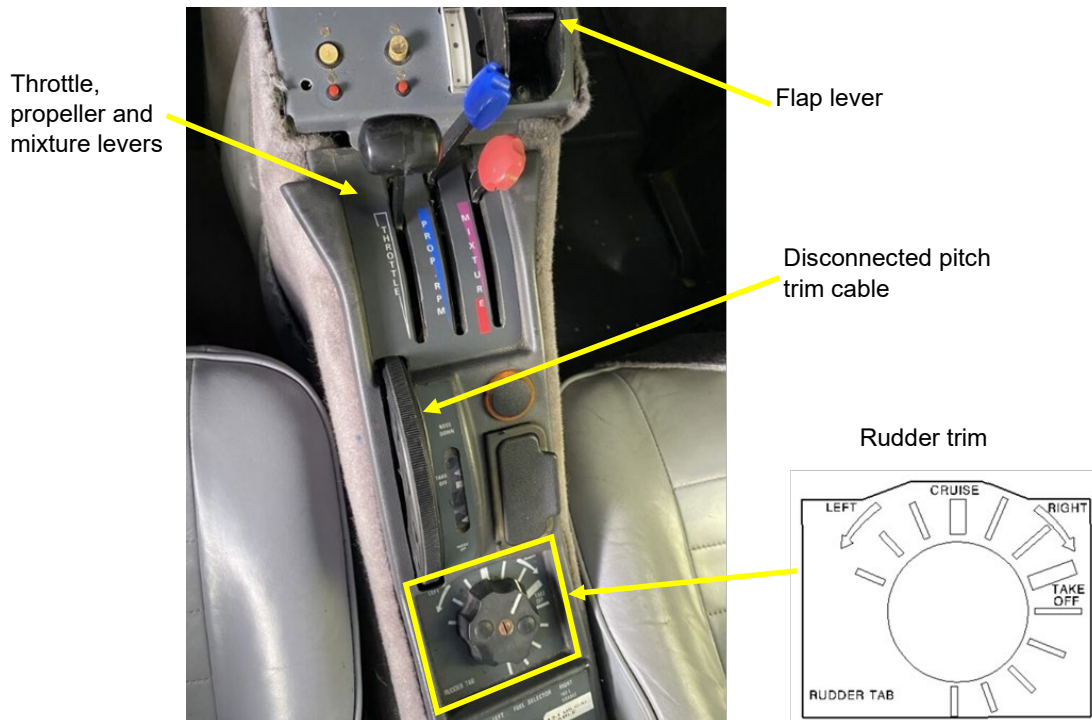
**Figure 4**

Control positions post-accident

Damage to the propeller indicated that it was under power at the time of the accident, and the throttle, propeller rpm and mixture levers were all fully forward which are the normal positions for takeoff (Figure 4).

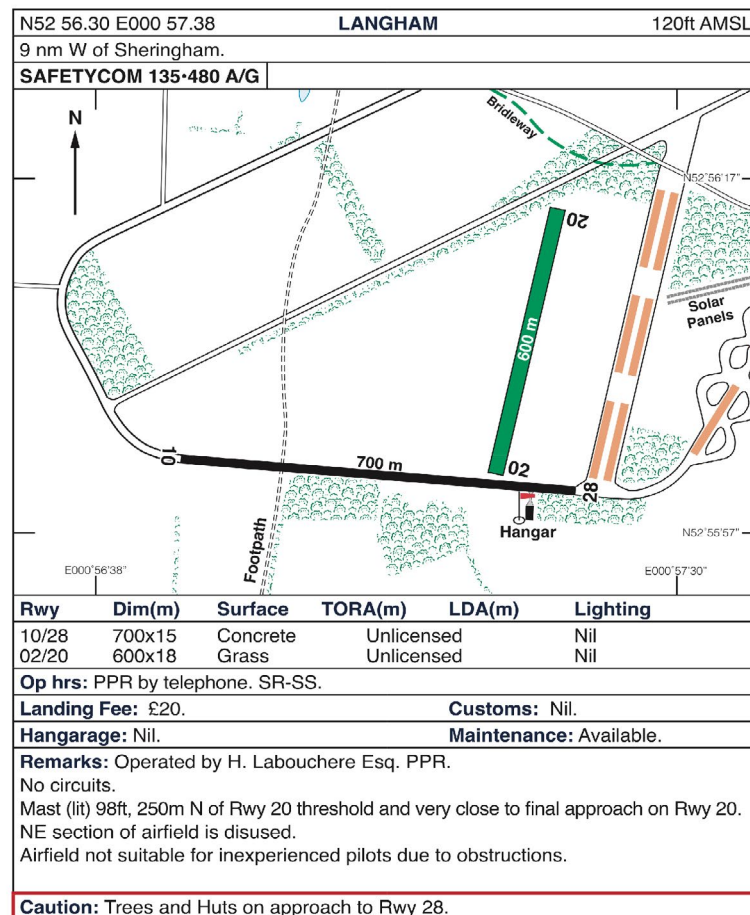
**Figure 5**  
Langham airfield plate (Pooley's Flight Guide)

Langham is an unlicensed aerodrome located on the southern periphery of a disused airfield. Runway 28 is 700 m long, 15 m wide, and is part of the old airfield's concrete perimeter track. The runway's surface condition is varied along its length with some pothole and cracking damage. Its alignment is nearly perpendicular to the prevailing south-westerly winds. The Pooley's plate for Langham (Figure 4) shows the trees along the southern edge of Runway 10/28 and notes 'Airfield not suitable for inexperienced pilots due to obstructions.'

Runway 10/28 is lined by tall trees along much of its southern side (Figure 5). The trees at the runway's mid-point are approximately 9 to 10 m tall and are 3 m from the runway's edge, while those at the threshold of Runway 28 are in excess of 20 m tall.

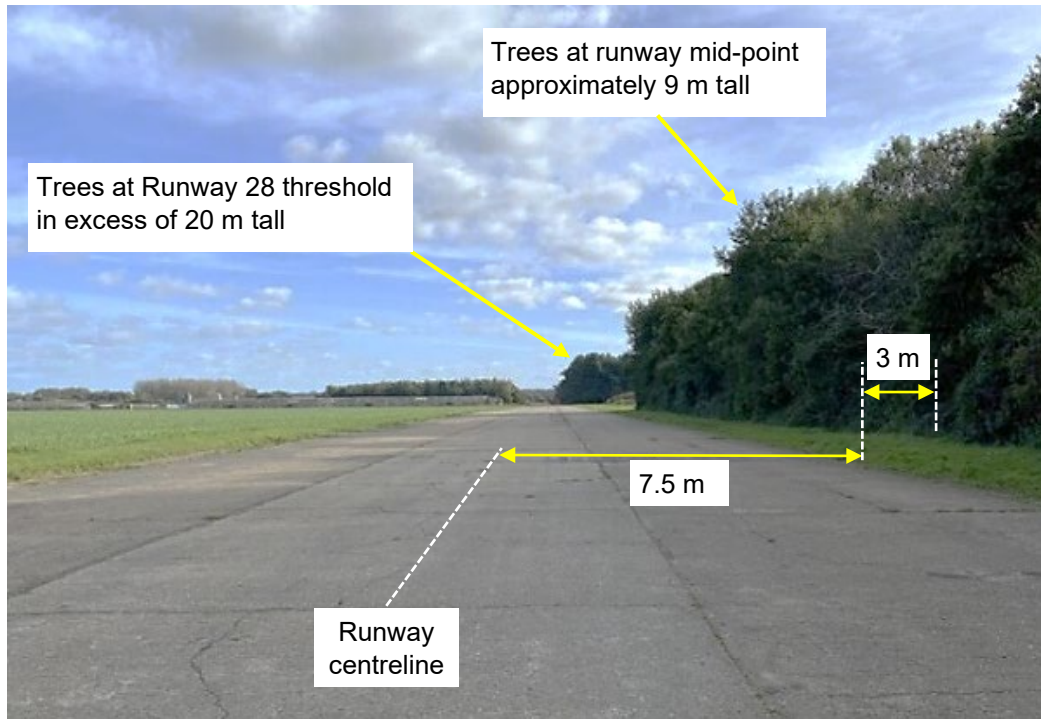
**Figure 6**

View along Runway 10, towards the threshold of Runway 28

The distance between the left wingtip and the trees was 5.5 m with the aircraft on the runway centreline. This is less than the minimum distance recommended within CAP 793 which, although not mandatory, would have been 15 m. The aircraft was seen to drift left after becoming airborne, it is possible that the rudder trim position set to approximately half the manufacturer's TAKE OFF setting was contributory, but it was not possible to confirm the cause. During the climb the margin between the wingtip and the trees was then reduced to an extent that the pilot was unable to recover the aircraft's position before striking the trees.

Pilots flying to unfamiliar or unlicensed airfields are encouraged to consider how the effects of features, particularly close to a runway, such as trees and buildings identified during pre-flight planning may further reduce expected safety margins in the event of an unexpected flight situation developing. CAA CAP 793 and Safety Sense Leaflet 12 provide information to assist with pre-flight planning.
