Rail Accident Investigation Branch

Rail Accident Report

Derailment of a passenger train at Roudham Heath, Norfolk 6 February 2024

Report 03/2025
February 2025

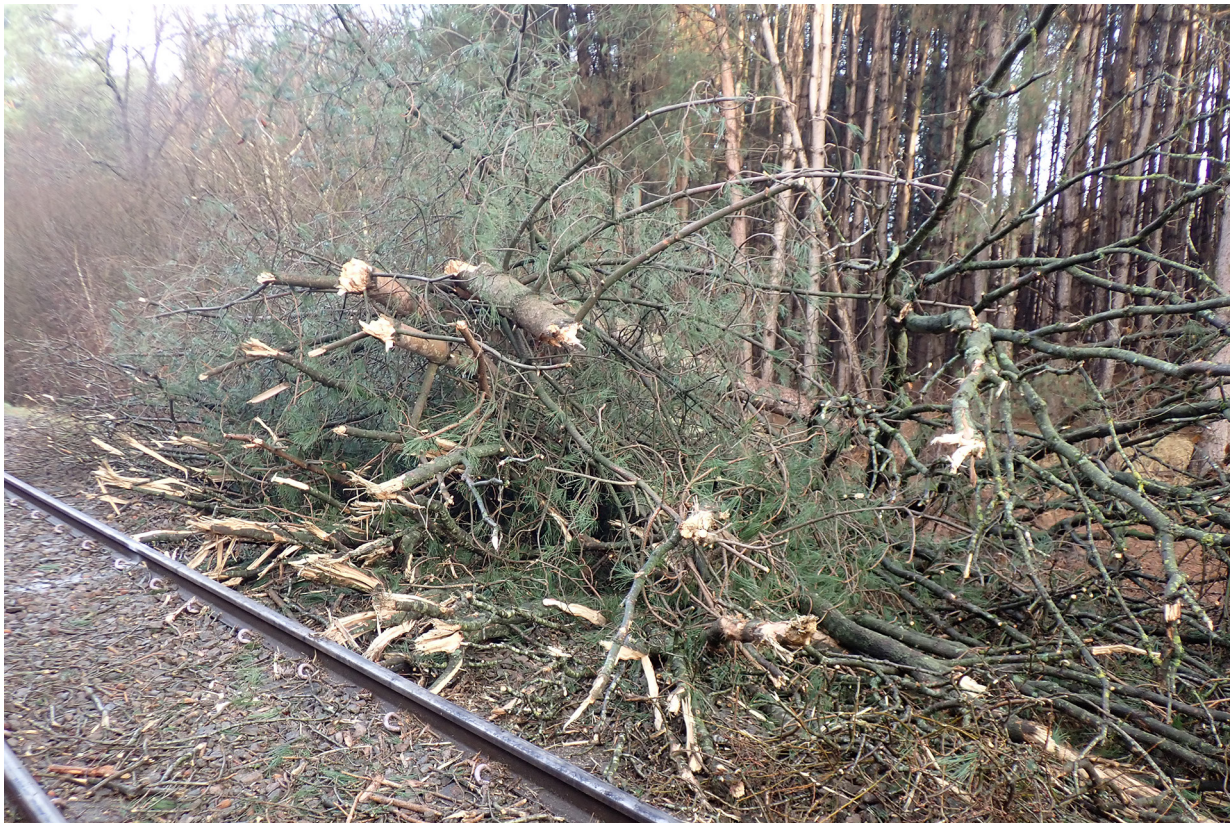
- 24 At an unknown time between train 1R88 passing through Roudham Heath at 20:30 and the accident at 20:53, the pine tree fell towards the railway, striking and felling the oak tree, resulting in the trees fouling both the Up and Down Main lines around 180 metres east of Shadwell level crossing. Nobody witnessed the trees falling. The pine tree came to rest on top of the oak tree. At the point the trees crossed the Down Main line, the upper branches of the oak tree were just above the rail and the upper trunks and branches of the pine tree were around 2 metres above rail level (figure 3).

Figure 3: The two trees after being struck by the train.

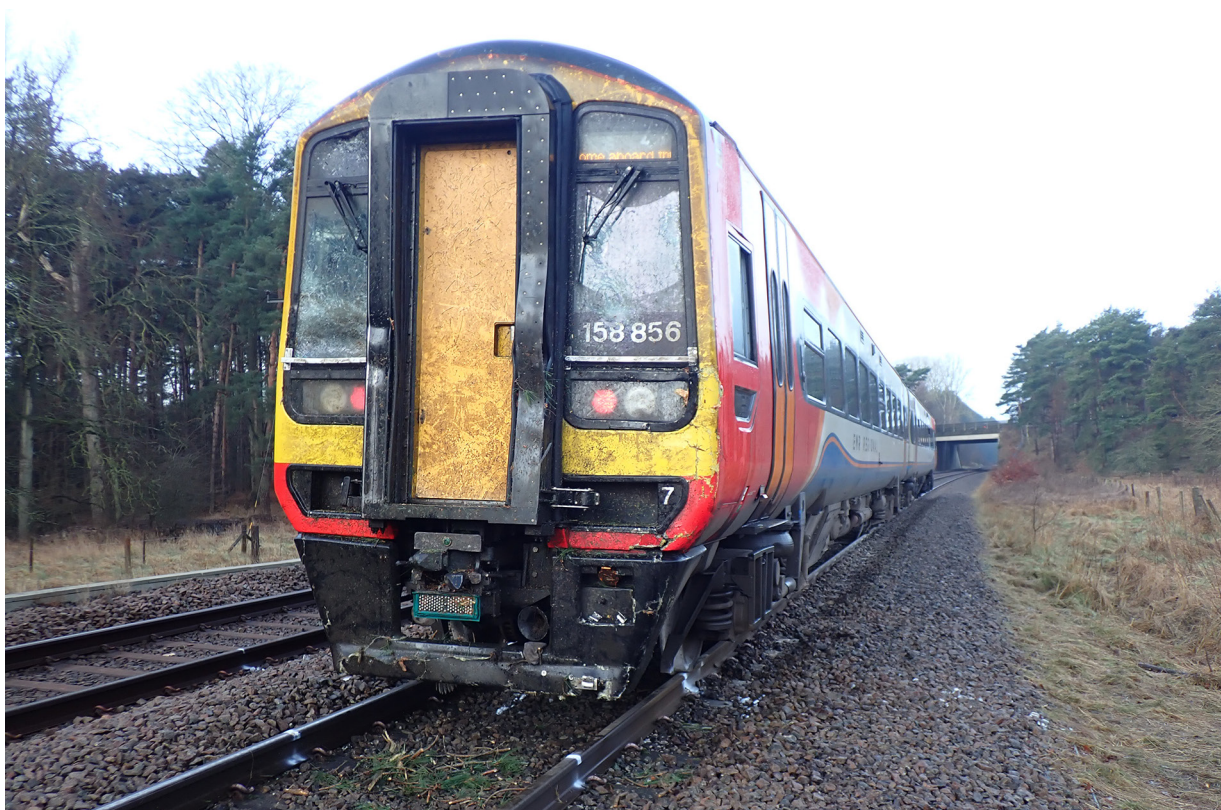
- 27 The twin stems of the pine tree were around 2 metres above rail level. As the train collided with them, the lower of the stems impacted the train at the level of its headlight assembly. The upper stem impacted halfway up the driver's windscreen, causing it to crack, although it remained in place. Both stems struck the front of the train's gangway faceplate, deforming its left-hand section (figure 4).

Figure 4: The damage to the front of the train (train shown after being rerailed).

- 83 Minor damage was evident to various places on the front and underside of the train, in keeping with the train running derailed. The gangway faceplate was deformed in two places, where it had been struck by the two primary stems of the pine tree (paragraph 27 and figure 4). The impact with these stems had also cracked both windscreens, but they remained in place with no penetration into the driving cab. There was also a small crack to an internal cab desk panel.

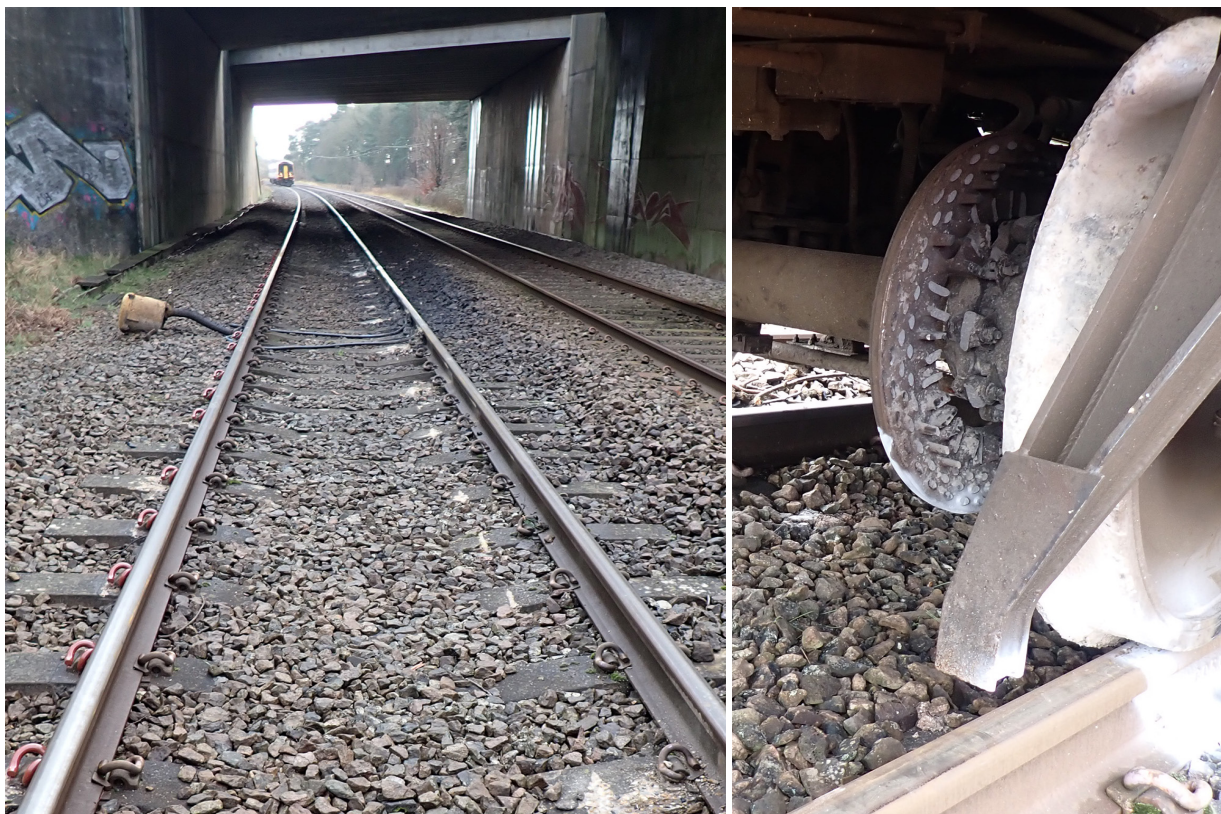
- 32 Around 60 metres from the final position of the train, the brake disc that had been in sustained contact with the left rail fractured and fell onto the track. Without the guidance this disc had been providing, the train began to deviate slightly further to the left, with the left-hand wheel leaving the sleeper ends. However, by this point the train was travelling slowly and it came to rest shortly thereafter.

- 87 Each wheelset on a class 158 train is fitted with two axle-mounted brake discs (figure 9). Marks on the rail, sleepers and ballast showed the path that the leading wheels of the train took after the derailment, tending to steer to the left as the left wheel engaged with the sleepers and ballast. These marks are consistent with the movement to the left being limited by the engagement of the left-hand brake disc with the left-hand rail (paragraph 30). This prevented any further lateral movement away from the track centreline, which, unrestrained, could have resulted in the train moving further off the tracks or potentially striking the abutment of the A11 dual carriageway overbridge. Around 60 metres before the train came to a stop, the brake disc broke, eliminating the lateral restraint, and the train began to move slightly further from the track centreline (figure 9).

Figure 9: The train's final stopping position beyond the A11 bridge and the sleeper marks made during the derailment (left) and the remains of the axle-mounted brake disc following the train being rerailed (right).
