Report on the investigation of
the capsizing and foundering of the fishing vessel
***Njord* (SH 90)**
resulting in one fatality
150 miles north-east of Peterhead, Scotland
on 6 March 2022

The capsized and foundering of the fishing vessel *Njord* (SH 90), resulting in one fatality, 150 miles north-east of Peterhead, Scotland, on 6 March 2022

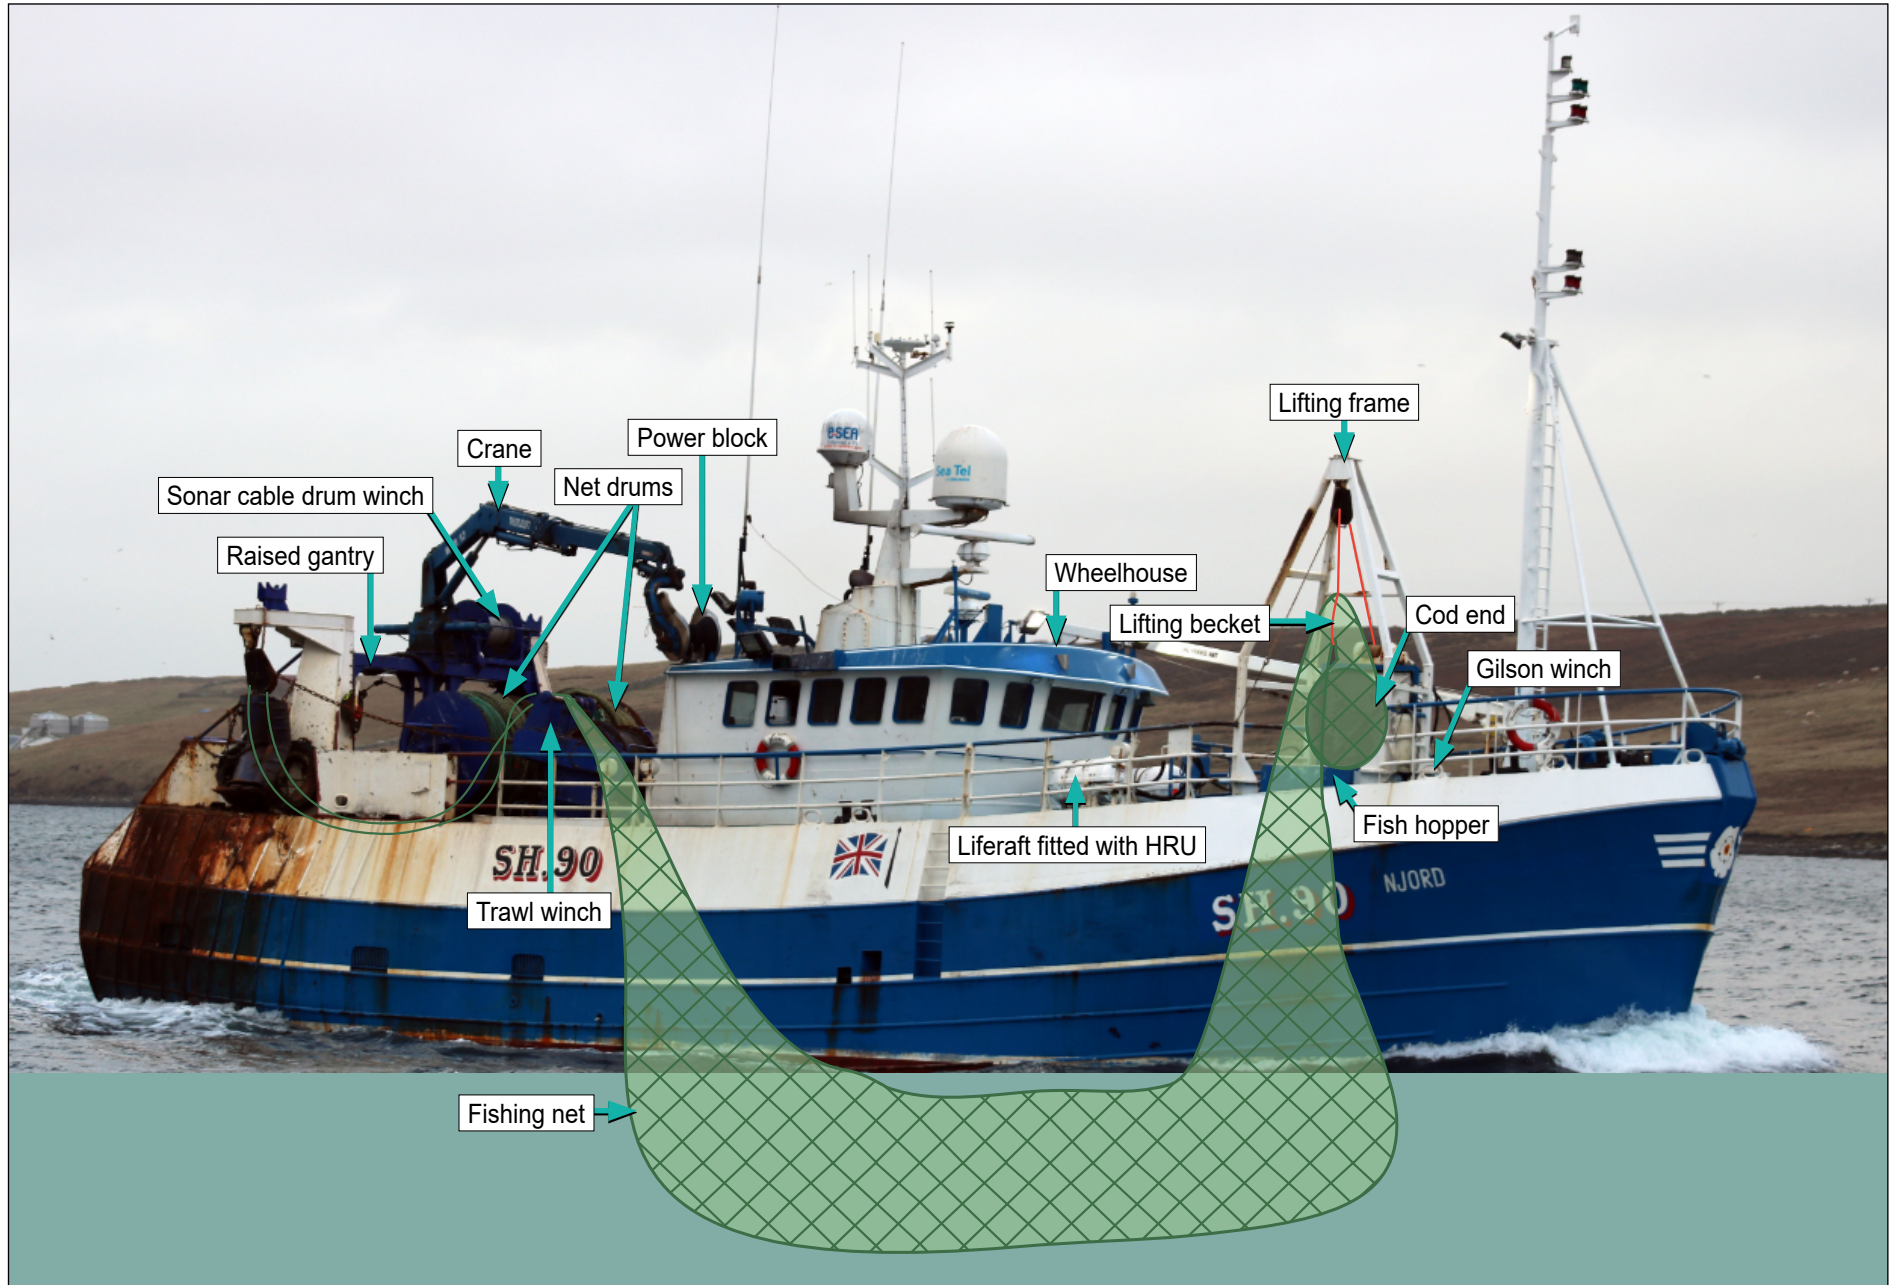
The investigation found that the net had been secured to the starboard trawl winch and the weight of the catch then acted on a handrail high up on the vessel's starboard side. As the remaining fish in the net started to sink, along with the vessel's hopper being overloaded, a substantial list developed to the point that downflooding could occur.

Figure 2: *Njord* net indicative lashing and general layout

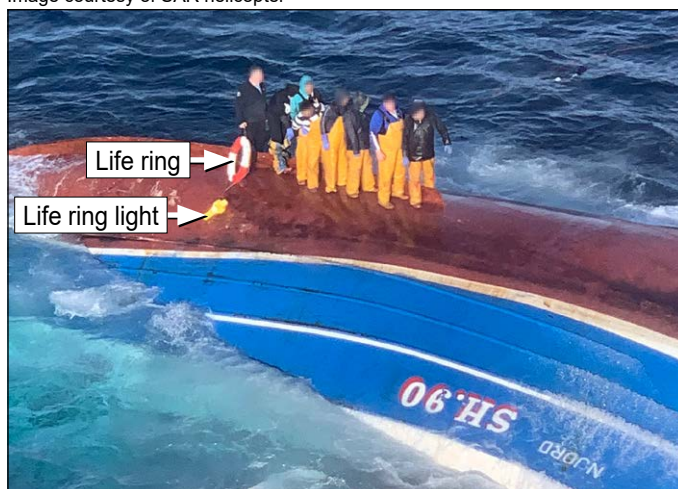
While the crew stood together on *Njord's* hull (**Figure 4**), they noticed that the vessel's Emergency Position Indicating Radio Beacon (EPIRB) had released; the flashing light on the top of the unit indicated that it had activated and, at 1339,

Figure 4: The crew standing on the upturned hull of *Njord*

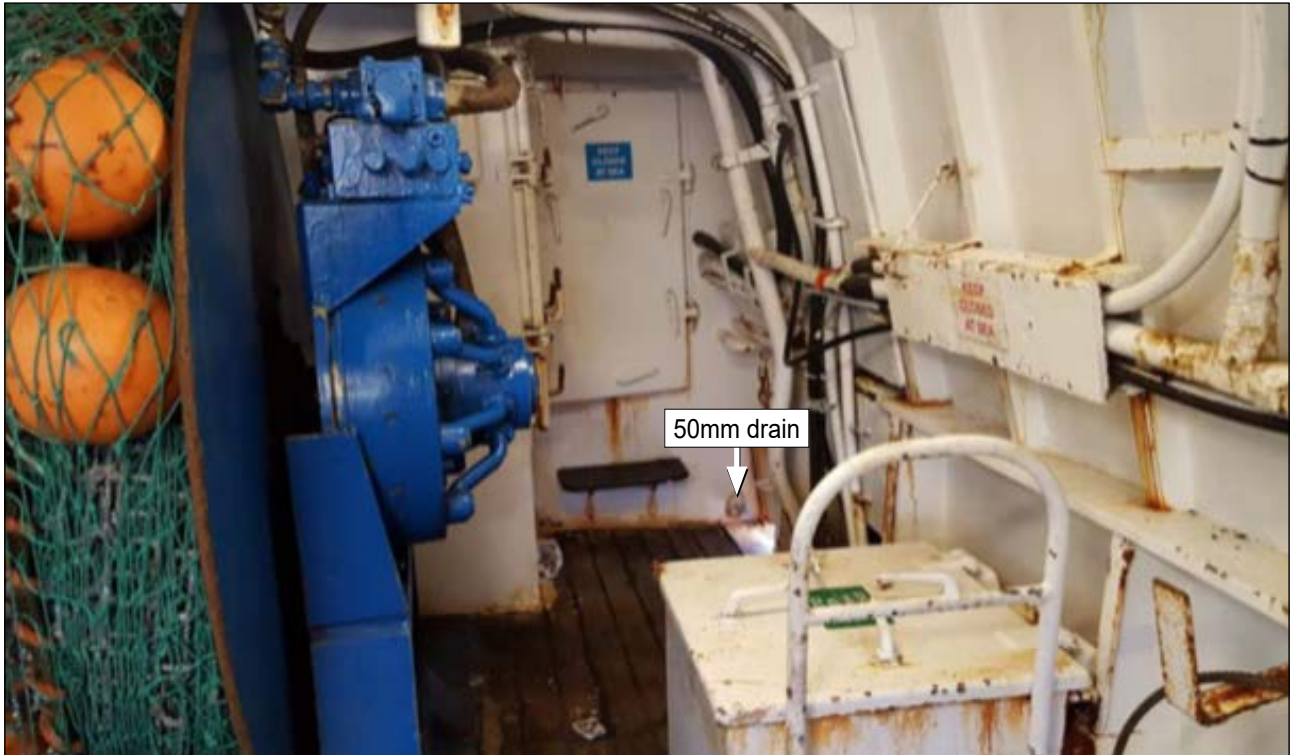
A 50mm drain was cut into the lower starboard corner of the aft bulkhead of the starboard passageway (**Figure 6**) and fitted with a stub pipe, to which a valve was fitted on the inside of the bulkhead. The drain allowed accumulated water in the starboard passageway to flow to the outside deck. The MAIB investigation found that the drain had been in situ for some years before the skipper had purchased the vessel. The drain was neither referenced on the general arrangement plans nor in the vessel's stability book, and there was no record of it in any MCA documentation to indicate that it had been reported to the organisation for approval.

Figure 6: Position of the drain from the starboard passageway

The reason for the installation of the drain hole in the aft bulkhead of the starboard passageway is unknown; its purpose might have been to drain water from periodic cleaning of the space. The downflooding angle reduced from 46° to around 17° when the vessel was assessed in its pre-accident loading condition (scenario A) if the valve was left open. It is likely that *Njord* would not have capsized had the valve on the drain been closed, as it should have been, while the vessel was at sea.

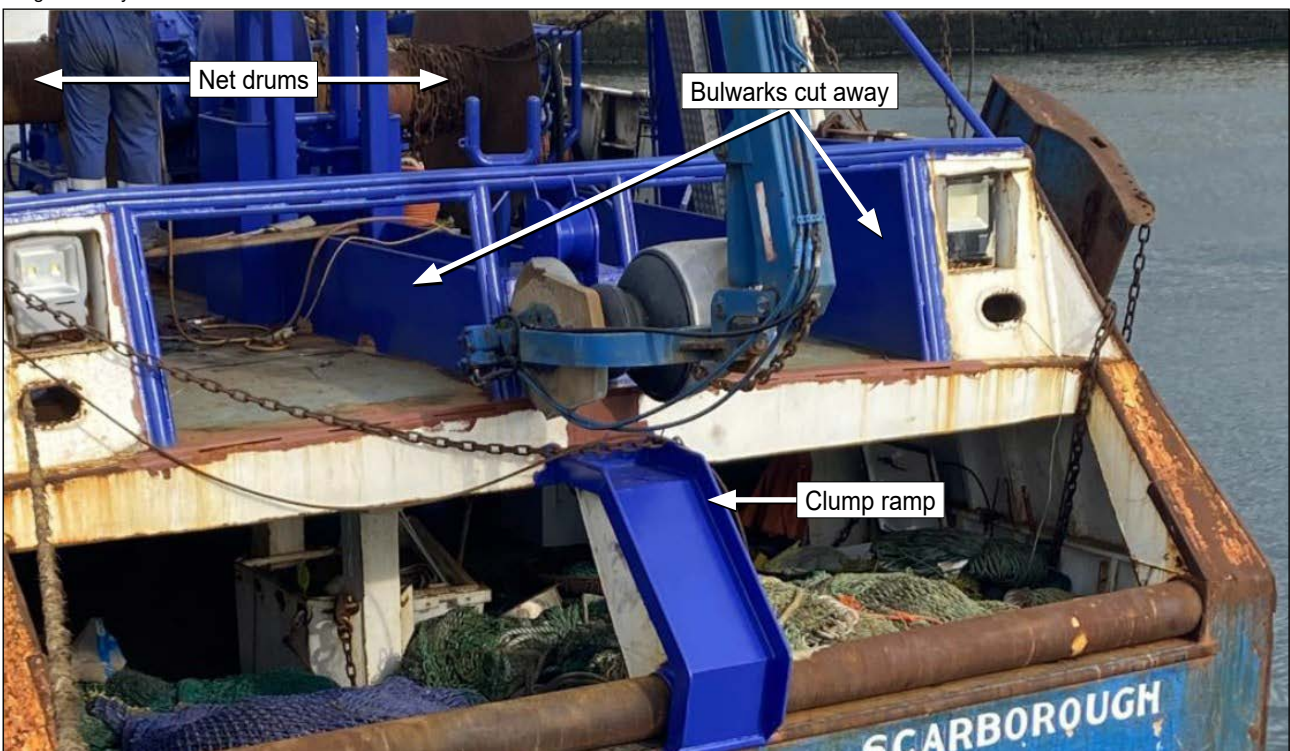
Sections of the top deck's aft bulwark were also removed to enable the shooting of prawn nets through the stern. Additionally, a gantry was constructed between the towing gallows to raise the power block crane from the deck, and to allow the shooting of the prawn nets. A sonar cable drum was also installed on this raised gantry. Various other modifications were made to the top deck, including the removal of storage pounds, relocation of a capstan and its base, removal of other steel structures, and the addition of steel net running tracks to the deck.

Figure 8: Clump ramp and cut away bulwarks on *Njord*'s stern

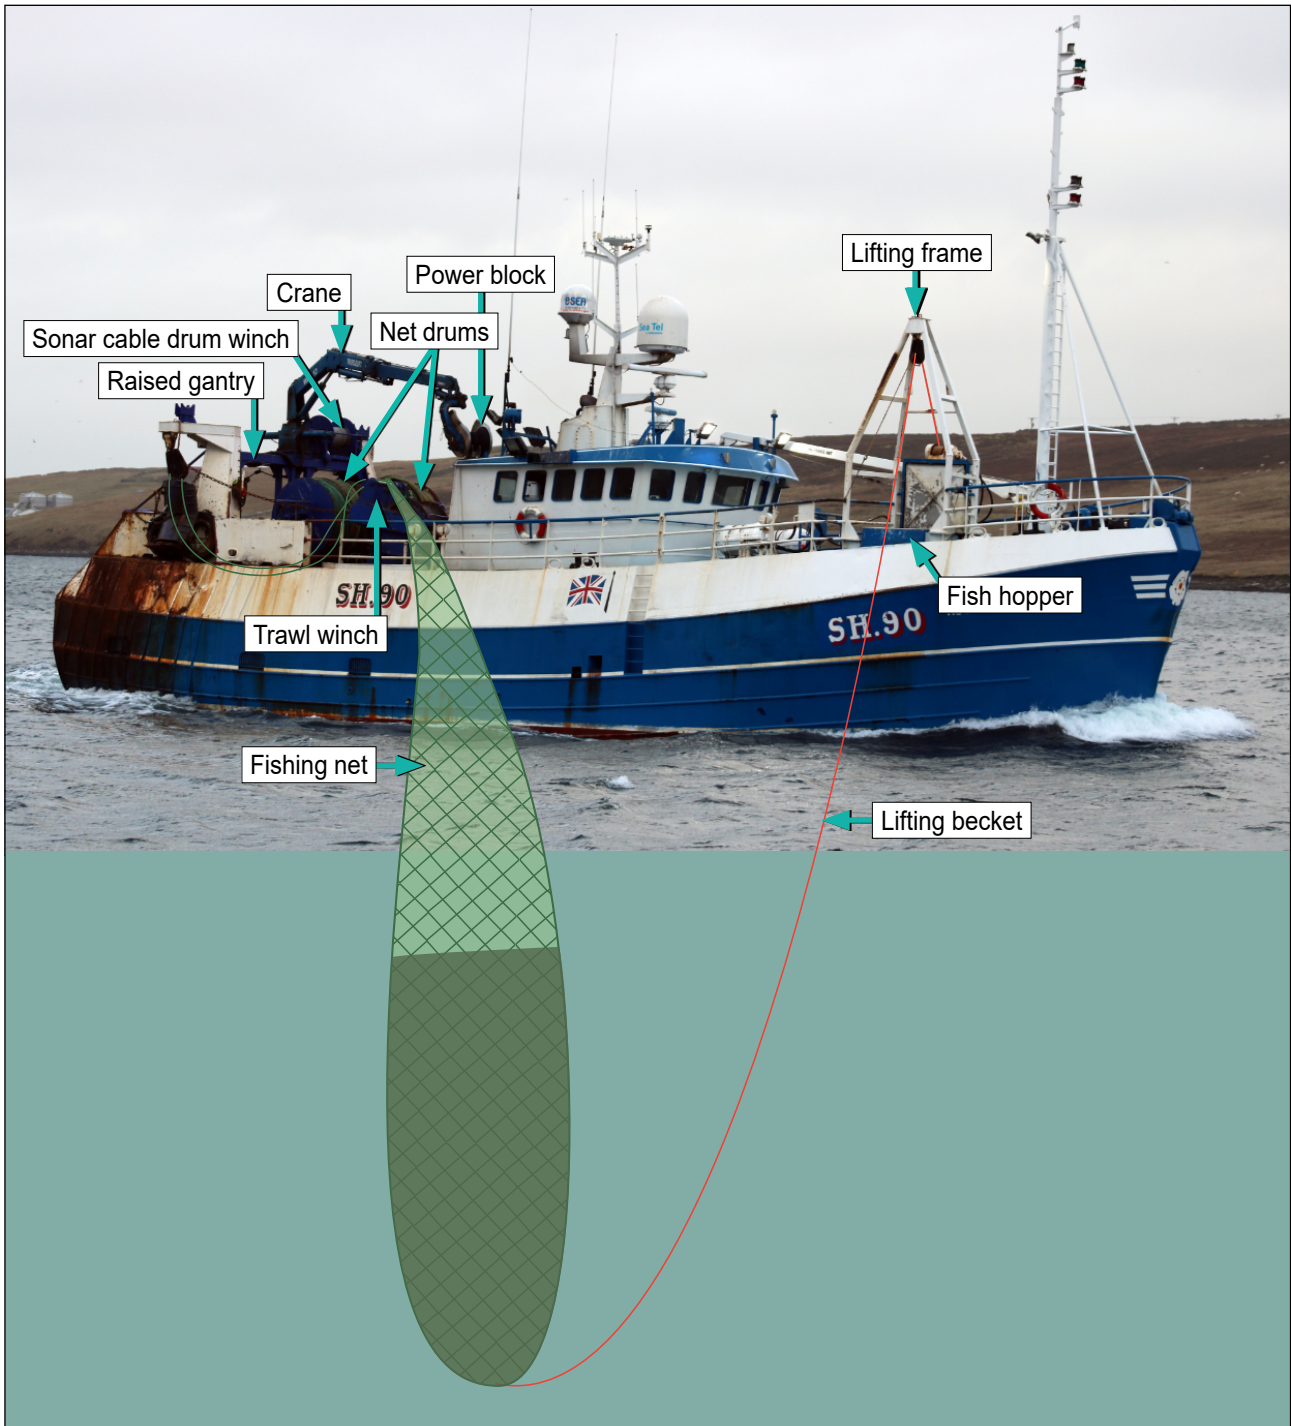
Figure 10: Position of net during loss scenario

The results of the scenario A loading condition indicated that 3.10t was required to act at the net lashing position for progressive flooding to immerse the starboard passageway drain hole (downflooding point 2) and begin flooding the passageway. The digital model demonstrated that a list of 46.6° would capsize the vessel before flooding of the lower accommodation through an internal door (internal downflooding point 4) would occur (**Figure 11**).

The results of the scenario B loading condition indicated that *Njord* would have immediately capsized without downflooding if a load of 9.9t or more had been applied to the net lashing position. It would not have been possible to apply sufficient net load to submerge the fish landing hatch (downflooding point 1) before capsize occurred.

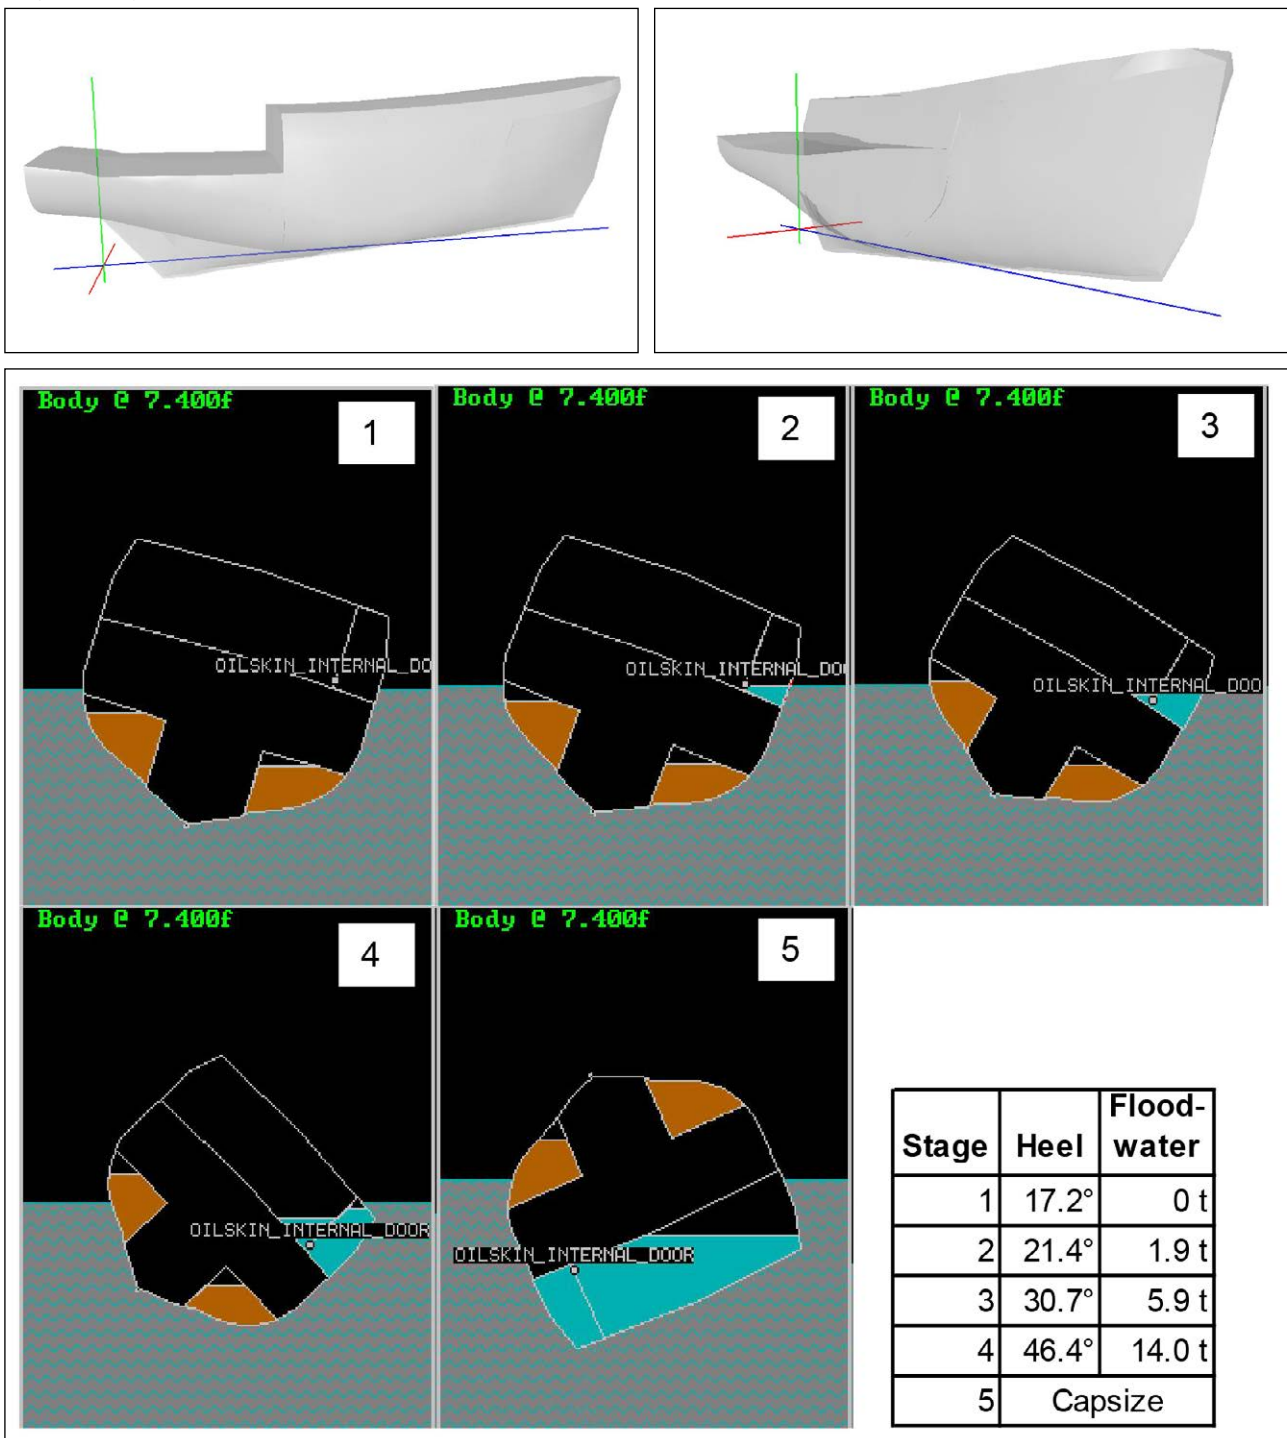
Figure 11: *Njord*'s likely flooding sequence
