AAIB Bulletin

2/2025

Published: 13 February 2025.

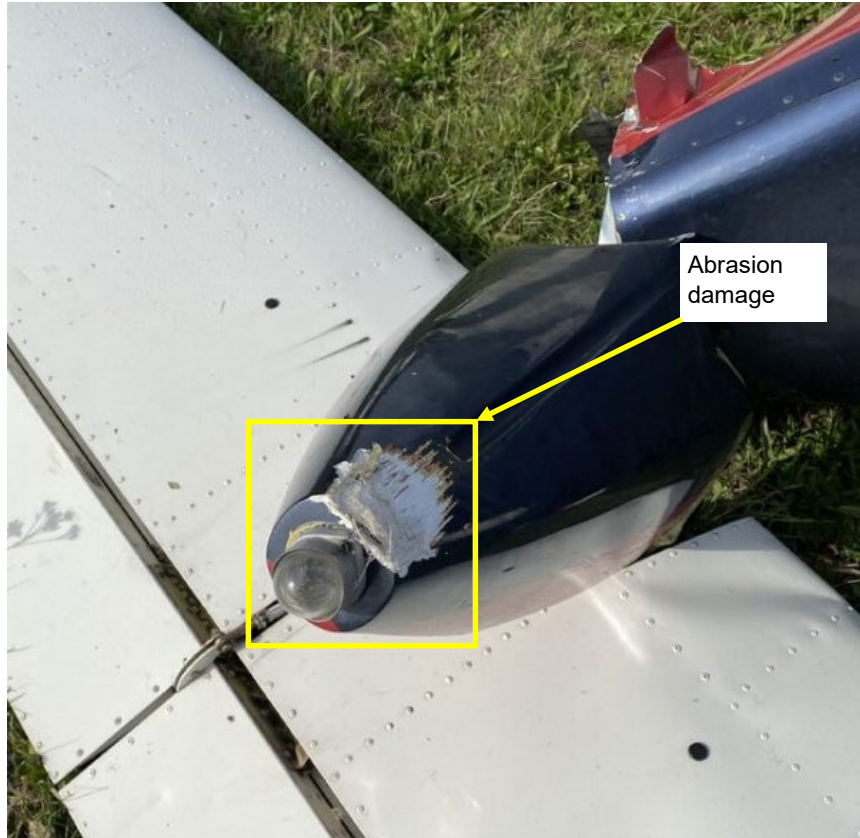
Figure 3

The underside of the tail cone had abrasion damage consistent with the tailcone being in contact with the runway during a tailstrike rather than impact damage with trees. (Figure 3) The pilot confirmed the damage was not present prior to the flight.

Tailstrike damage to the underside of the tailcone

During the takeoff or the early climb it is likely that the tail struck the concrete runway as the pilot did not recall having seen the damage prior to flight. The pilot subsequently disagreed with this analysis, but the evidence still suggests this is a contributory factor to the accident. The passengers remembered feeling as if the aircraft had hit something or been caught by a gust of wind as it took off, but neither the passengers or pilot were aware of a tailstrike. It is probable that as the aircraft became airborne it encountered some form of turbulent air in the lee of the trees from the crosswind. As the pilot applied corrective control inputs, the combination of encountering turbulent air and a tailstrike is likely to have led to the aircraft entering an unstable climb.

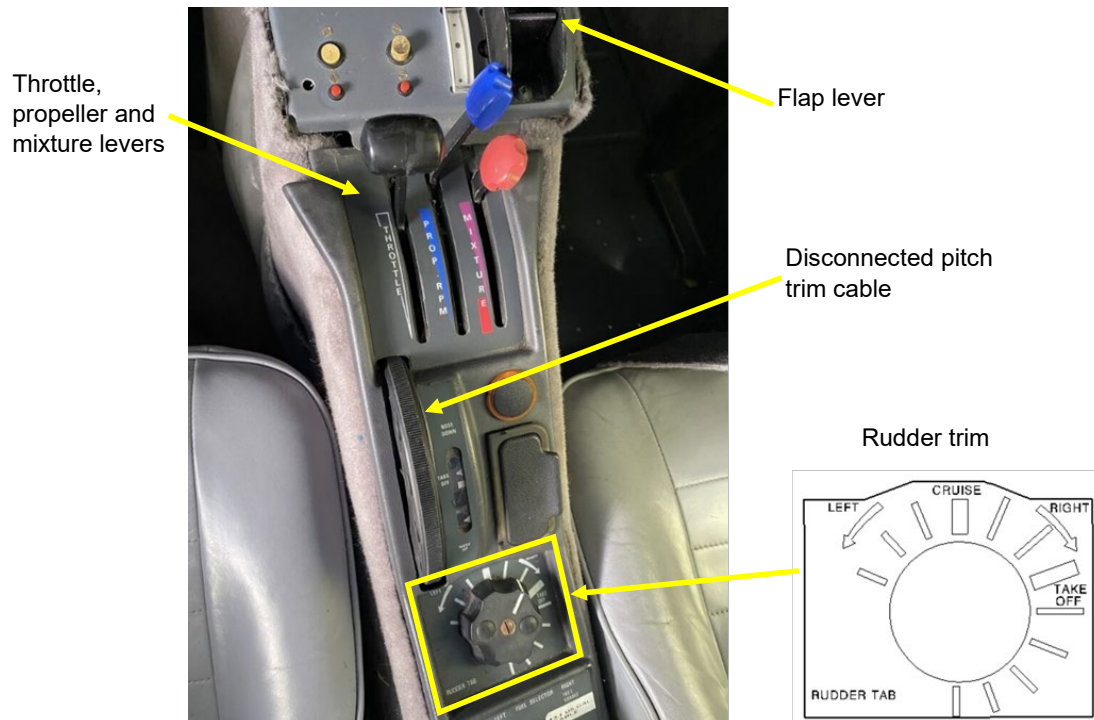
Figure 4

Control positions post-accident

Damage to the propeller indicated that it was under power at the time of the accident, and the throttle, propeller rpm and mixture levers were all fully forward which are the normal positions for takeoff (Figure 4).

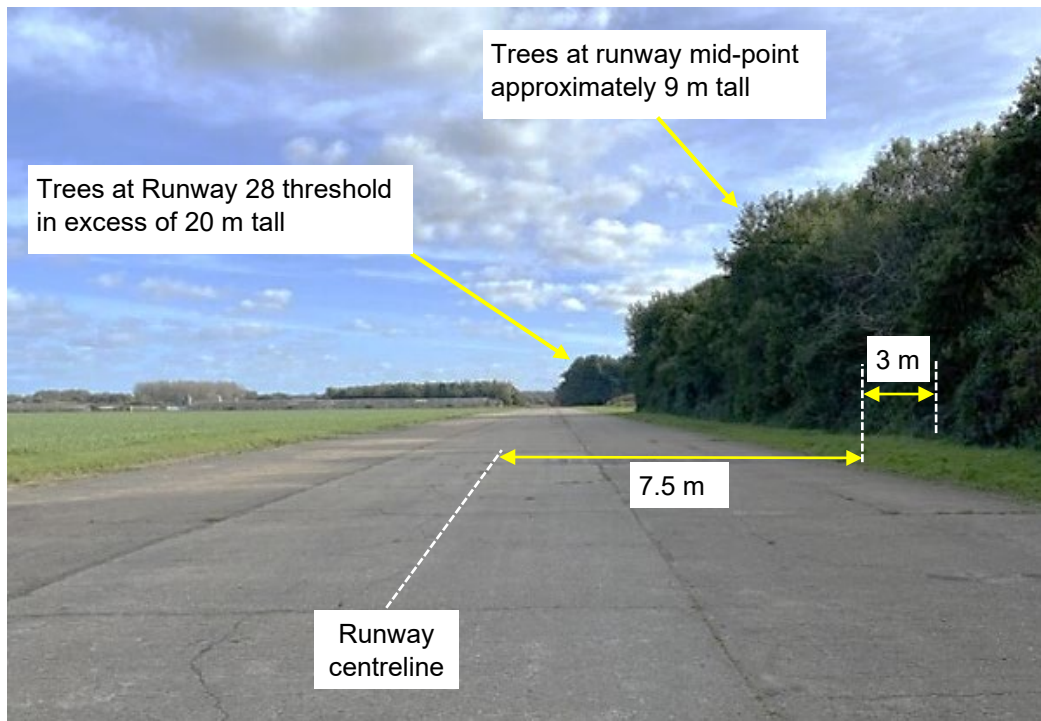
Figure 6

View along Runway 10, towards the threshold of Runway 28

The distance between the left wingtip and the trees was 5.5 m with the aircraft on the runway centreline. This is less than the minimum distance recommended within CAP 793 which, although not mandatory, would have been 15 m. The aircraft was seen to drift left after becoming airborne, it is possible that the rudder trim position set to approximately half the manufacturer's TAKE OFF setting was contributory, but it was not possible to confirm the cause. During the climb the margin between the wingtip and the trees was then reduced to an extent that the pilot was unable to recover the aircraft's position before striking the trees.

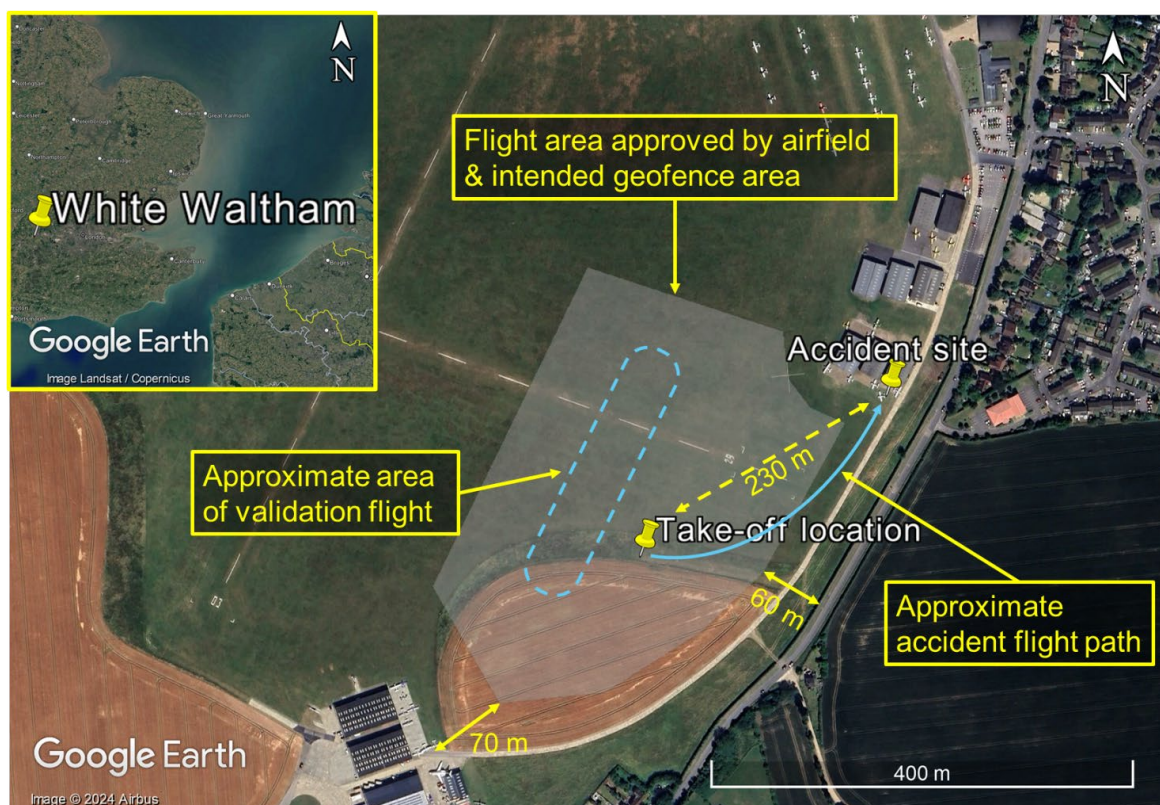
Figure 1

White Waltham Airfield and designated UA area
© 2024 Google, Image © Airbus

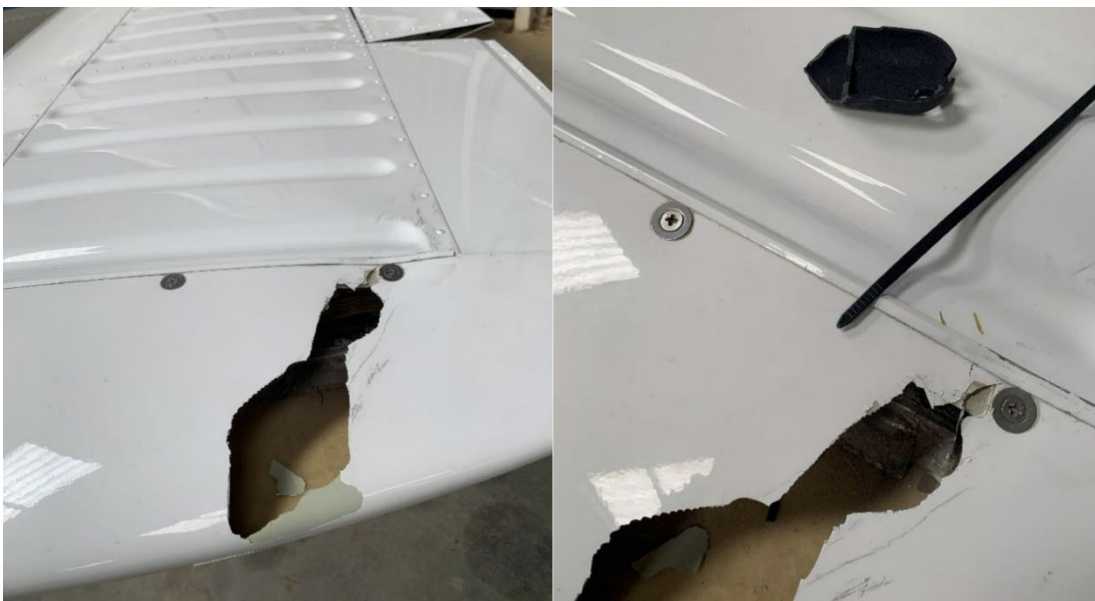
Figure 3

Damage was later found to another parked aircraft, which was near to the aircraft partly seen in Figure 2. There was a hole in the outboard edge of the left horizontal tailplane, and a small component from the UA was found inside it (Figure 3).

Damage to the second parked aircraft (left), with debris removed belonging to the UA (right)
