# Rail Accident Report

## **Derailment of a passenger train at Grange-over-Sands, Cumbria 22 March 2024**

Report 02/2025  
January 2025

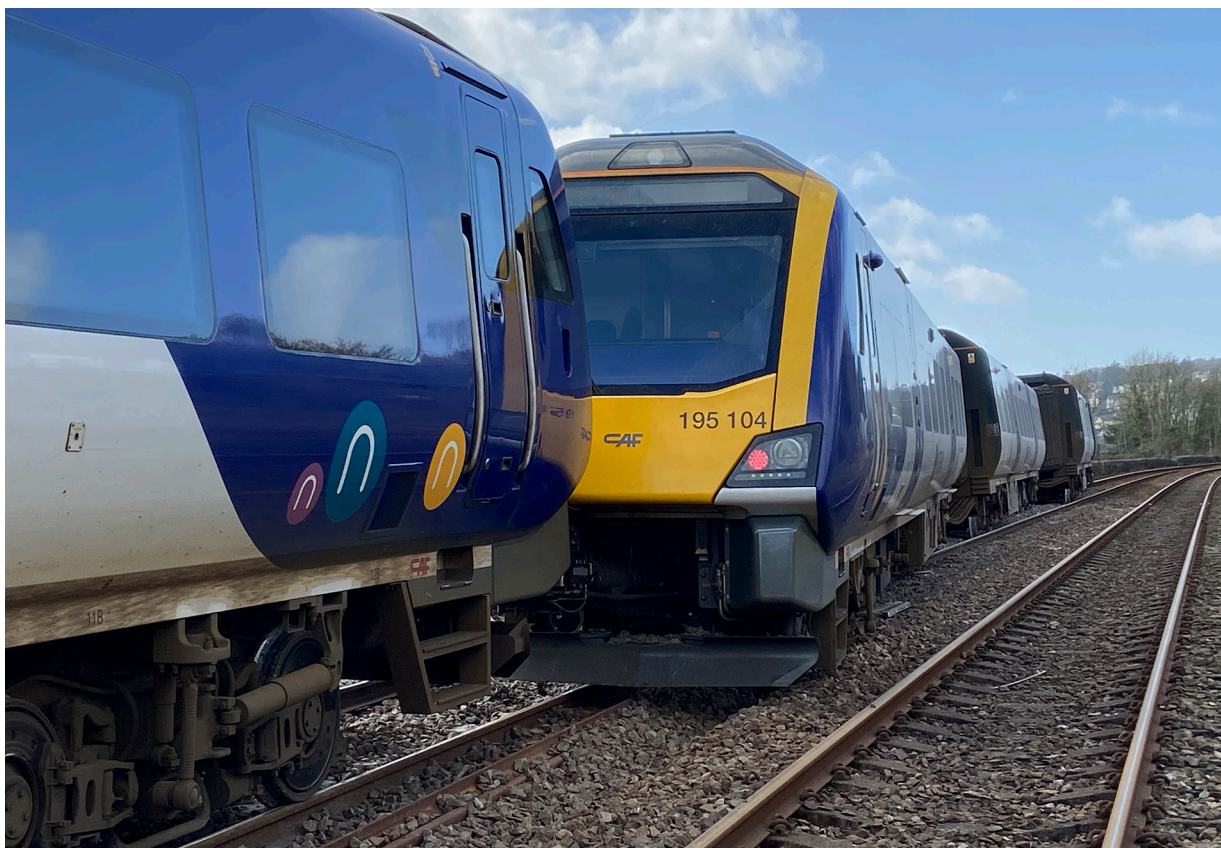
- 4 Nobody was injured in the accident. Damage was caused to lineside infrastructure including broken sleepers, masonry knocked from the parapet wall which runs alongside the railway, and damage to mechanical signalling equipment. The train also suffered significant damage after striking the parapet wall. The derailment and damage cut power to the train's control and communication systems including the Global System for Mobile Communications Railway (GSM-R) radio. The consequences of the derailment could have been more serious had the train not been restrained by the parapet wall, which sits at the top of an embankment leading to a beach below.

Figure 4: Train 2C37 following the derailment.

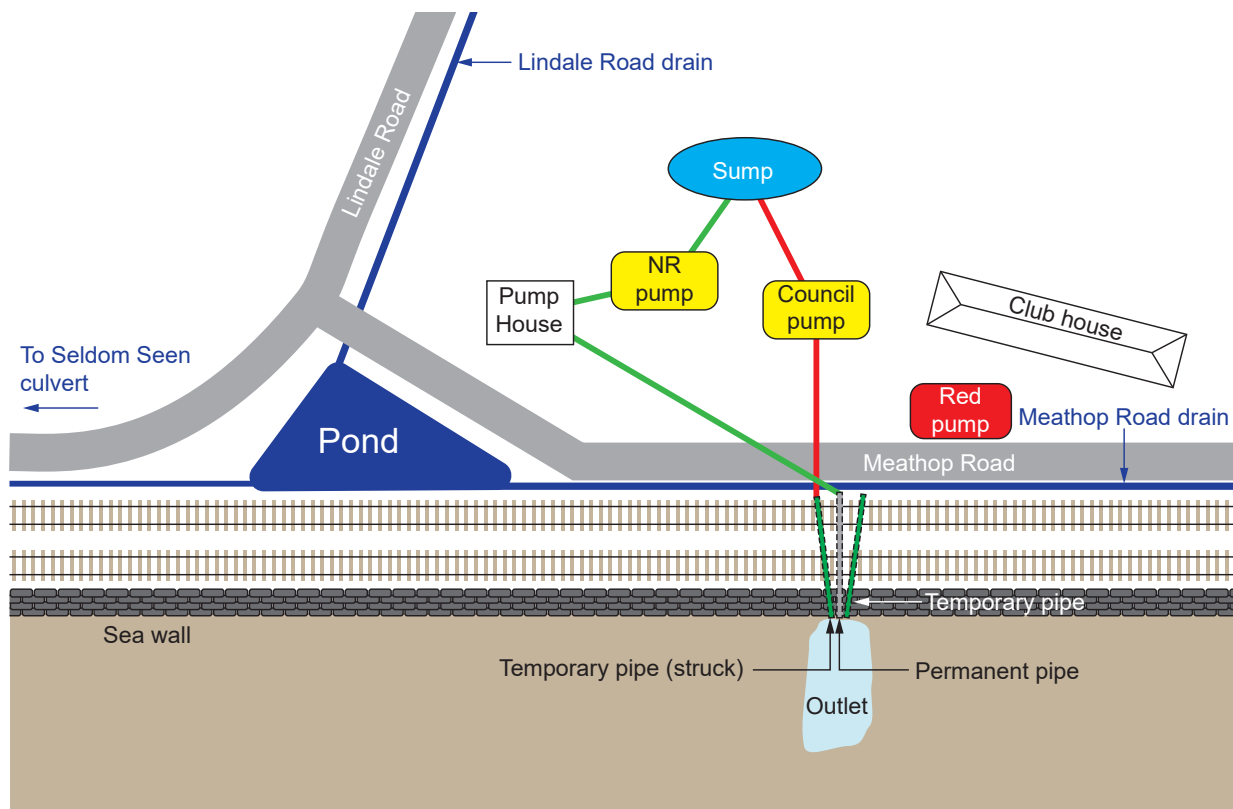
- A diesel pump provided by the council (paragraph 60) which was connected to the first temporary pipe installed by Network Rail. This was the pipe that was damaged by the railway maintenance activity (paragraph 5). The consequent leak created the void that led to the accident (see paragraph 115).

Figure 9: The pipe and pump arrangements at the golf club as discovered immediately after the accident.

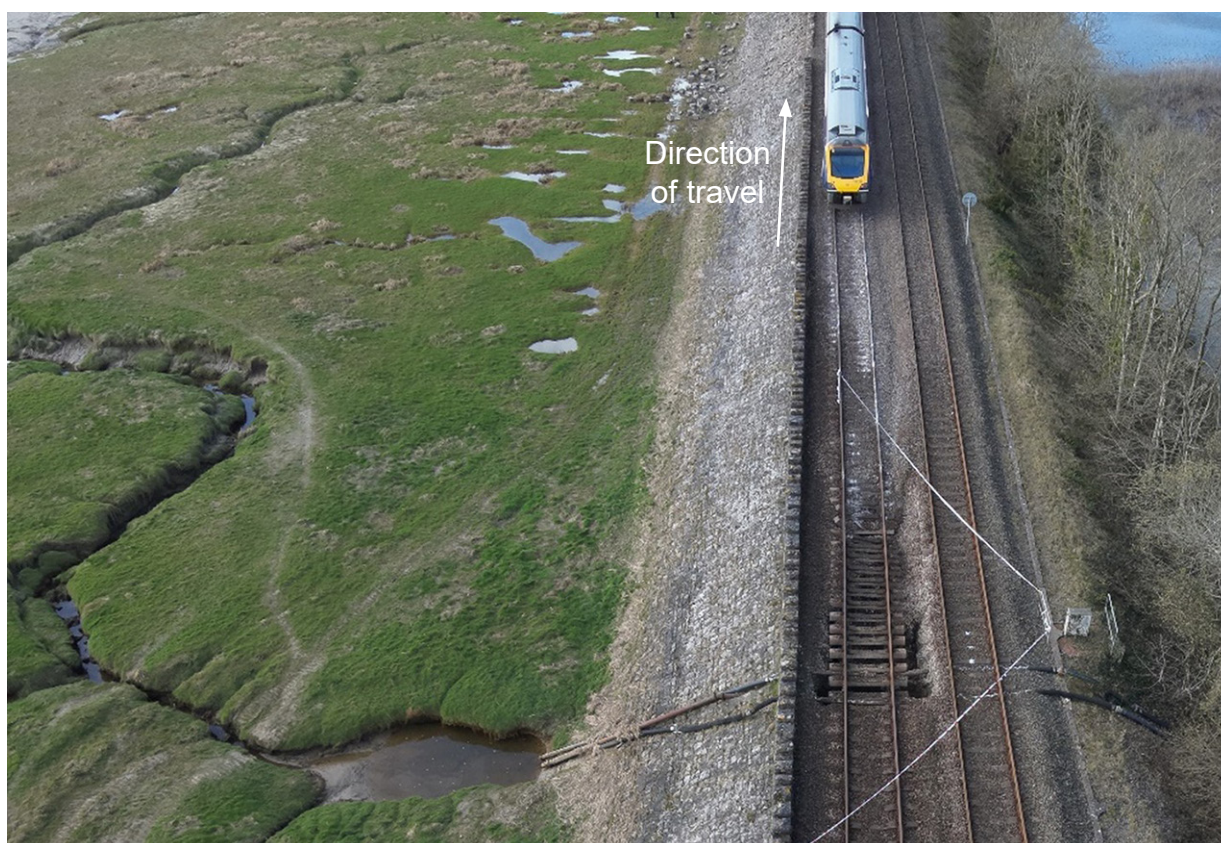
- 24 The tamper which struck the pipe, train reporting number 6J87, was being used for routine track maintenance (figure 6). This tamper requires a three-person crew to operate it, comprising of one supervisor and two operatives. The OTM supervisor sits in the cab of the machine looking in the direction of travel. The operatives sit in the middle of the machine facing backwards and operate its tines. This tamper is also fitted with a welfare area, for staff not directly involved in the tamping operation and for the crew to take breaks.

Figure 10: Void which opened under the track as train 2C37 passed (courtesy of Network Rail with RAIB annotations).

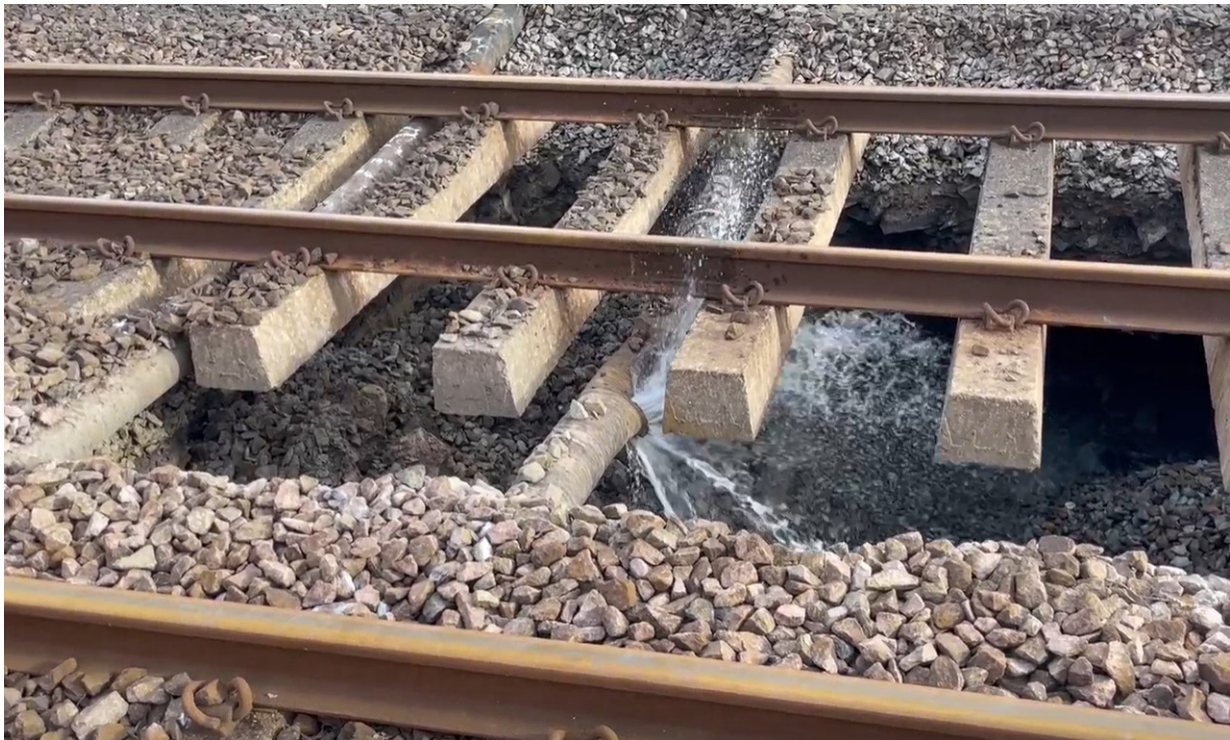
### Radio systems

Figure 11: Water being sprayed from the damaged pipe during a site test.

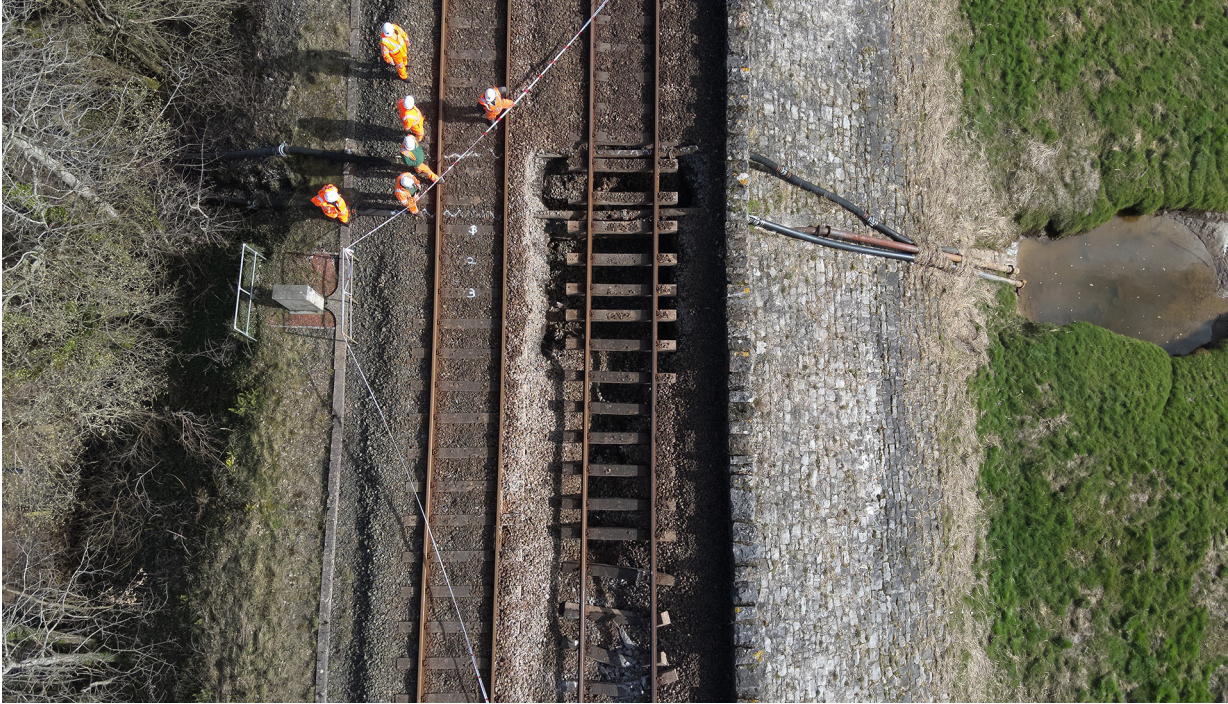
- 37 By August 1899, the railway was entering into further legal agreements to change how drainage should be managed on the landward side of the railway. An agreement was reached that the railway would no longer have to maintain Seldom Seen culvert. In exchange for this, the railway would take responsibility for maintaining Meathop Road drain from where it crosses Meathop Road (approximately 340 metres east of the golf club) to where it joins the canalised River Winster. In February 1902, the council bought the foreshore from the Duchy of Lancaster, including the outfall for Seldom Seen culvert.

Figure 14: Overview of the site captured by a drone showing the adjacent line marked with a 3-2-1 countdown (courtesy of Network Rail).

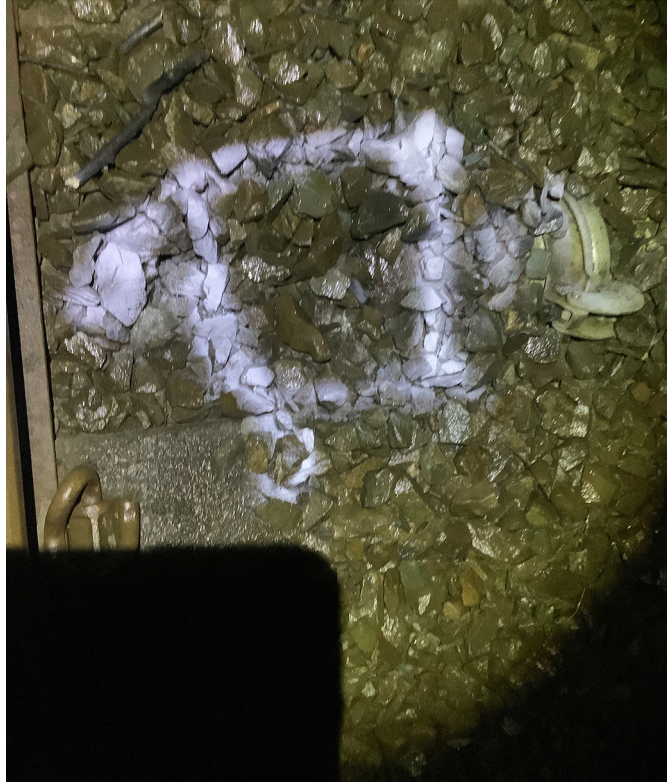
- 47 In May 2016, a Network Rail drainage engineer wrote to Network Rail's legal team to advise that they ought to make provision for a second pipe across the embankment at this location. Network Rail's legal team advised that they would be happy to allow this additional pipe to be installed, at no cost to the golf club.

Figure 15: The pipe after it had been struck by the tamper. This is the image that was provided to the IC at Manchester ROC (courtesy of Network Rail).

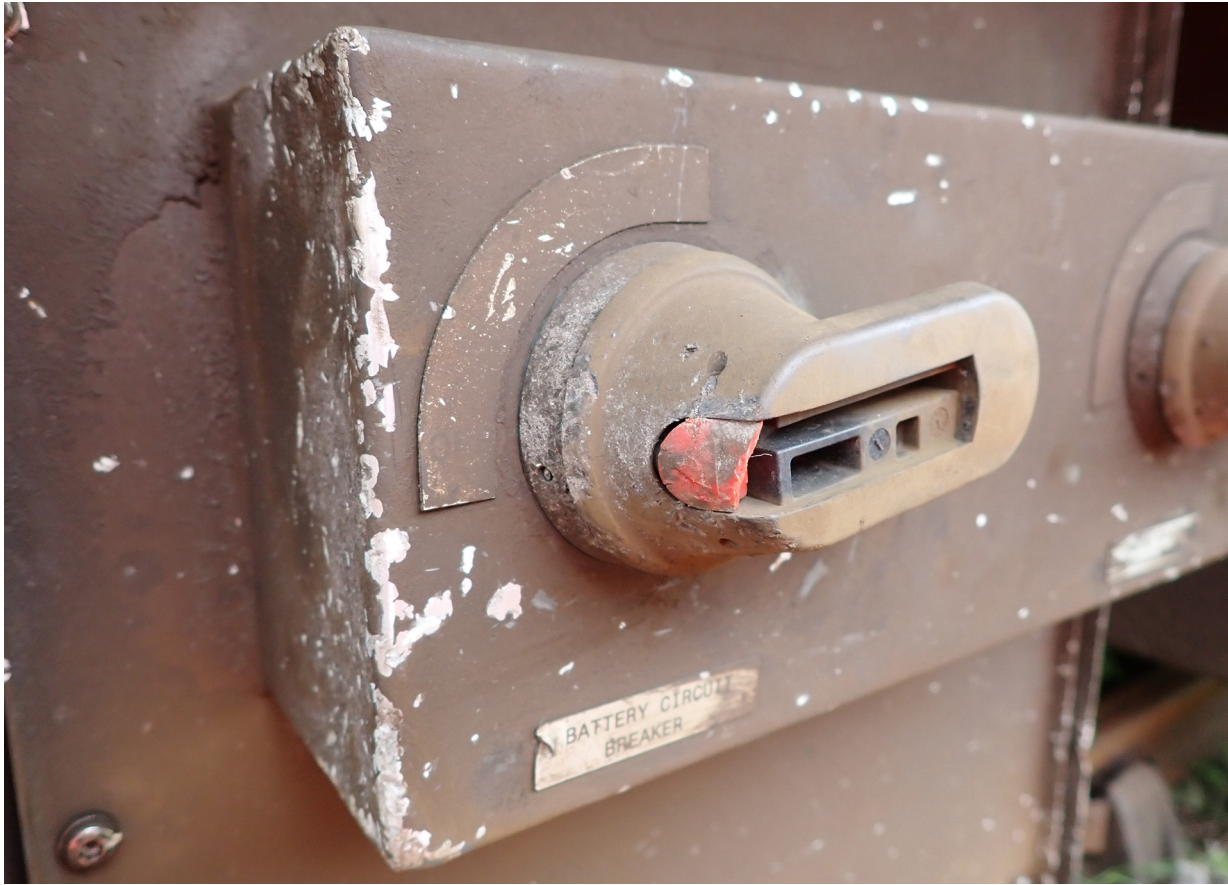
- 69 At 02:22, the IC phoned the on-call manager, who happened to be the SAE with responsibility for this asset, to seek technical assistance on how to resolve this issue. There was no answer, so they left a voicemail. This was followed up by an email from the IC to the SAE.

Figure 17: Damage caused to the battery isolation switch as it was knocked to the isolated position during the derailment.

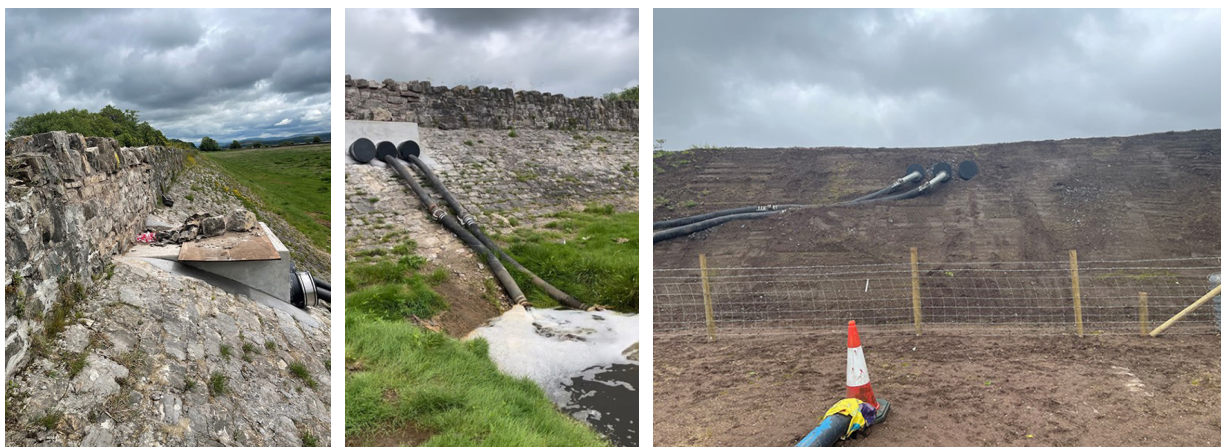
Figure 18: Railway embankment following repair by Network Rail (courtesy of Network Rail).

172 During the repair of the railway embankment involved in this accident, Network Rail installed a permanent structure to house and protect up to three temporary pipes (figure 18). This structure has been installed at the appropriate depth for buried services and currently only houses two temporary pipes, with a third available channel for increased future demands. The permanent pipe fitted by British Rail was removed as part of these works.
