Rail Accident Investigation Branch

Rail Accident Report

Derailment of a passenger train near Walton-on-Thames, Surrey 4 March 2024

Report 04/2025
February 2025

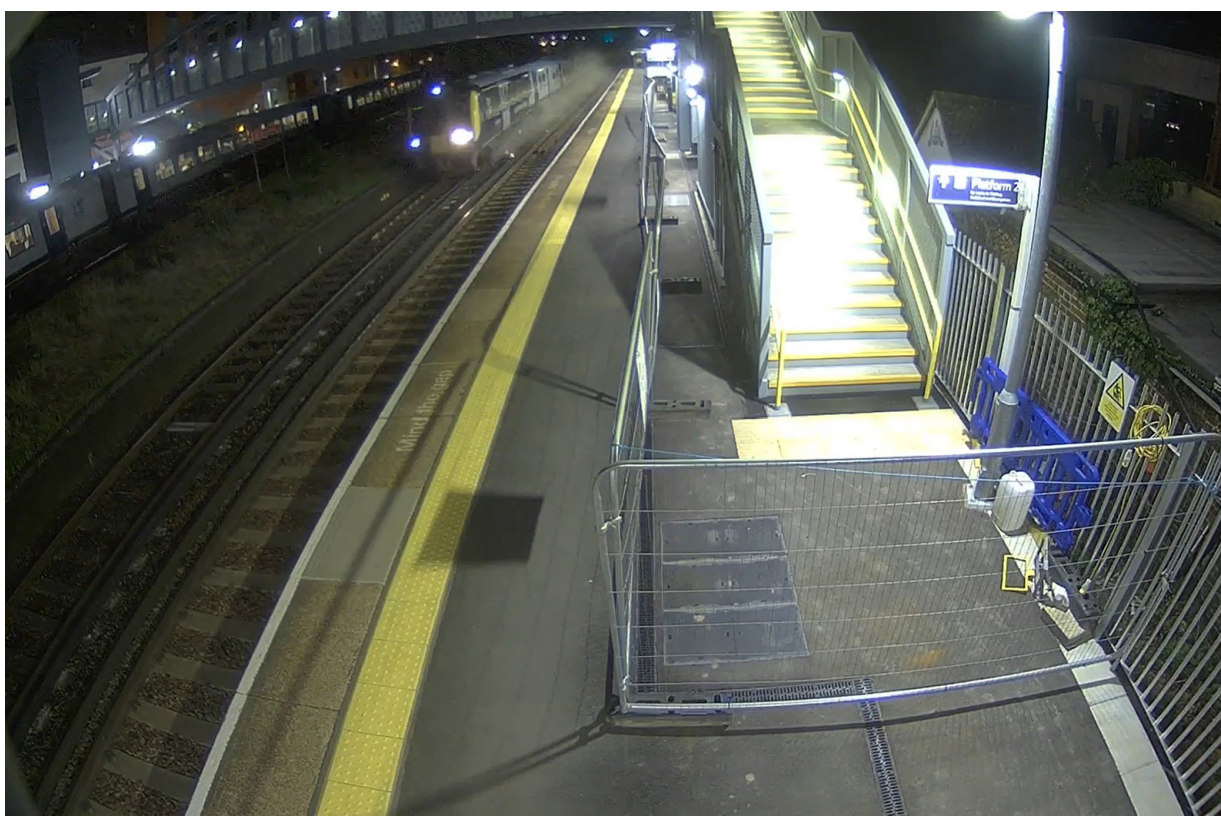
- 3 At around 05:40 on Monday 4 March 2024, train reporting number 2L10, the 04:54 South Western Railway passenger service from Basingstoke to Waterloo, struck a 2.5 metre section of redundant rail. This occurred on a road-rail vehicle access point (RRAP) on the approach to Walton-on-Thames station. At the time, the train was travelling at around 85 mph (137 km/h). The leading wheelset derailed to the left, but the train remained upright and came to a stand around 500 metres beyond the point of collision (figure 1).

Figure 1: Image from Walton-on-Thames station CCTV showing train 2L10 running derailed as it passed the out-of-use platform at Walton-on-Thames station (courtesy of South Western Railway).

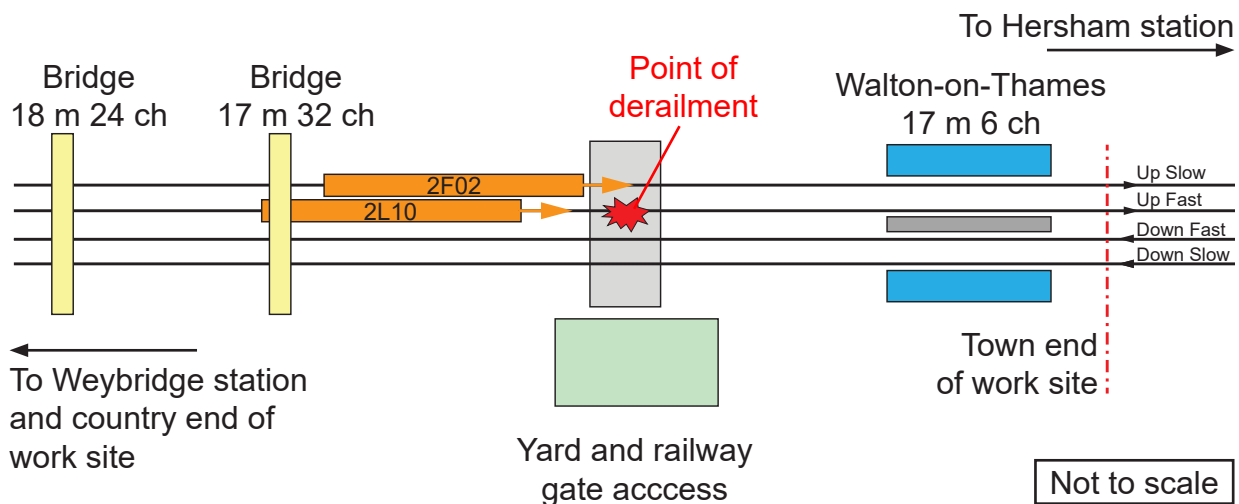
- 58 At around 05:37, train 2L10 approached the RRAP travelling at around 85 mph (137 km/h) on the Up Fast line. It struck a section of scrap rail on the RRAP and the train's leading wheelset derailed to the left (see figure 11).
- 59 The driver made an emergency brake application between 1 and 2 seconds after the derailment. The train came to a stand, upright, around 500 metres beyond the point of collision.

Figure 11: Diagram of work site, showing the directions of travel of trains 2F02 and 2L10 and the point of derailment of 2L10.

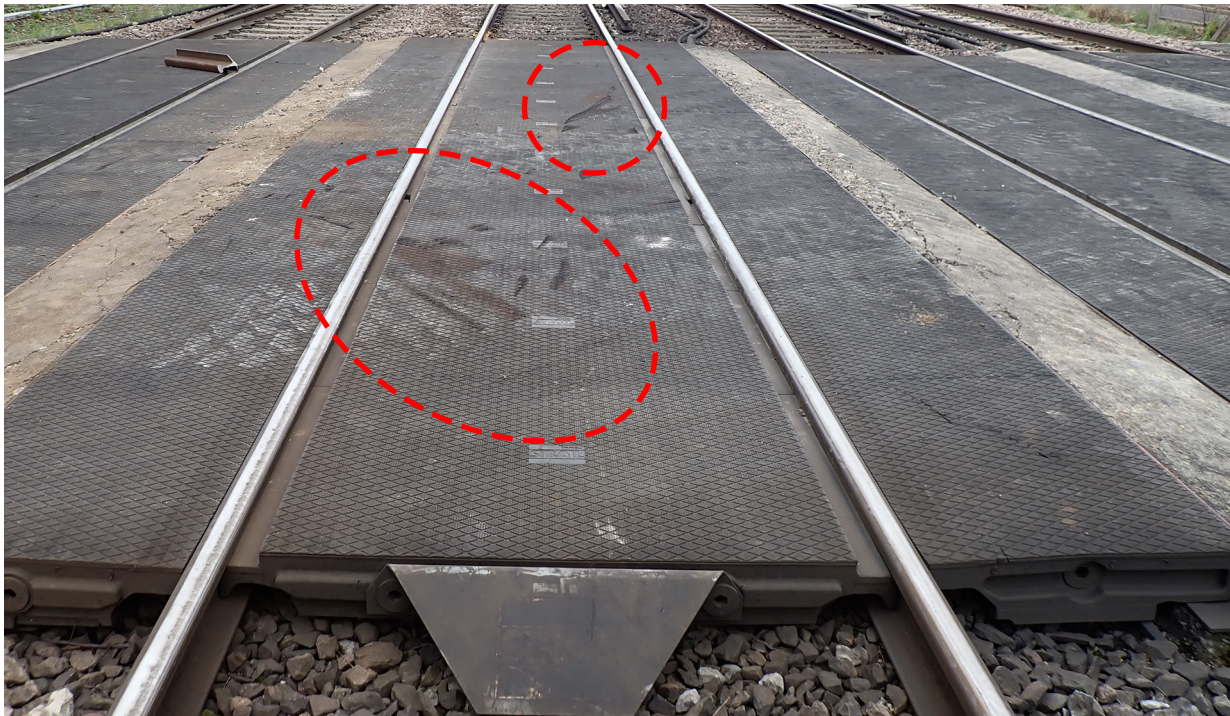
75 While the driver of train 2F02 reported that the object their train struck was sitting on top of the conductor rail on the cess side (the side of the train furthest from the Up Fast line, paragraph 55) the breaking of a bodyside window on the other side of the train, next to the six-foot (paragraph 57) suggests that the collision resulted in the object moving in the direction of the Up Fast line.

Figure 12: The witness marks (red dashed circles) caused by the section of rail impacting the rubber surface of the RRAP around the Up Fast line. Tyre marks on the RRAP surface, probably caused by the RRV on the 2 March, are also visible on the Up Slow and Up Fast lines.

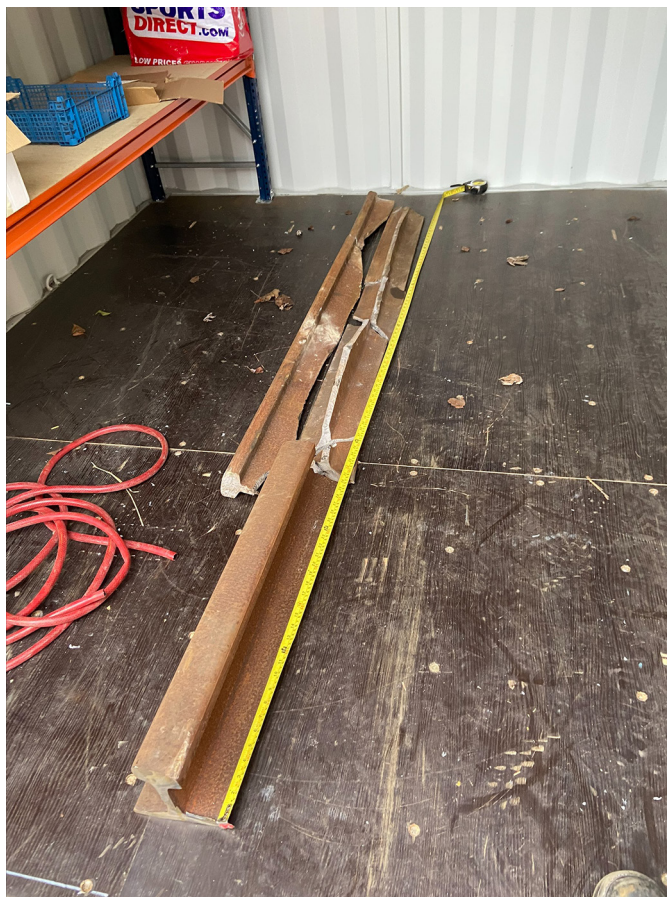
74 No other substantial object was found on or near the RRAP after the accident. This suggests that the section of redundant rail was also the object struck earlier by train 2F02. The driver of train 2F02 reported striking the object near to Hersham and there were no witness marks present on or near the Up Slow line on the RRAP to show exactly where train 2F02 struck this object. However, FFCCTV from train 2F02 shows a collision occurring with a substantial object, which results in arcing with the conductor rail, either on, or on the immediate approach to, the RRAP (paragraph 54). Data from the electronic logs for the power supplies to the conductor rail also shows that power tripped at around the same time as train 2F02 was passing the RRAP.

Figure 13: The section of running rail having been reassembled from the fragments found on and near the RRAP after the collision.

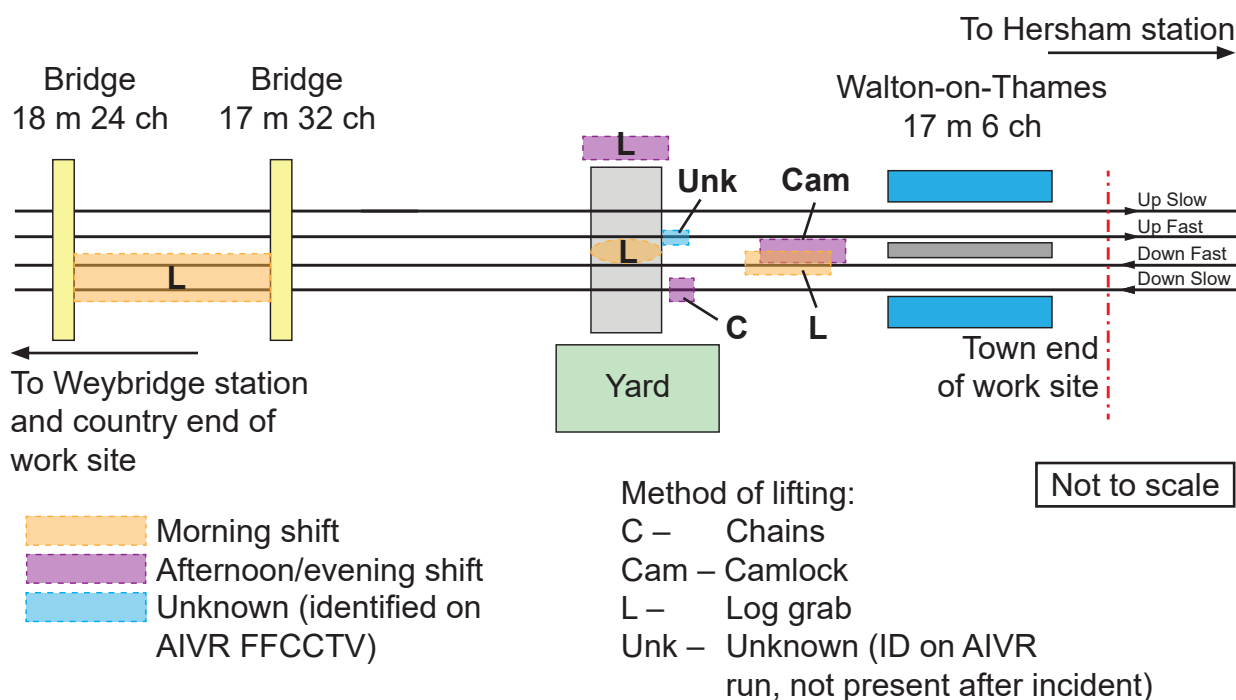
83 RAIB has not been able to identify which element of the work undertaken during the weekend of 2 to 3 March 2024 resulted in the redundant rail being left foul of the track. Neither the planning process nor the SWP (see paragraph 116) required a system to record where each section of redundant rail was cut and collected from. RAIB has therefore analysed the tasks that were undertaken at Walton-on-Thames to determine the most likely cause of the section of redundant rail being left on the RRAP.

84 FFCCTV from the Automated Intelligent Video Review (AIVR) system shows sections of redundant rail lying near the RRAP in the four-foot of the Up Fast line (figure 14) when a train passed through the location of the work site on 20 February 2024. Network Rail has confirmed that there had been no rail collection at this location between 20 February and 3 March. Post-accident examination of the site showed that this redundant rail was not present, suggesting that it was removed from near the RRAP during the weekend of 3 to 4 March, although such an activity had not been planned and witnesses did not report this work had been completed during the possession.

Figure 14: Diagram of the work site showing the different locations, times and methods of lift used to collect the redundant rail.

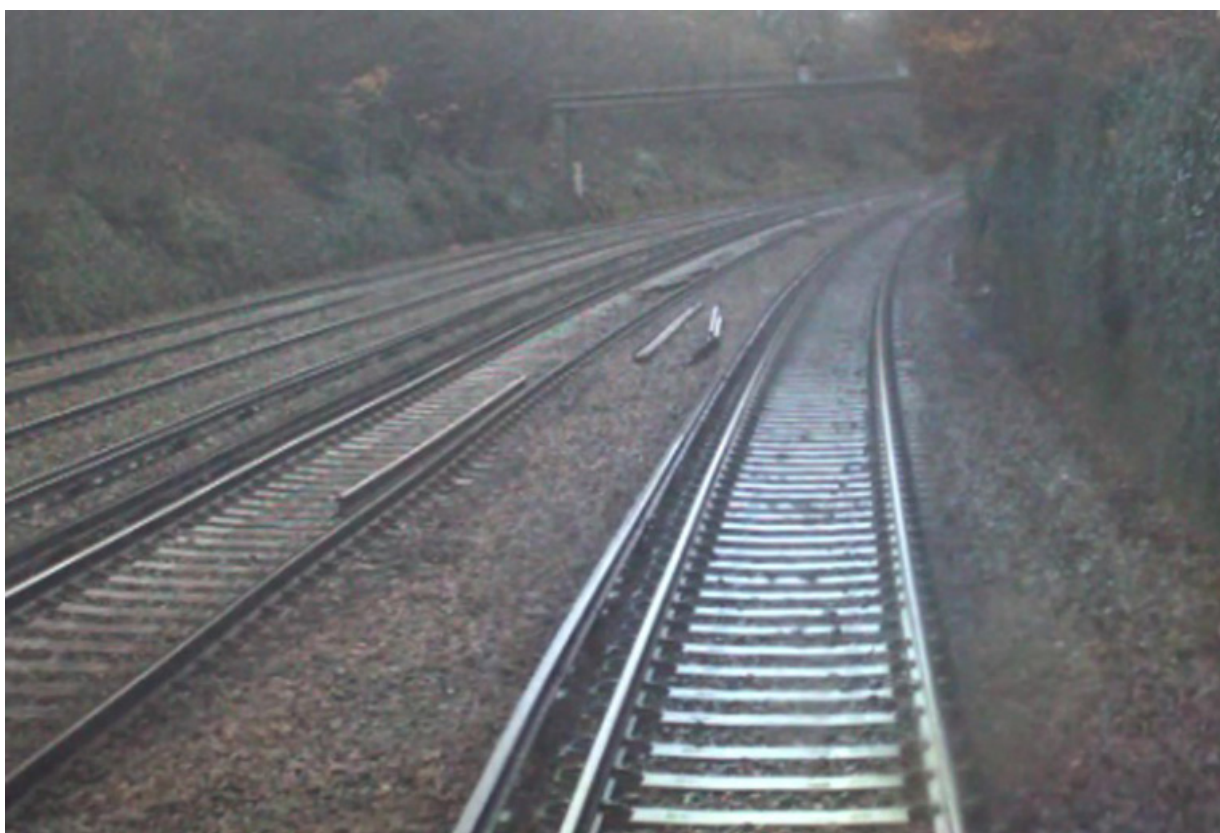
Figure 15: Photo of the FFCCTV from the inspection train used in the email from the project lead to other Colas Rail staff as an 'example of the scrap rail, present in 6ft and adjacent road' (courtesy of Network Rail).

- 113 The email to the site supervisor and handback engineer was ambiguous about which types of rail were to be removed and this may have caused confusion for staff on site as to the intended scope of the work. This is supported by witness and physical evidence that shows both redundant conductor rail and substantial amounts of redundant running rail were removed from several locations in addition to the removal of redundant conductor rail around the Down Slow line. This also affected the handback engineer's understanding of the lines that needed to be checked when the handback inspection was undertaken (paragraph 102).

114 The ambiguity around scope caused significantly more redundant rail to be collected on site than was intended and consequently work at Walton-on-Thames took longer than anticipated. This delay was further exacerbated by issues and delays encountered on site. The combined effect was that some of the work near the RRAP was conducted in darkness (with no site lighting) and this significantly increased the risk that a section of rail would not be detected if inadvertently dropped or left on site. The delays in the work also affected the presence of the POS representative who left site at 16:00 (as scheduled) with lifting of redundant rail sections continuing after this. Although this role is largely duplicated by that of the machine controller, the POS representative may have challenged the use of the unapproved methods used to collect and move the redundant rail and the lack of available lighting (paragraph 90).
