## Serious Incident

<b>Aircraft Type and Registration:</b>	ATR 72-500 (72-212A), LY-JUP	
<b>No &amp; Type of Engines:</b>	2 Pratt and Whitney PW-127F turboprop engines	
<b>Year of Manufacture:</b>	2007 (Serial no: 747)	
<b>Date &amp; Time (UTC):</b>	12 August 2024 at 0842 hrs	
<b>Location:</b>	Guernsey Airport	
<b>Type of Flight:</b>	Commercial Air Transport (Passenger)	
<b>Persons on Board:</b>	Crew - 5	Passengers - 52
<b>Injuries:</b>	Crew - None	Passengers - None
<b>Nature of Damage:</b>	None	
<b>Commander's Licence:</b>	Airline Transport Pilot's Licence	
<b>Commander's Age:</b>	56 years	
<b>Commander's Flying Experience:</b>	10,360 hours (of which 4,805 were on type) Last 90 days - 151 hours Last 28 days - 34 hours	
<b>Information Source:</b>	AAIB Field Investigation

## Synopsis

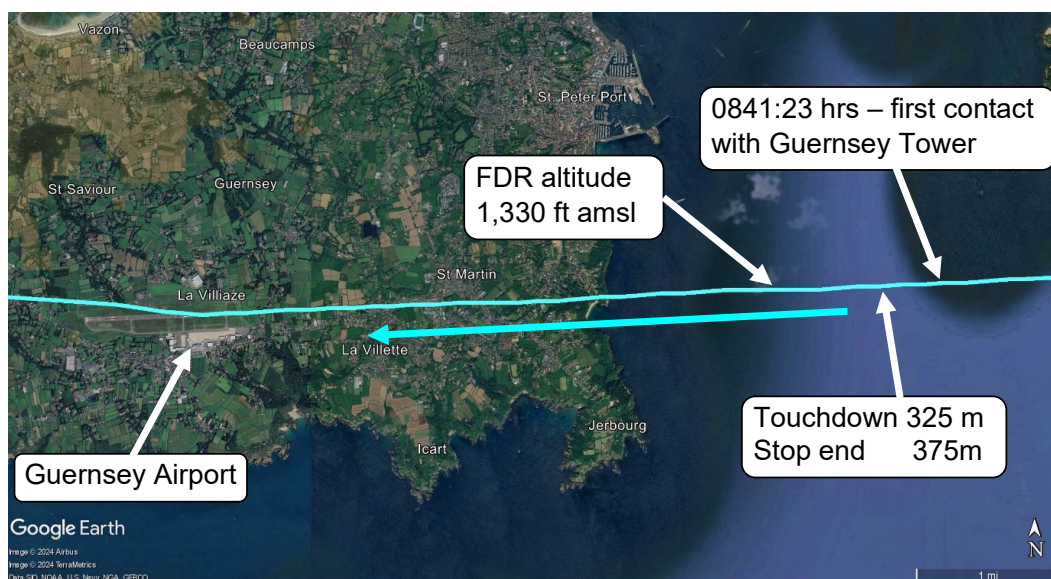
**Figure 1**

ATC kept the crew informed of the RVR during the approach and having established themselves on final approach the crew were cleared for the ILS and handed over to the tower frequency as the aircraft began its descent on the ILS. When they contacted tower, they were informed, as they passed 1,750 ft amsl, that the touchdown RVR was 325 m and the stop end 400 m. ATC again reported the RVR as the aircraft passed 1,540 ft amsl as 325 m (touchdown), 375 m (stop end). Despite the RVR being below that required for the CAT1 ILS, the approach was continued below 1,000 ft aal (1,336 ft amsl).

LY-JUP approach to Guernsey Airport from FDR data

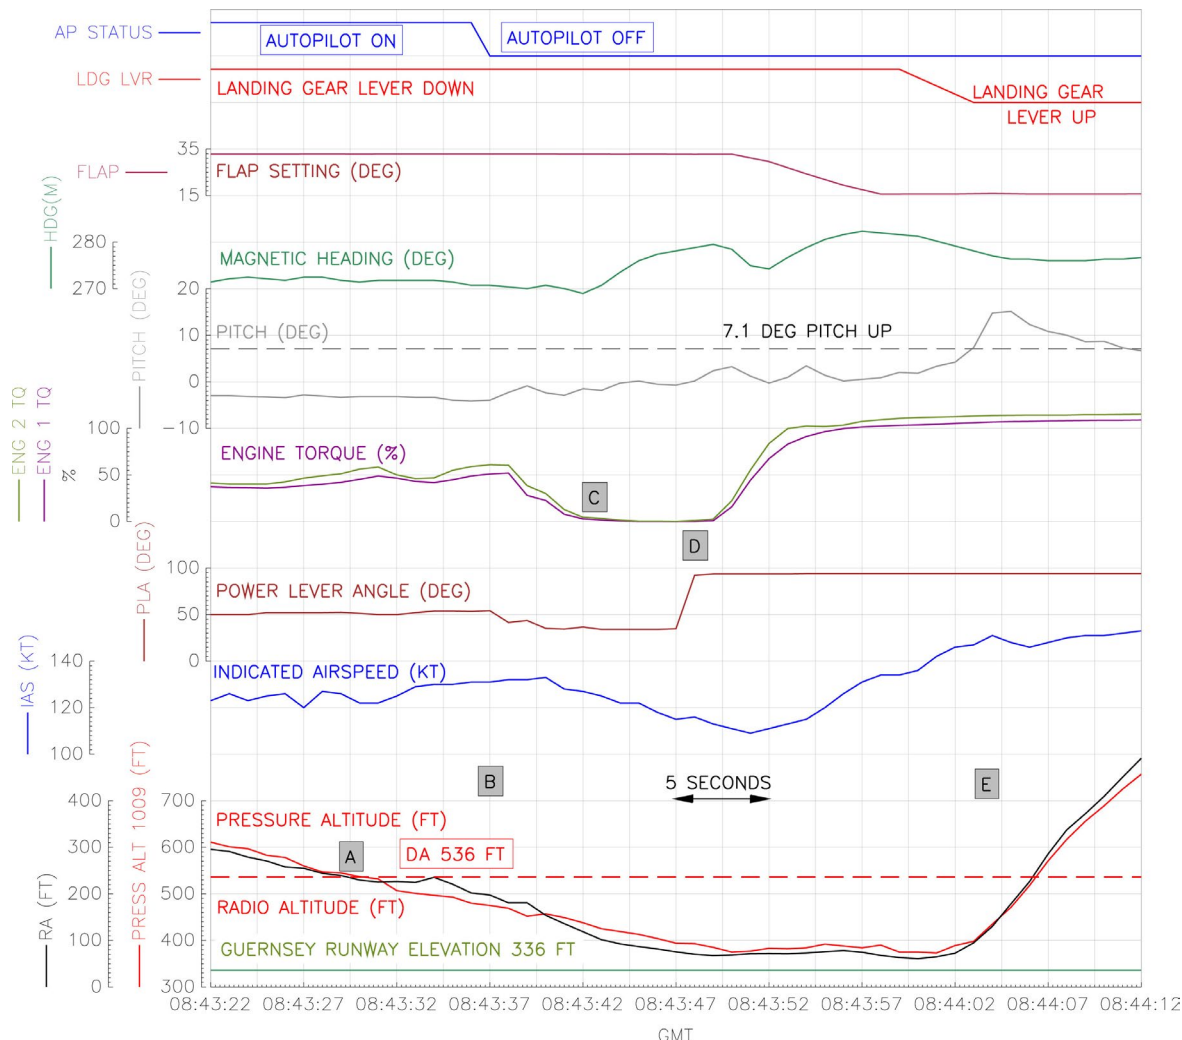
**Figure 2**  
LY-JUP FDR data during approach and go-around

At 0843:30 hrs, the recorded pressure altitude reduced below the decision height<sup>3</sup> of 536 ft amsl when the aircraft was just over 0.5 nm from the Runway 27 displaced threshold (point A, Figure 2). The approach continued and the autopilot was disconnected seven seconds later at 475 ft amsl and 131 KIAS (point B).

Engine power was then reduced to flight idle and the aircraft pitched up (point C). Just after crossing the displaced threshold, the power levers were advanced to full power when the aircraft was at a radio altitude of 70 ft agl and 116 KIAS (point D). The selection of the go-around pushbuttons on the power levers and the FD were not recorded parameters on the FDR. At the time, the recorded selected heading was 269°.

Engine power increased, flap setting was reduced to  $15^\circ$  and the indicated airspeed increased. The landing gear remained down, and pitch attitude remained below the  $7.1^\circ$  for 15 seconds after the power levers were advanced. The aircraft remained at a radio altitude of between 61 to 78 ft agl and recorded GPS position showed a deviation to the right of the runway (Figure 3). The recorded position showed that the aircraft came within 40 m laterally of the Runway 27 DME transmitter whilst at 375 ft amsl (top of the DME transmitter is 348 ft amsl).

At 0844:03 hrs, pitch attitude increased above  $7.1^\circ$  and the landing gear lever was selected to the UP position (Figure 2 Point E). The aircraft climbed and pitch attitude continued to increase to a maximum of  $15.8^\circ$  before then reducing as the aircraft continued to climb. At 0844:22 hrs, the aircraft made a radio transmission that it was going around and diverting to Southampton.

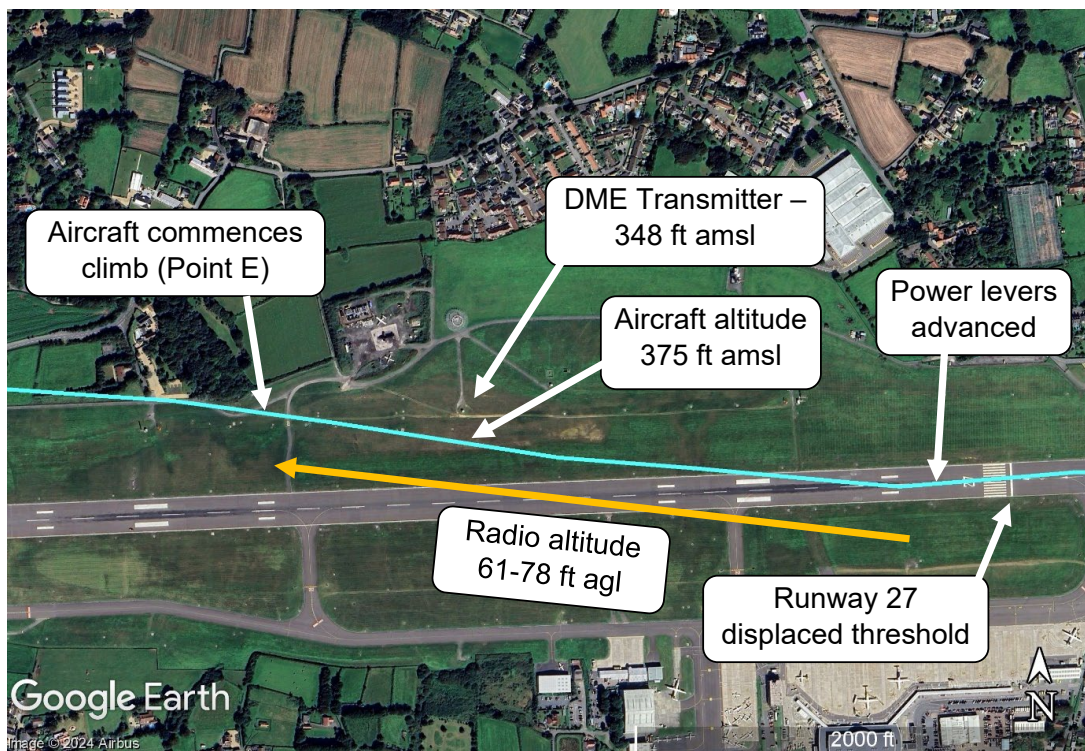
**Figure 3**

LY-JUP ground track during approach and go-around

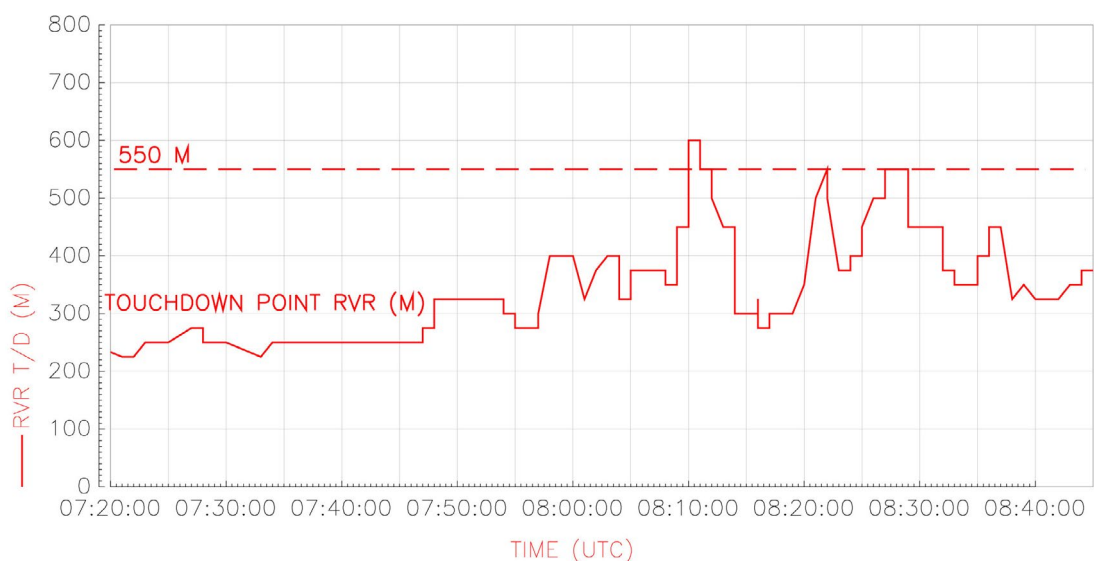
Figure 4

The airport at Guernsey has two RVR reading stations – the touchdown and the stop end. The figures for these were recorded every minute during the approach to Runway 27. A plot of the touchdown readings from the time the aircraft departed from Southampton until the time of the go-around is shown in Figure 4.

Runway 27 touchdown point recorded RVR

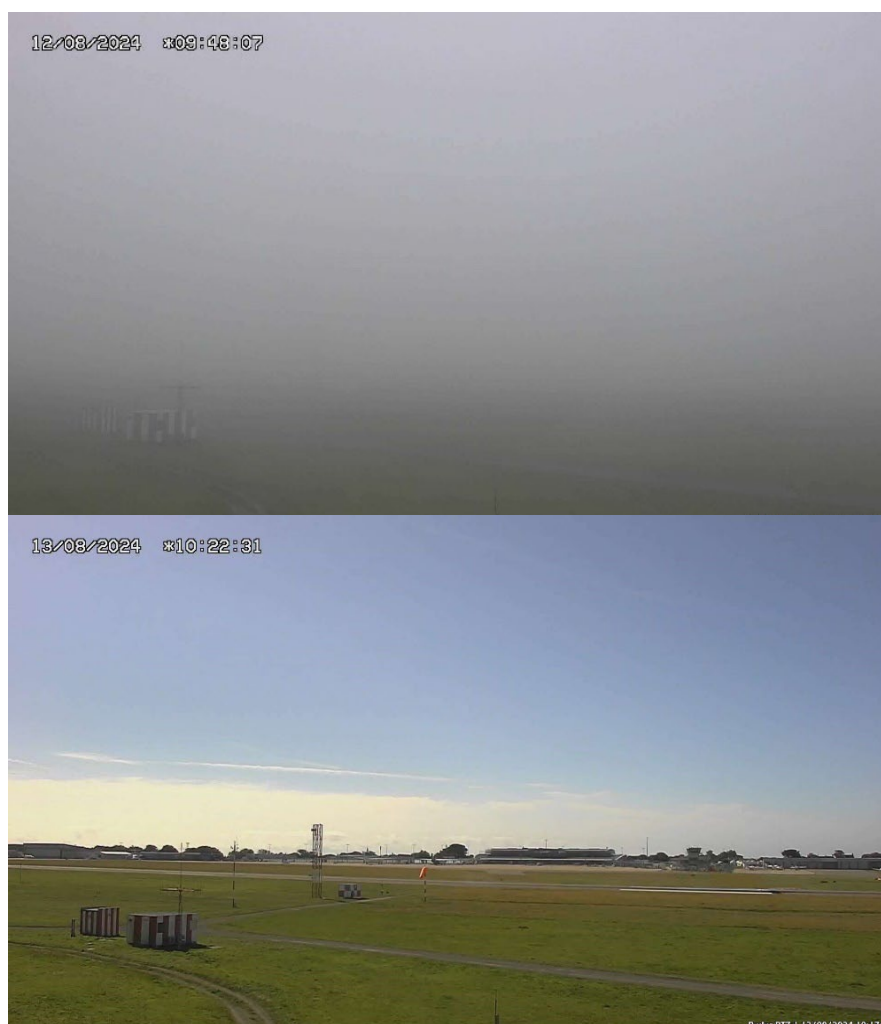
**Figure 5**

The airport is equipped with CCTV, stills of which were provided showing the view of the Runway 27 touch down zone. The stills show the weather around the time of the approach and on the subsequent day when there was no fog.

Airport CCTV images looking south over the Runway 27 touchdown zone (times are BST)
