Grounding and capsizing of the creel fishing vessel *Lexi Rose* (BF 370) on Melrose Point, north-east Scotland resulting in one fatality on 21 September 2023

SUMMARY

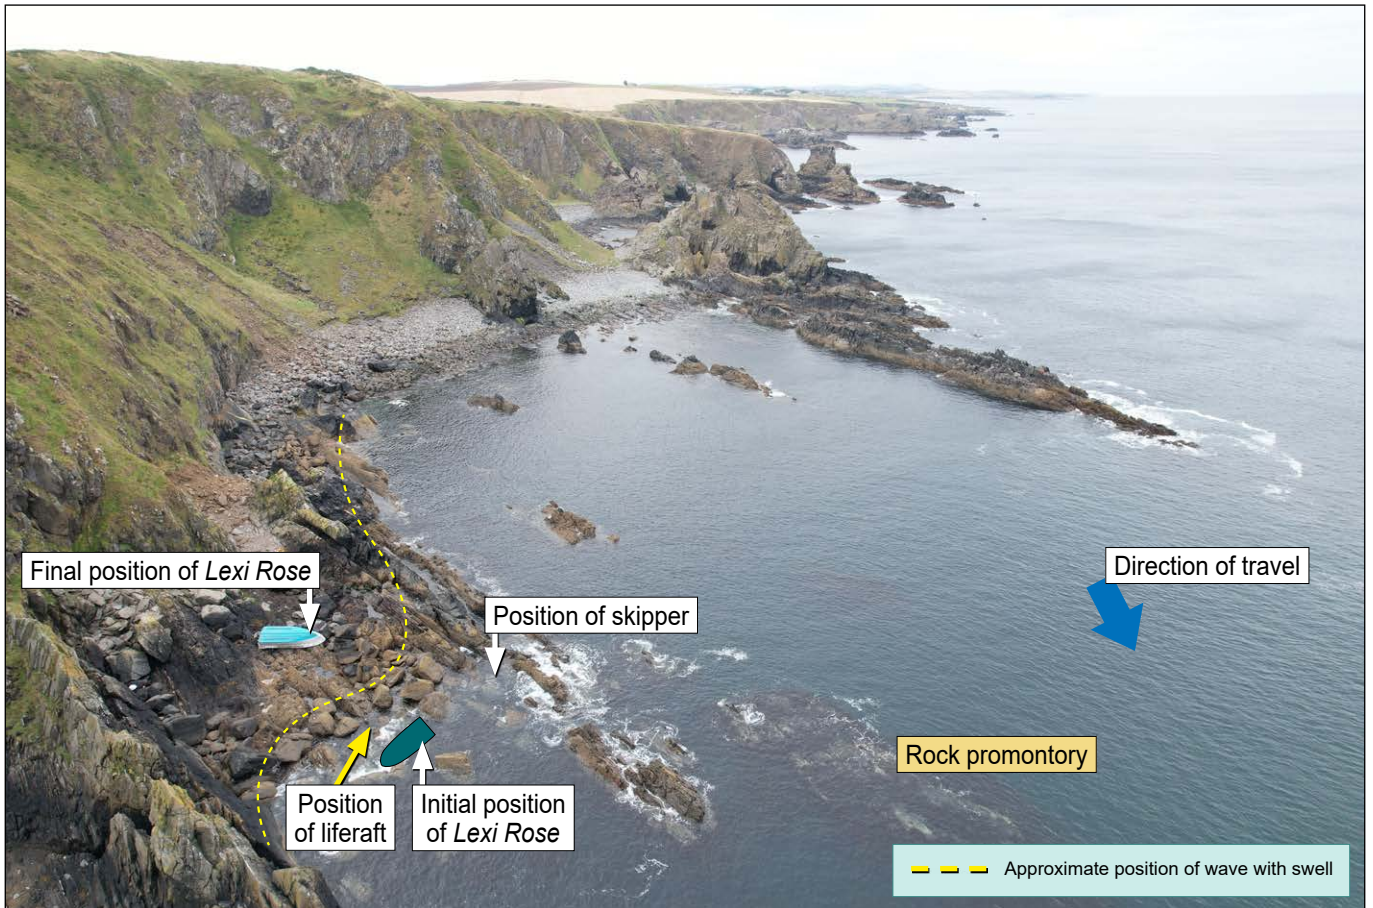
Figure 2: Position of *Lexi Rose* and skipper observed by *R151* crew (looking west)

At 1200, coastguard helicopter *R151* arrived on scene and quickly located a person, who was later identified as *Lexi Rose's* skipper, floating in the cove (**Figures 2 and 3**). The skipper was not wearing a personal flotation device (PFD) and had been found in shallow water near rocks, 5m to the west of *Lexi Rose*. At 1204, a winchman entered the water to recover the unconscious skipper to *R151*. During the flight to Aberdeen *Lexi Rose's* skipper was declared deceased.

The exact circumstances and capsize mechanism are unknown. However, when *Lexi Rose* was found the vessel was already inverted in shallow water and the skipper was close to the wreckage (see **Figures 2 and 3**). There were no indications that the skipper had tried to self-rescue from the water or climb onto the rocks. It was not possible to determine what caused the skipper's head injury.

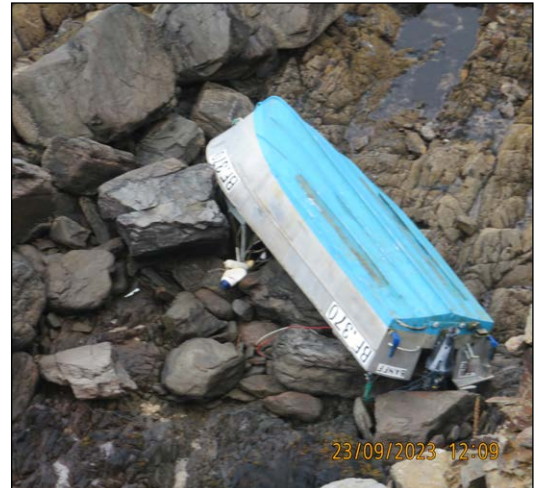
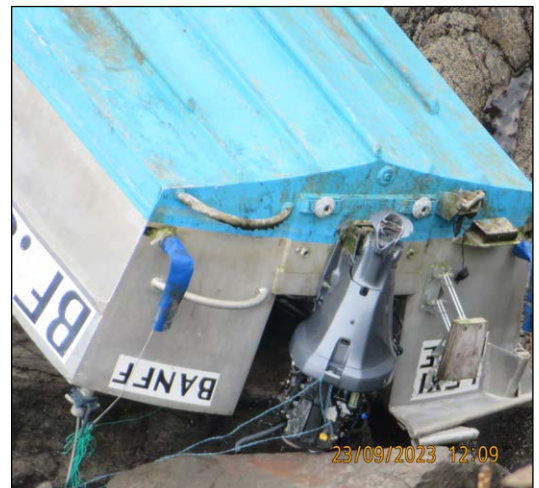
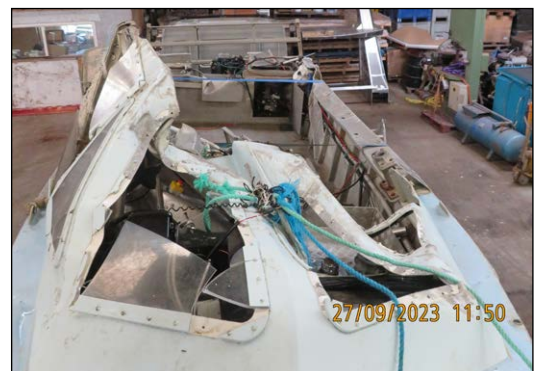
Figure 4: *Lexi Rose* post-recovery and damage to the deck

The post-recovery inspection of the wreck of *Lexi Rose* found that the outboard engine's lower assembly unit was missing, the wheelhouse had been crushed by wave action at the wreck site, and the cat catcher had been ripped off. No creels or catch were found in the wreckage (**Figure 4**). One of two electronic plotters thought to be on board the vessel was found in the wreckage. The aluminium hull was intact, with no signs of any breaches or impact damage.

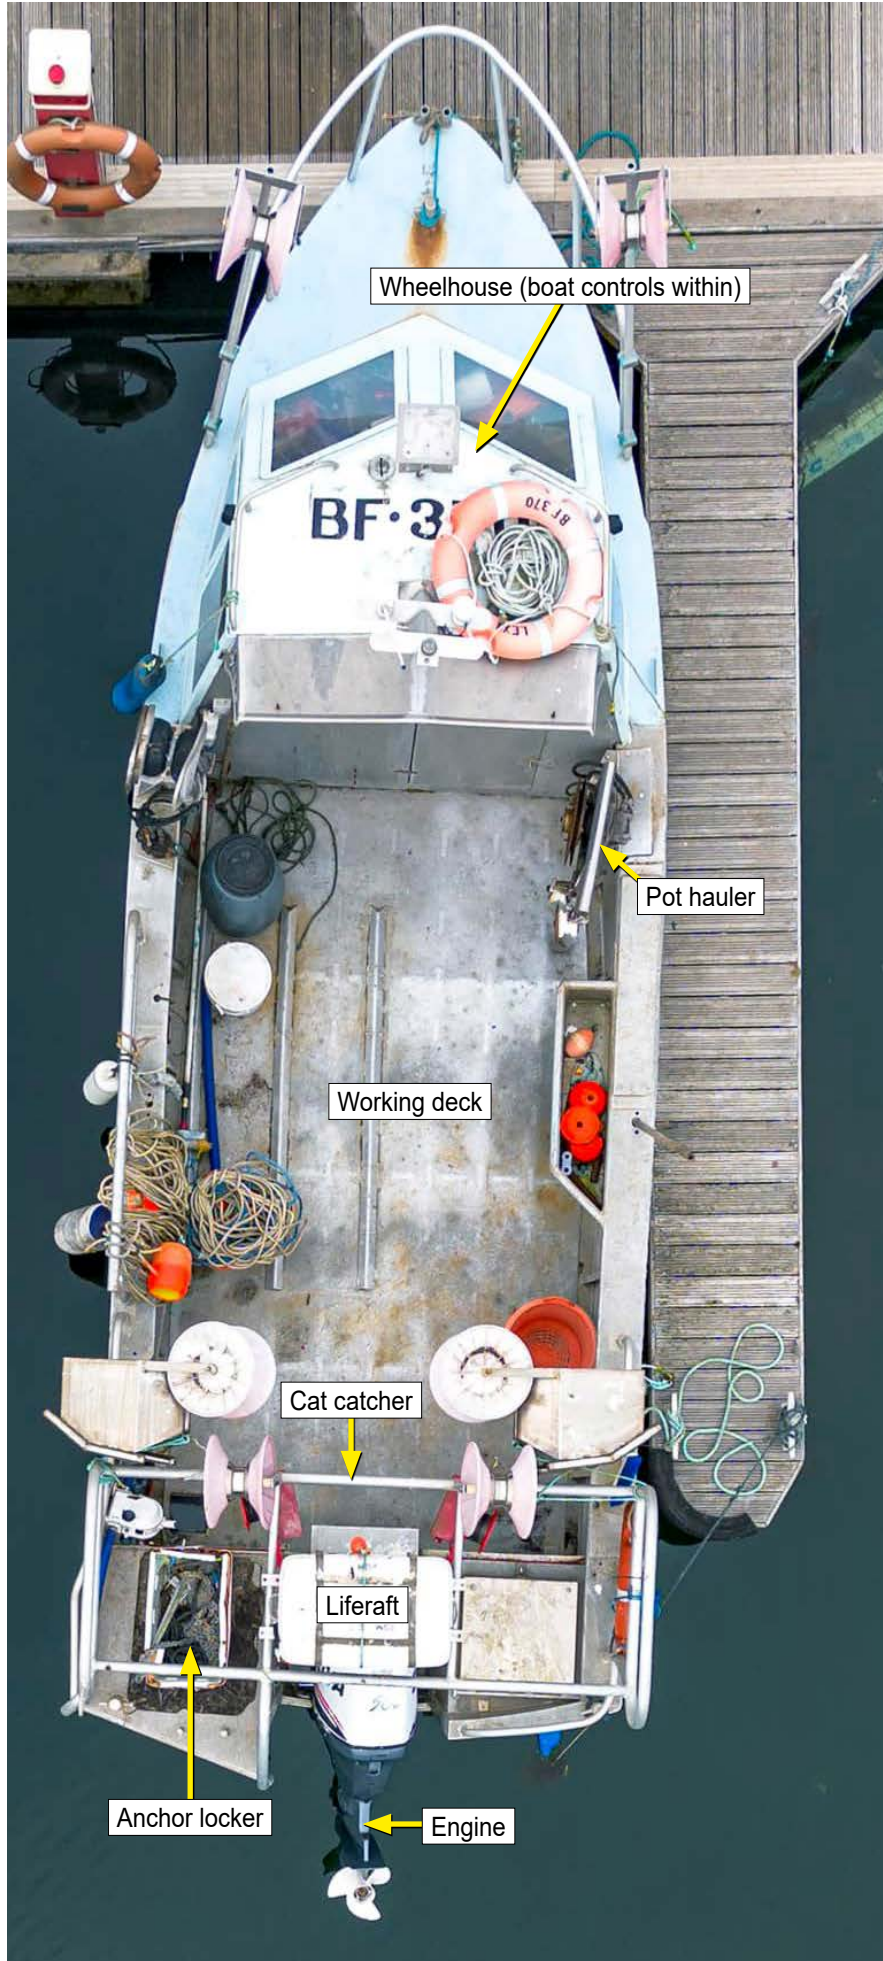
Figure 5: Lexi Rose's deck arrangement

Lexi Rose was powered by a centrally-mounted 50 horsepower outboard engine that was controlled from the wheelhouse (**Figure 5**). There was no secondary propulsion. The vessel's deepest point was the outboard engine's lower assembly unit, which projected approximately 150mm below the keel.

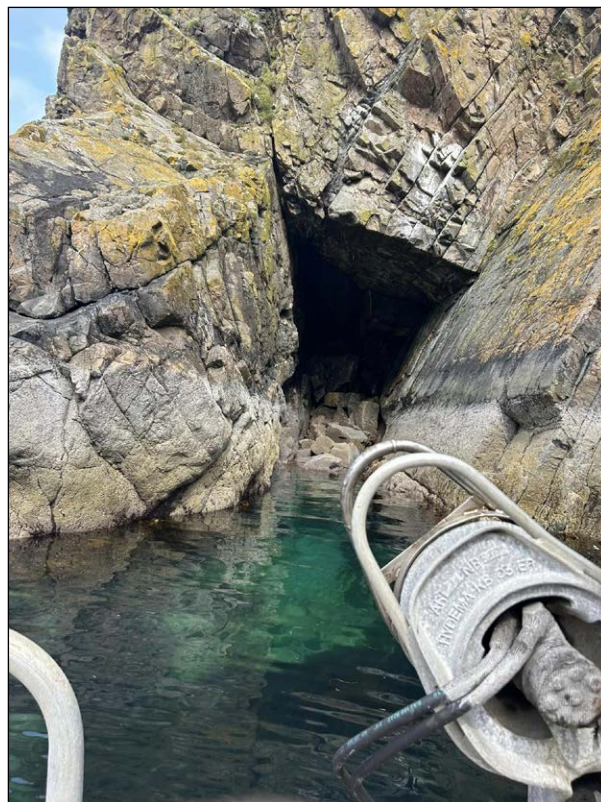
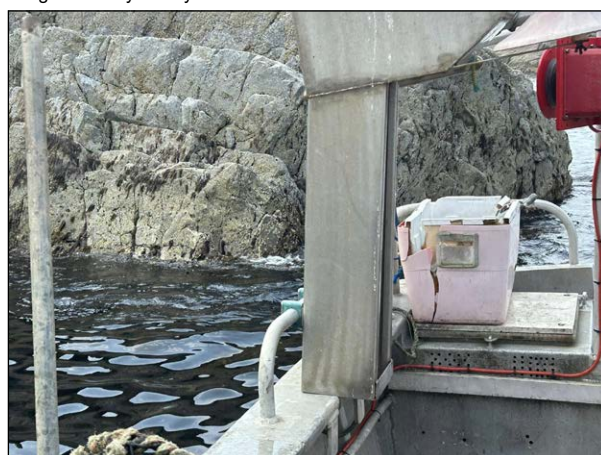
Figure 6: *Lexi Rose* fishing close inshore

Fishing in the Banff and Macduff area was strongly affected by wind direction, with the optimal wind direction being offshore so small vessels could access the rocky area close inshore that lobsters favoured. Local fishermen reported they could fish with a westerly or easterly wind but would avoid a northerly wind as this tended to take them too close to the rocks. The skipper was reported to regularly access mobile phone applications to check weather conditions and he had specifically selected *Lexi Rose* for its shallow draught, which allowed access into the small inshore coves (**Figure 6**).
