SAFETY FLYER TO THE FISHING INDUSTRY

Grounding and capsizing of the single-handed creel fishing vessel *Lexi Rose* (BF 370) resulting in one fatality on Melrose Point, north-east Scotland on 21 September 2023

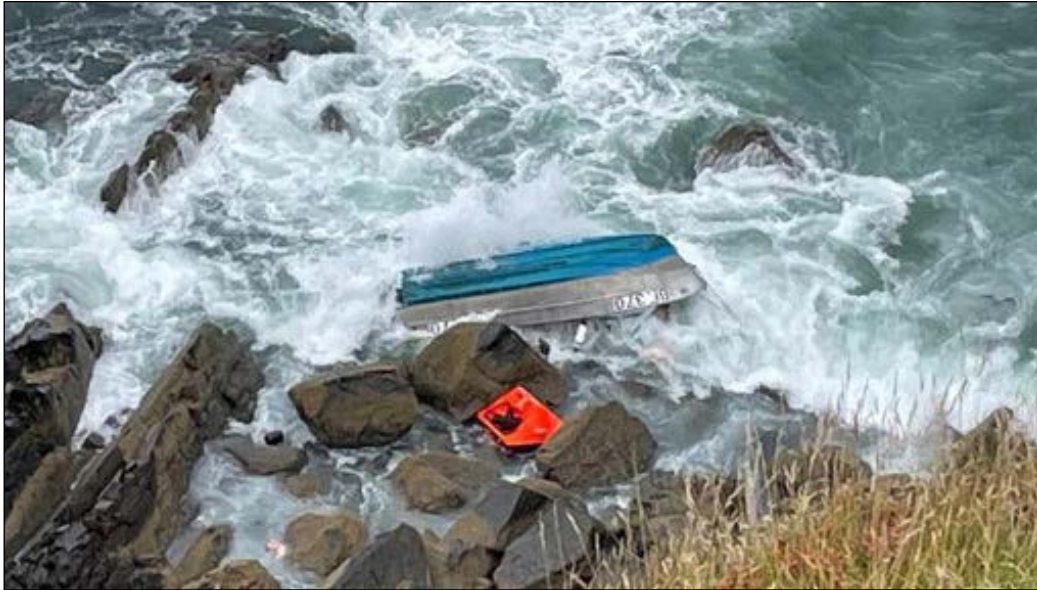
Lexi Rose and liferaft after the recovery of the skipper

Lexi Rose's skipper began working his individually placed creels in the small coves along the coast before the other fishing vessel had arrived in the area. As *Lexi Rose's* skipper moved his vessel from one creel to another the outboard engine's lower assembly unit hit a rock promontory at the entrance of a small cove. The engine's lower assembly unit detached from its mounting, causing an immediate loss of propulsion.

Lexi Rose became subject to the waves washing against the shore and was moved onto the rocks within 4 minutes. The skipper made an initial radio call on the local working channel to say he was grounded and in need of immediate aid. Moments later, he made another call on the same channel to say the vessel was going over. The skipper of the other fishing vessel heard the calls and raised the alarm.

1. When operating close inshore, the presence of a swell or other unusual weather event can increase the risk of exposure to the hazards of grounding and capsizing. If unsure, the safe action is to abort fishing operations.
2. The risks of operating single-handedly are well known, but are compounded when working close inshore when the time to react is reduced. Good preparation is essential to deal with emergencies effectively.
3. Preventing a grounding using an anchor requires sufficient room between the vessel and shore for the anchor and chain to have an effect. This method might prove ineffective when close inshore, particularly when waves are acting on the vessel.
4. Wearing a PFD with crotch straps when there is any risk of entering the water increases the chances of survival as it will keep an unconscious person's airway out of the water.
