Accident

Aircraft Type and Registration:	Extra EA-200, G-EEEEK	
No & Type of Engines:	1 Lycoming AEIO-360-A1E piston engine	
Year of Manufacture:	2006 (Serial no: 1034)	
Date & Time (UTC):	13 July 2024 at 1142 hrs	
Location:	Spanhoe Airfield, Northamptonshire	
Type of Flight:	Private	
Persons on Board:	Crew - 1	Passengers - None
Injuries:	Crew - 1 (Fatal)	Passengers - N/A
Nature of Damage:	Aircraft destroyed	
Commander's Licence:	Private Pilot's Licence	
Commander's Age:	65 years	
Commander's Flying Experience:	At least 4,076 hours (of which approximately 1,100 were on type) Last 90 days – at least 225 hours Last 28 days – at least 81 hours	
Information Source:	AAIB Field Investigation

Synopsis

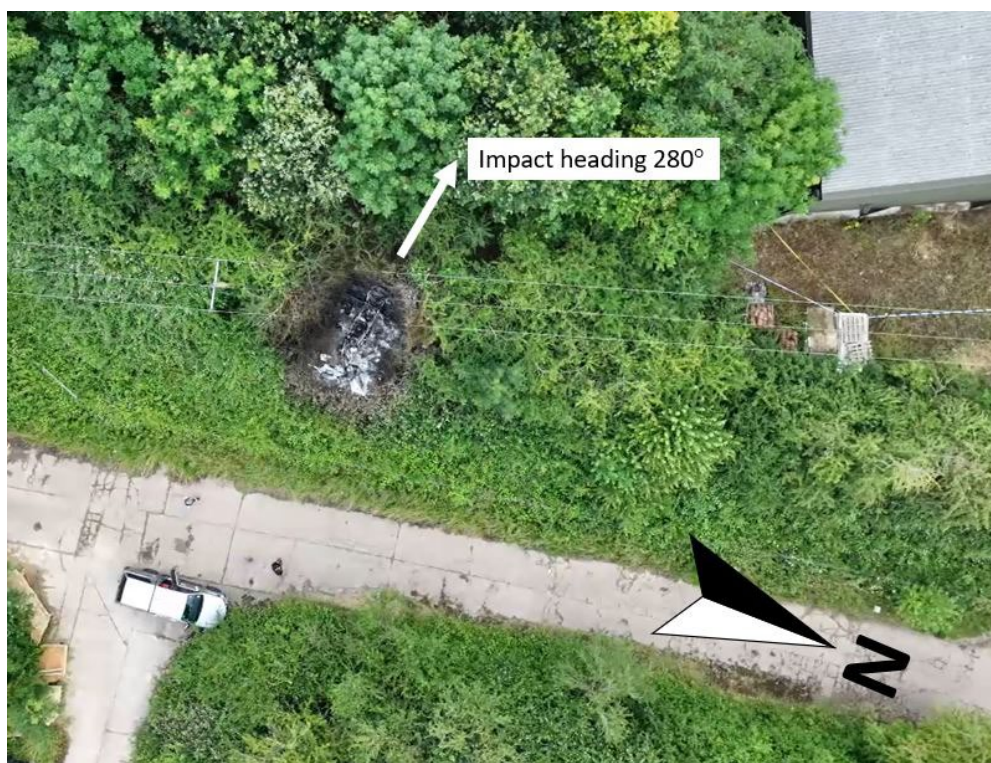
Figure 1
G-EEEEK accident site

The aircraft struck the ground in a wooded area approximately 170 m to the south of Runway 09-27, adjacent to the airfield access road. The compact nature of the accident site, lack of ground impact marks away from the aircraft wreckage and relative lack of distortion to the fuselage's welded steel frame showed that the aircraft had struck the ground at low speed in an approximately level pitch and roll attitude (Figure 1). Three-phase electrical cables directly above the aircraft wreckage were intact, apart from minor fire damage, indicating that the flight path prior to impact was not vertical to the ground and that the aircraft had a low degree of forward speed at impact. The low forward speed was further confirmed by the lack of significant forward displacement of debris from the main aircraft wreckage.

An intense post-impact fire had occurred, consuming the majority of the flammable material of the aircraft's structure, and it was not possible to determine if the aircraft had been rotating in yaw at impact.

Examination of the aircraft wreckage at the accident site confirmed that all major airframe structural elements, control surfaces, canopy, landing gear, engine and propeller were present. Damage to the aircraft's three-bladed wooden propeller showed that the propeller had been rotating under power at impact. The pilot was sitting in the rear seat, with the steel buckle of the seat harness present in the rear cockpit, however the seat belt straps had been consumed by fire. The accident was not survivable.
