Report on the investigation of  
the contact made by the paddle steamer  
***Waverley***  
with Brodick pier, Isle of Arran, Scotland  
on 3 September 2020

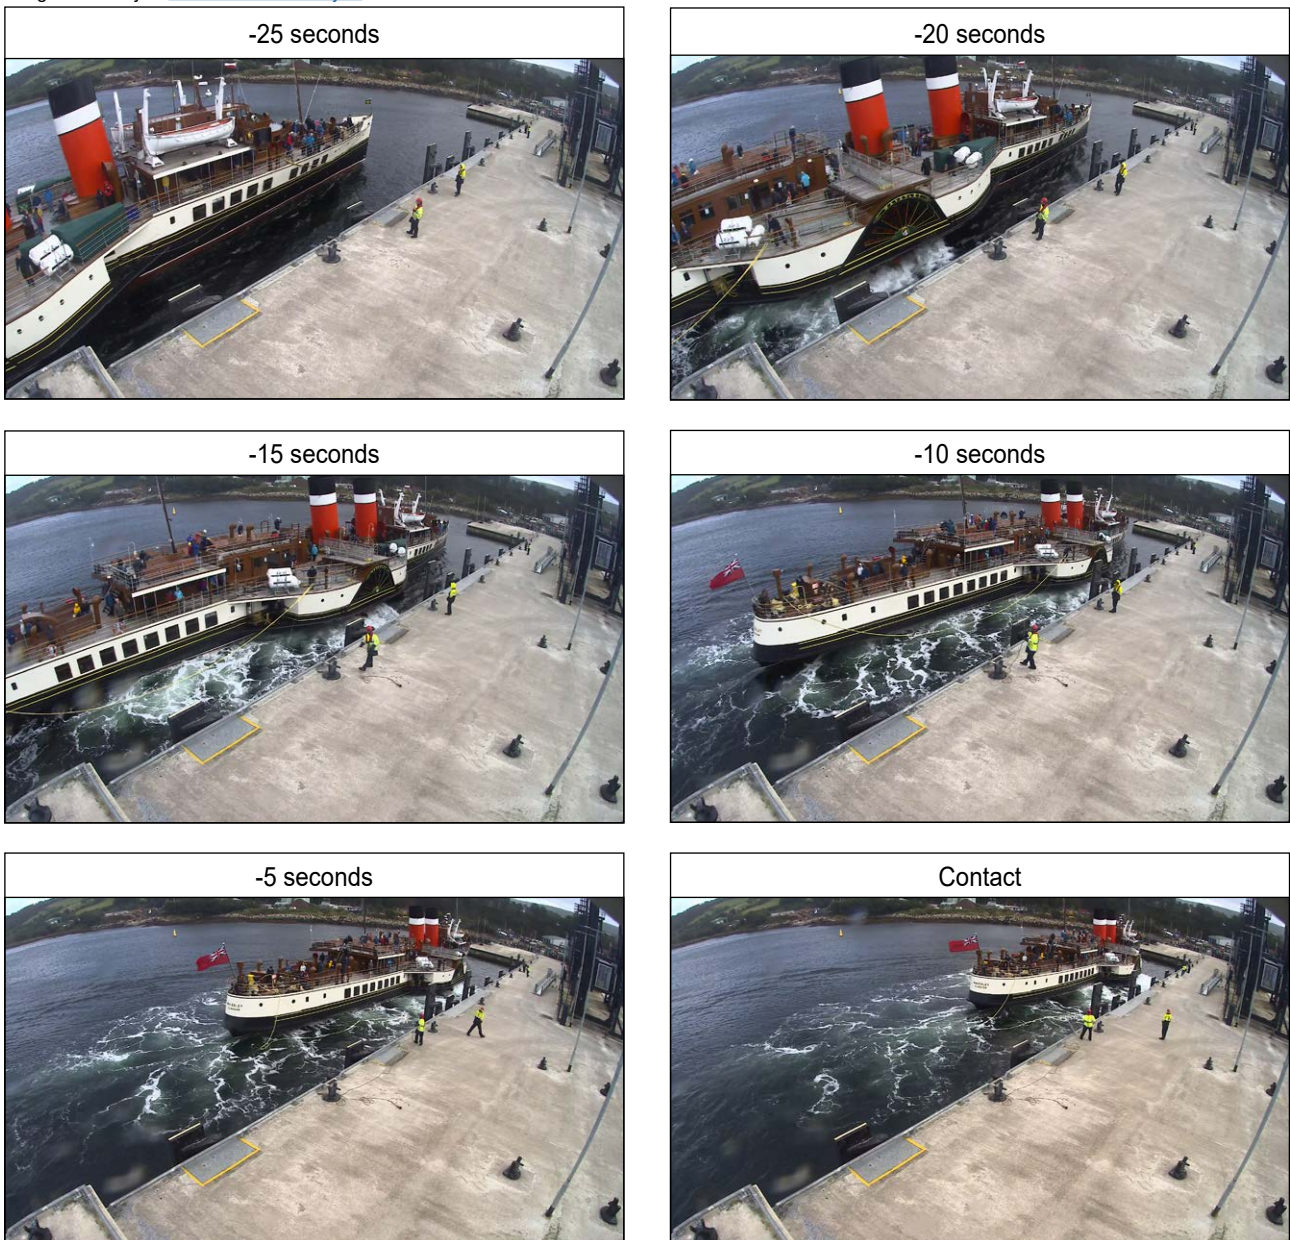
**Figure 5:** CCTV stills showing *Waverley* moving down the pier before making contact with the pier structure at 1646 on 3 September 2020

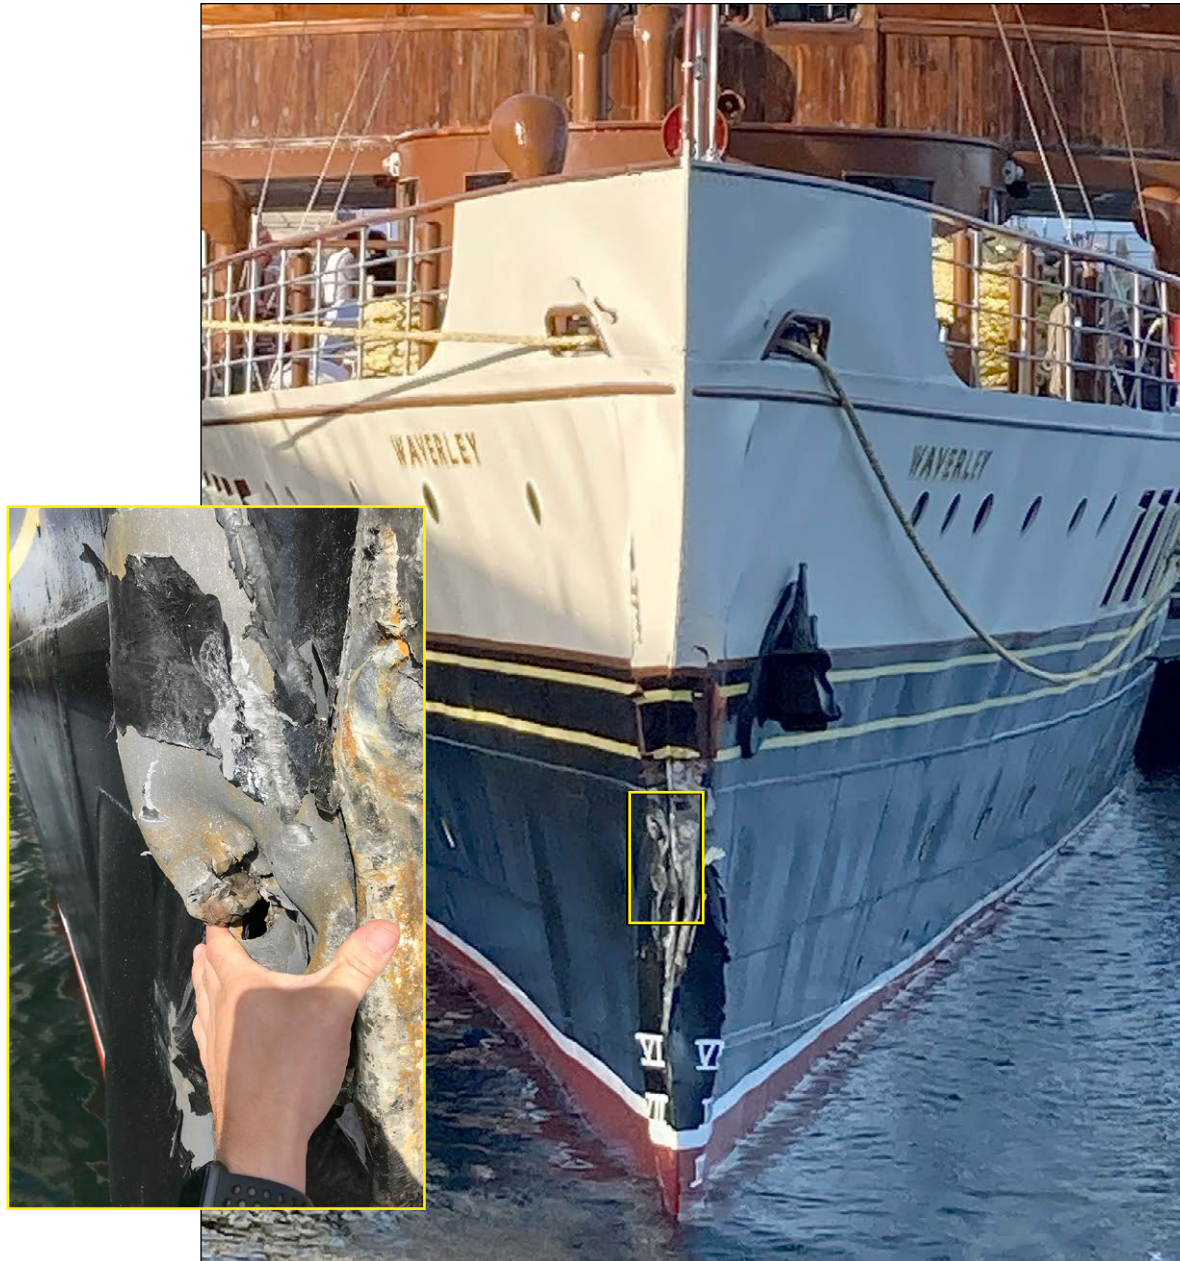
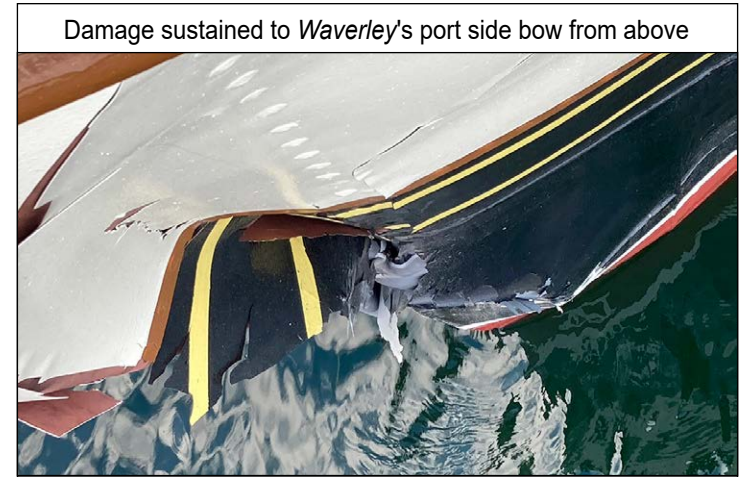
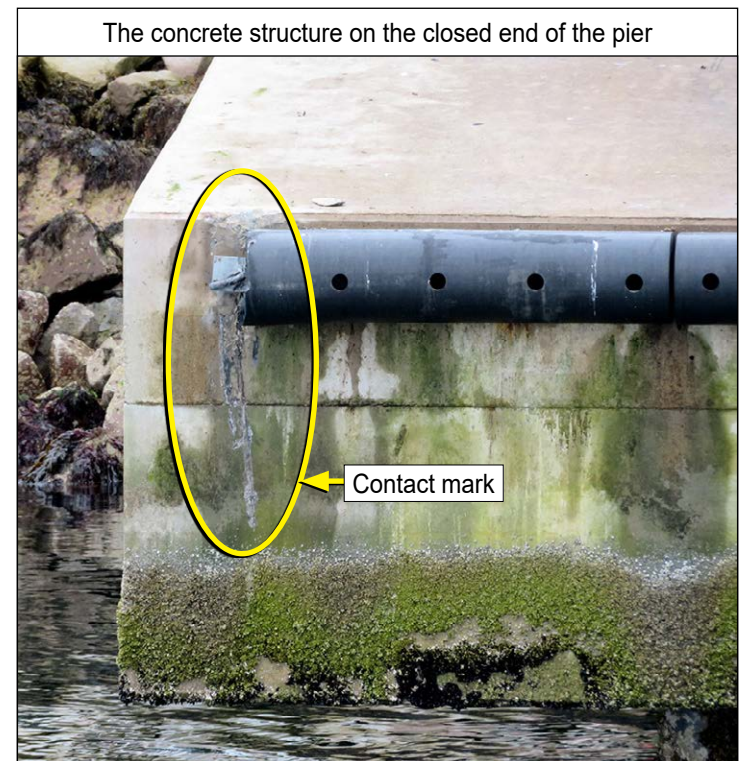
Figure 7: Damage sustained to the vessel's bow and the berth

*Waverley* remained at Brodick pier while temporary repairs were undertaken to the bow and approved by the Maritime and Coastguard Agency (MCA). On 9 September 2020, *Waverley* sailed from Brodick to Glasgow, Scotland for full repair to the bow and remained out of service for the remainder of the 2020 season. *Waverley* returned to service in June 2021, after the MCA had conducted a full assessment of the repairs and directed a set of sea trials.

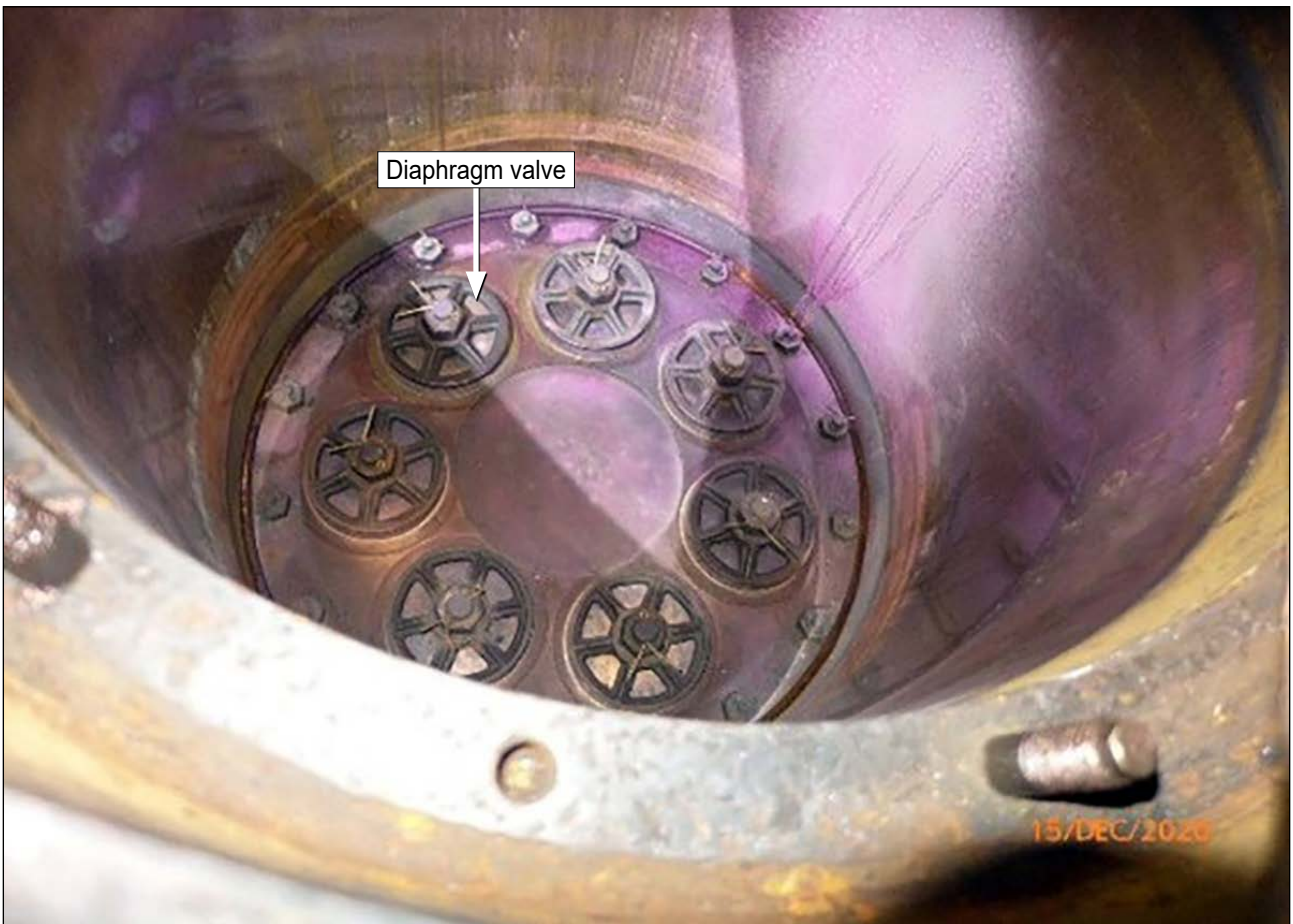
**Figure 12:** Vacuum pump diaphragm valves

- Three of the condenser vacuum pump's 36 diaphragm valves (**Figure 12**) were blocked. This resulted in a vacuum of 796 millibar (mb) rather than 846mb, which reduced the engine's efficiency.
- The locking nuts that secured the HP piston valve to its piston rod were loose (**Figure 13**). The washers in use were not an original design and had probably been introduced to reduce the gap between the end nut and the split pin. The fabricated nature of the washers made tightening the nuts difficult. The loose nuts extended the piston valve's travel by 5.4%, causing the piston valve to open or close prematurely and impacting the engine's timing.

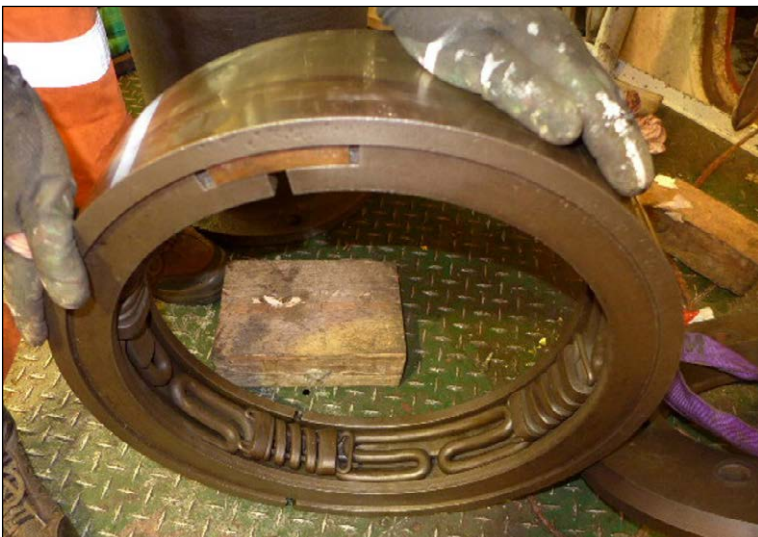
**Figure 14:** Piston valve ring

During the 2015 winter engine overhaul period, *Waverley's* crew had found that the HP piston valve rings (**Figure 14**) were worn and required replacement. New rings were fabricated and installed but these failed after approximately one week as they had been manufactured using an incorrect material. The original piston valve rings were subsequently reinstalled while the correct material was identified and sourced. The original HP piston valve rings were still in place at the time of the accident.
