INTERIM REPORT

VERY SERIOUS MARINE CASUALTY

Interim report on the investigation of the flooding and foundering of the fishing vessel *Freedom II* (CN 111) 11 nautical miles south-west of Oban, Scotland on 21 February 2024

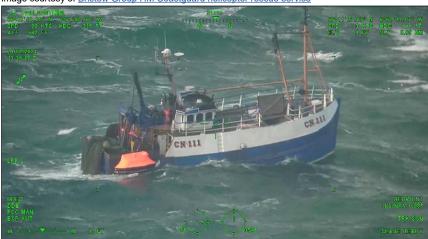
Freedom II with liferaft alongside 2 hours before foundering
