Rail Accident Investigation Branch

Rail Accident Report

Derailment of a passenger train at Roudham Heath, Norfolk 6 February 2024

Report 03/2025
February 2025

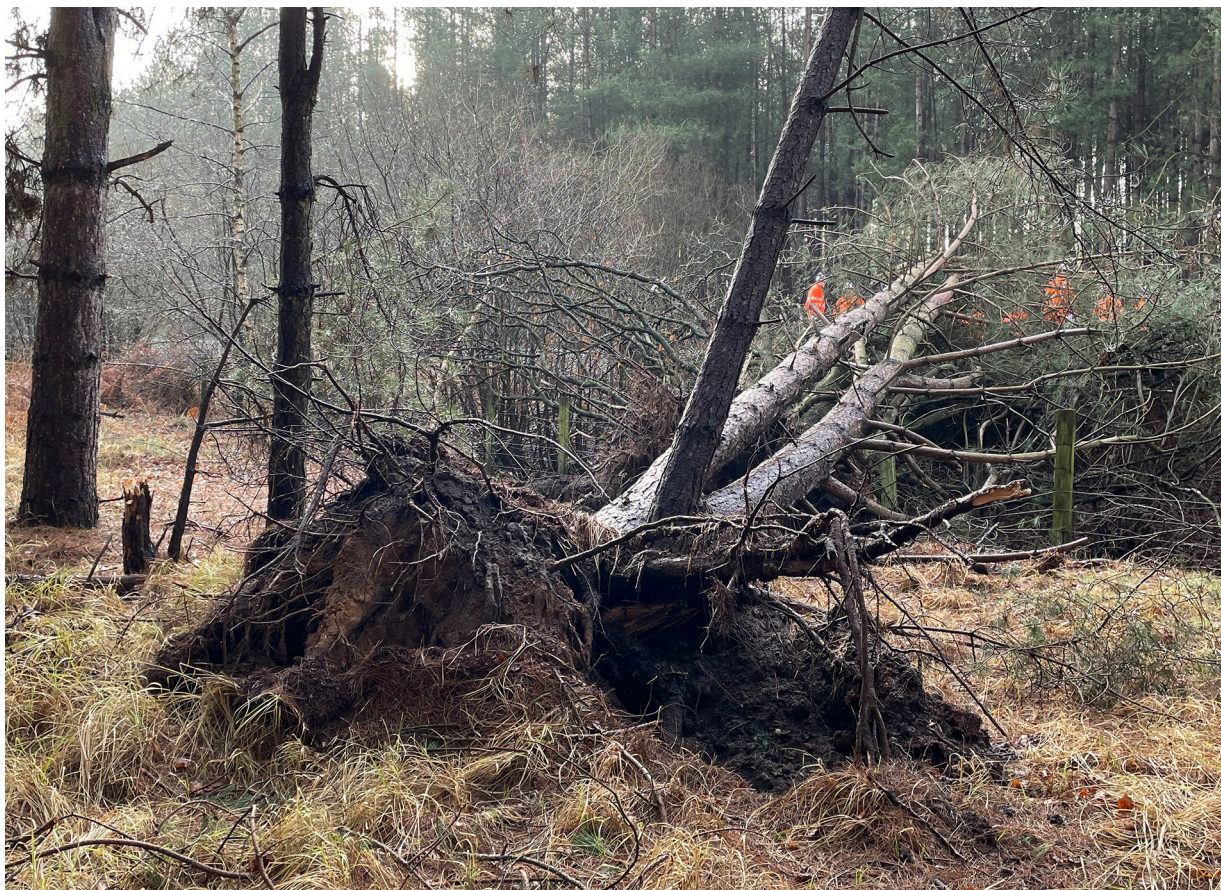
- 50 Examination of the pine tree by the arboriculturist in April 2024 showed many pulled out transport roots (figure 5), indicating this tree failed by the third mode, due to a loss of root anchorage.

- 51 The anchorage available to a tree is a function of the adhesion between its roots and the properties of the soil it is situated in. If the loads applied to a tree exceed the available anchorage, then the tree can begin to move, or even topple.

- 52 The geology at Roudham Heath is typical for this area of East Anglia, being composed of sandy soil over a chalk bedrock. Sand is an inherently non-cohesive soil with poor mechanical properties for tree root adhesion. Excessive water within a non-cohesive soil can reduce its mechanical strength and the ability of a tree root to adhere to it.

Figure 5: The root structure of the pine tree after the accident, showing the many pulled out transport roots.

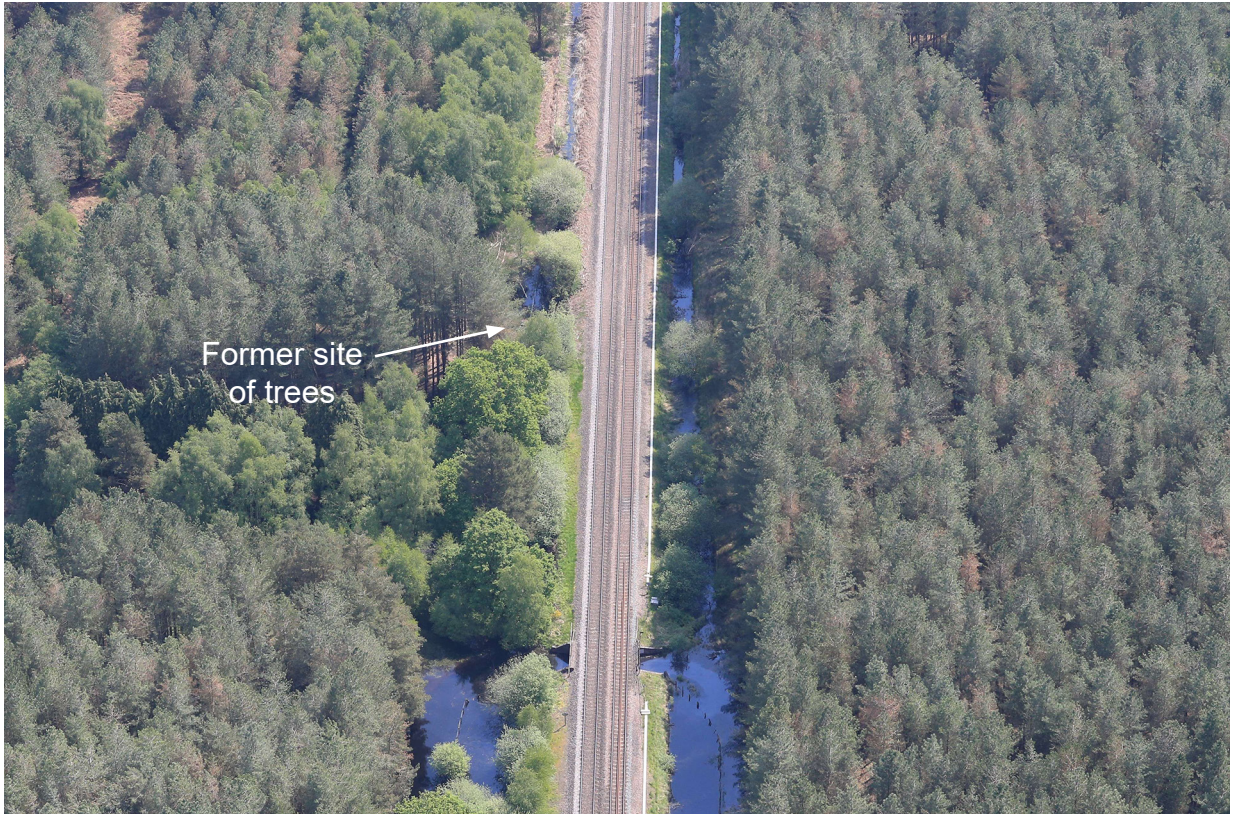
- 53 While the site was not flooded on the day of the accident, it had been raining extensively for around 3 hours before the collision occurred. The area where the tree was located is almost entirely flat, so there is little surface runoff during or following rain. Water is usually dispersed from the site by seepage through the soil to the level of the local water table. While there is a drainage ditch between the railway and the site of the two trees, this has a low flow rate due to the local topography.

Figure 7: The extent of flooding at the site in May 2024, just over 3 months after the accident. The previous location of the pine and oak trees is indicated (courtesy of Network Rail, with RAIB annotations).

- 55 The windspeed at the time the trees fell was not overly high and should not have been sufficient to blow over the pine tree in normal circumstances. The history of high groundwater, together with the onset of heavy rain before the collision, and the failure mode of the pine tree, suggest the primary reason for failure was the saturated nature of the soil the tree was standing in. As the adhesion between the roots and the soil decreased, the available root anchorage of the tree was reduced to a point that the wind load and self-mass of the tree were sufficient to overcome the tree's ability to remain standing.

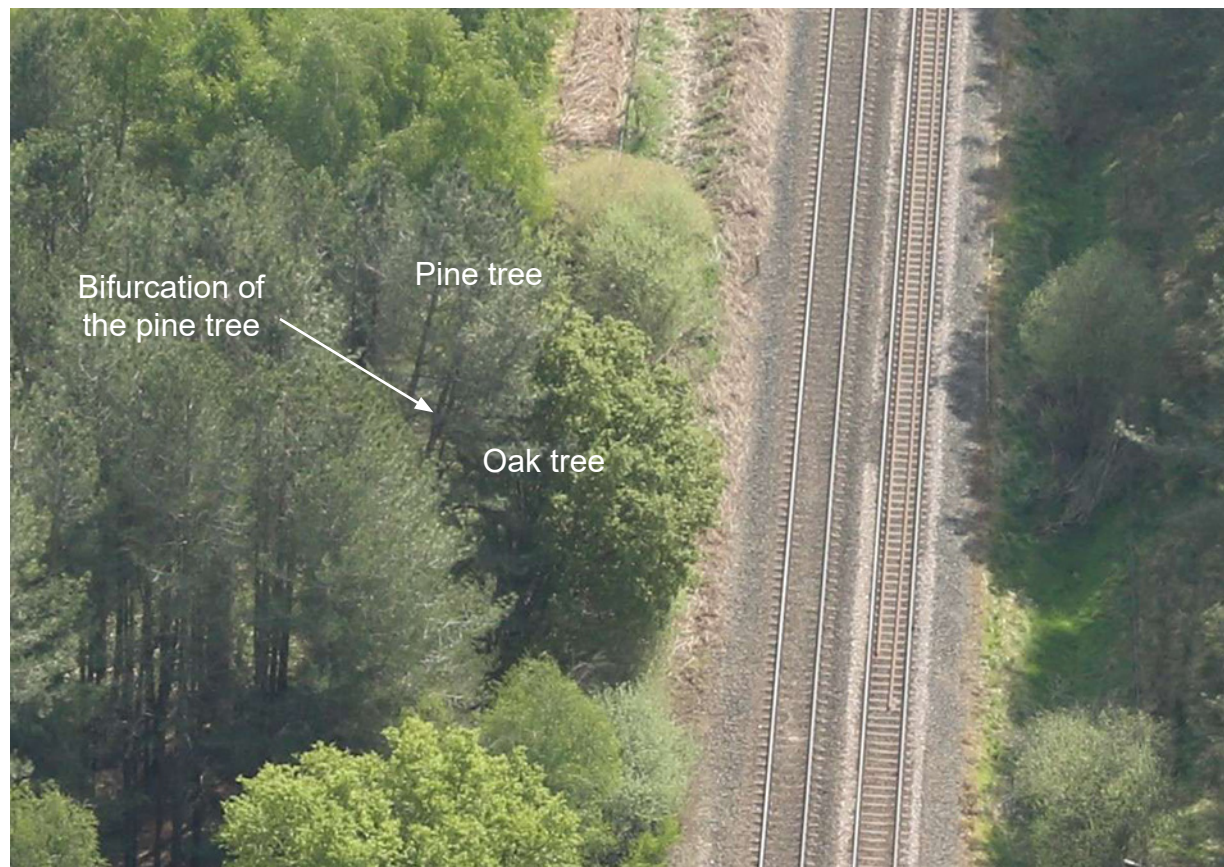
- 58 An aerial image, taken by Network Rail in May 2022, shows the pine tree with its bifurcated stem growing with a bias towards the railway (figure 8). Based on the post-accident inspection of sections of the pine tree, it is believed that this was a characteristic of its growth, and not rotation of the tree about the MAR. Trees will naturally grow to seek out as much light as possible, and the railway corridor offered a clear space for the pine tree to grow towards, away from the proximity of its immediate neighbours.

Figure 8: Aerial view taken in May 2022 showing the bias in the growth of the pine tree. The bifurcation of the pine tree is highlighted (courtesy of Network Rail, with RAIB annotations).

59 This bias meant that when the tree fell it was more likely to fall towards the railway, regardless of the direction of any wind load which was applied, especially in moderate wind speeds such as those on the day of the accident (paragraph 55).

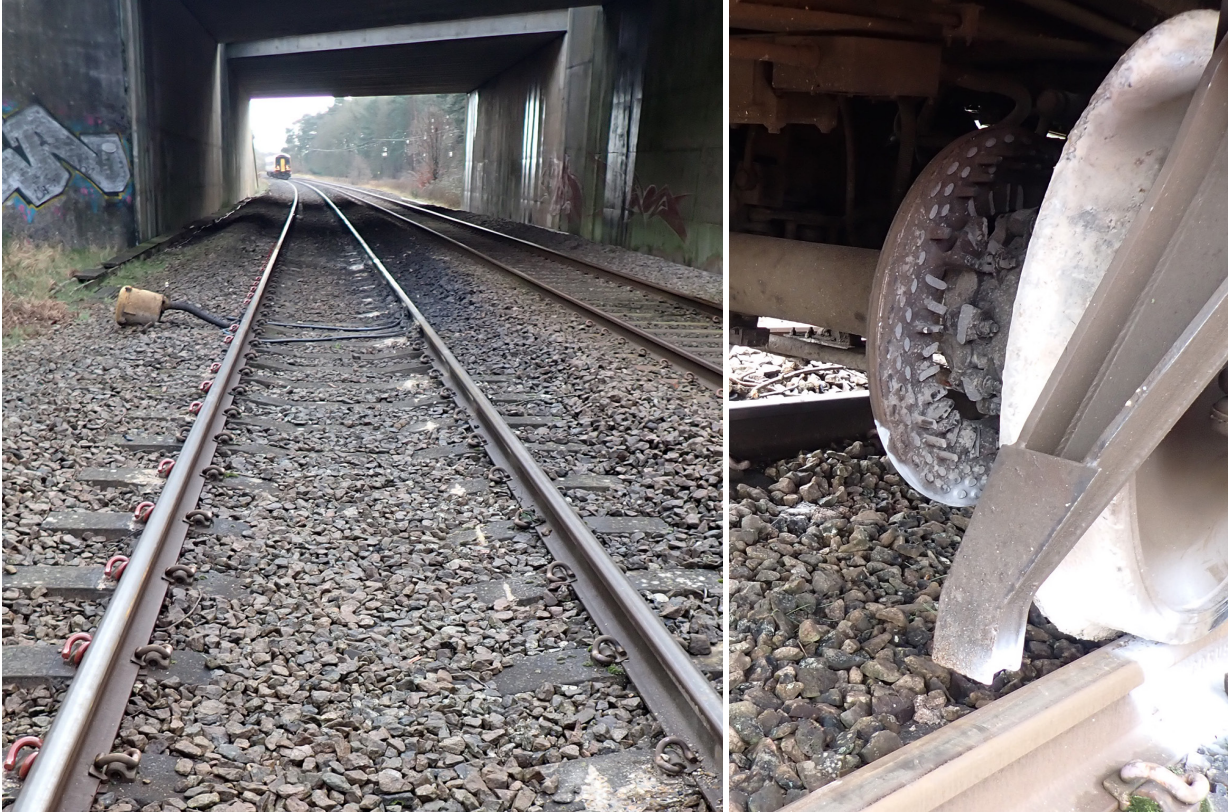
- 87 Each wheelset on a class 158 train is fitted with two axle-mounted brake discs (figure 9). Marks on the rail, sleepers and ballast showed the path that the leading wheels of the train took after the derailment, tending to steer to the left as the left wheel engaged with the sleepers and ballast. These marks are consistent with the movement to the left being limited by the engagement of the left-hand brake disc with the left-hand rail (paragraph 30). This prevented any further lateral movement away from the track centreline, which, unrestrained, could have resulted in the train moving further off the tracks or potentially striking the abutment of the A11 dual carriageway overbridge. Around 60 metres before the train came to a stop, the brake disc broke, eliminating the lateral restraint, and the train began to move slightly further from the track centreline (figure 9).

Figure 9: The train's final stopping position beyond the A11 bridge and the sleeper marks made during the derailment (left) and the remains of the axle-mounted brake disc following the train being rerailed (right).
