# AAIB Bulletin S1/2025

## *SPECIAL*

### Accident

<b>Aircraft Type and Registration:</b>	Rockwell Commander 112 TCA, N4698W	
<b>No &amp; Type of Engines:</b>	1 Lycoming TO-360-C1A6D piston engine	
<b>Year of Manufacture:</b>	1978 (Serial no: 13724)	
<b>Date &amp; Time (UTC):</b>	23 December 2024 at 1135 hrs	
<b>Location:</b>	Kinglassie, Fife	
<b>Type of Flight:</b>	Private	
<b>Persons on Board:</b>	Crew - 1	Passengers - None
<b>Injuries:</b>	Crew - 1 (Fatal)	Passengers - N/A
<b>Nature of Damage:</b>	Aircraft destroyed	
<b>Commander's Licence:</b>	Private Pilot's Licence	
<b>Commander's Age:</b>	50 years	
<b>Commander's Flying Experience:</b>	187 hours (of which 92 were on type) Last 90 days - 19 hours Last 28 days - 0 hours	
<b>Information Source:</b>	AAIB Field Investigation

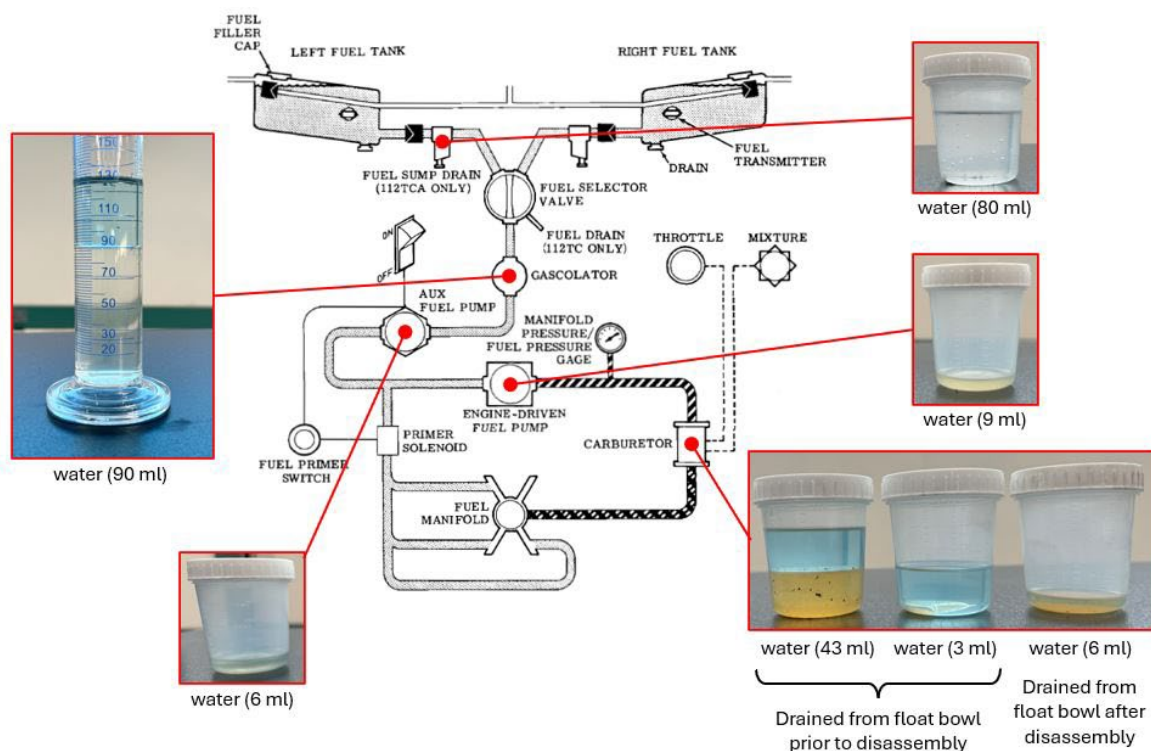
Testing of fuel recovered from the right wing confirmed it met the specification for AVGAS 100LL. Examination of the aircraft and engine fuel system revealed significant water contamination throughout the system downstream of the fuel selector valve and also in the left wheel well sump drain (Figure 1). The volume of water recovered from the carburettor float bowl was sufficient to cover the power jet inlet port in the bottom of the bowl, proving that it was possible for water, rather than fuel, to be drawn into the main nozzle and carburettor venturi.

**Figure 1**  
 Water recovered from the aircraft’s fuel system  
 (fuel system diagram courtesy of Commander Aircraft Corp)

The engine's rough running and loss of power was caused by ingestion of water into the carburettor float bowl, leading to water being fed into the main nozzle. Significant water contamination was present throughout the fuel system downstream of the fuel selector valve and also in the left wheel well sump drain. The cause of water ingress into the fuel system is subject to ongoing investigation.

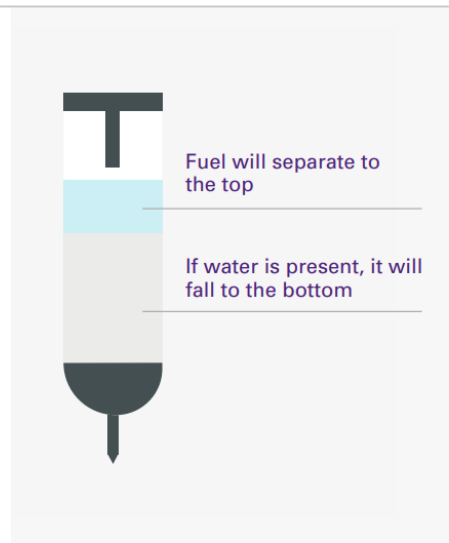
**Figure 2**

The picture illustrates the boundary between a considerable amount of water and the AVGAS. If you see no separation in the sample, confirm that the sample is all water rather than all fuel.

Extract from CAA Safety Sense Leaflet 28

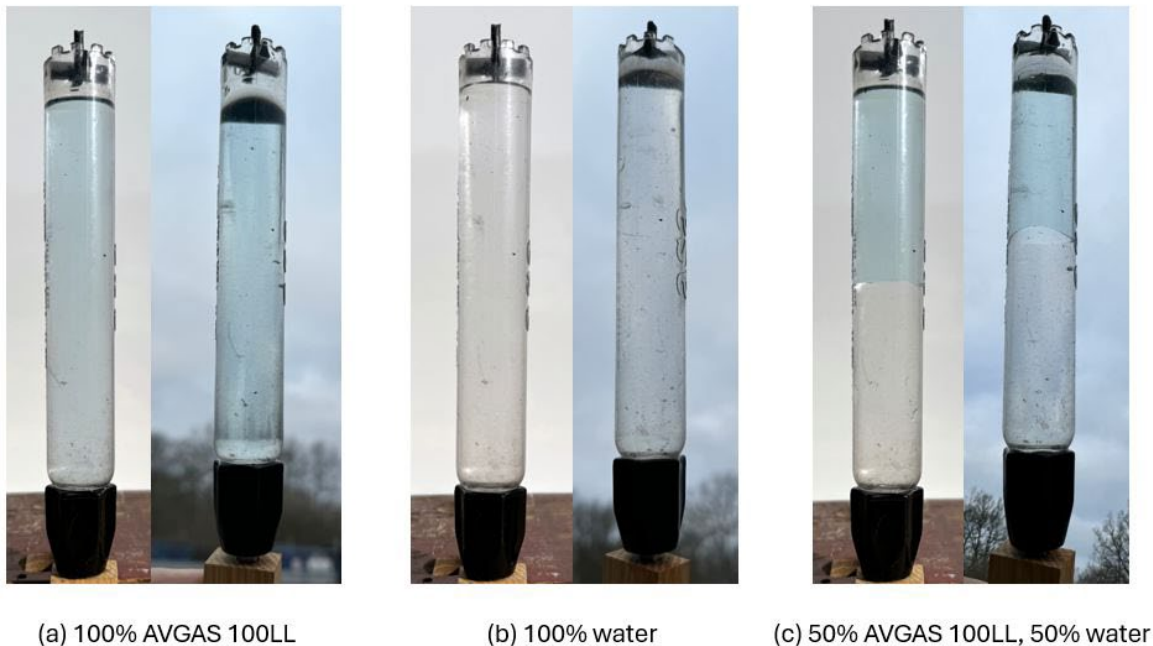
A fuel sample tube found in the aircraft was used in photographs recording differing fuel and water samples held against two different backgrounds (Figure 3). The fuel sample tube has a capacity of 34 ml. It was noted that the 100% water sample, using the sample tube straight after it had been filled with AVGAS 100LL, retained an odour of AVGAS, although it was not as strong as when the tube was filled with AVGAS.

Fuel and water samples photographed against two different backgrounds. Fuel sample tube from N4698W used
