Accident

Aircraft Type and Registration:	Flight Design CTSW, G-CFFJ	
No & Type of Engines:	1 Rotax 912ULS piston engine	
Year of Manufacture:	2008 (Serial no: 8391)	
Date & Time (UTC):	10 October 2024 at 0740 hrs	
Location:	Carlisle Airport, Cumbria	
Type of Flight:	Private	
Persons on Board:	Crew - 1	Passengers - None
Injuries:	Crew - 1 (Serious)	Passengers - N/A
Nature of Damage:	Aircraft destroyed	
Commander's Licence:	Private Pilot's Licence	
Commander's Age:	66 years	
Commander's Flying Experience:	628 hours (of which 85 were on type) Last 90 days - 14 hours Last 28 days - 8 hours	
Information Source:	Aircraft Accident Report Form submitted by the pilot

The aircraft's left cabin door came open in flight shortly after the aircraft became airborne, leading to a loss of control and impact with the ground in which the pilot was seriously injured.

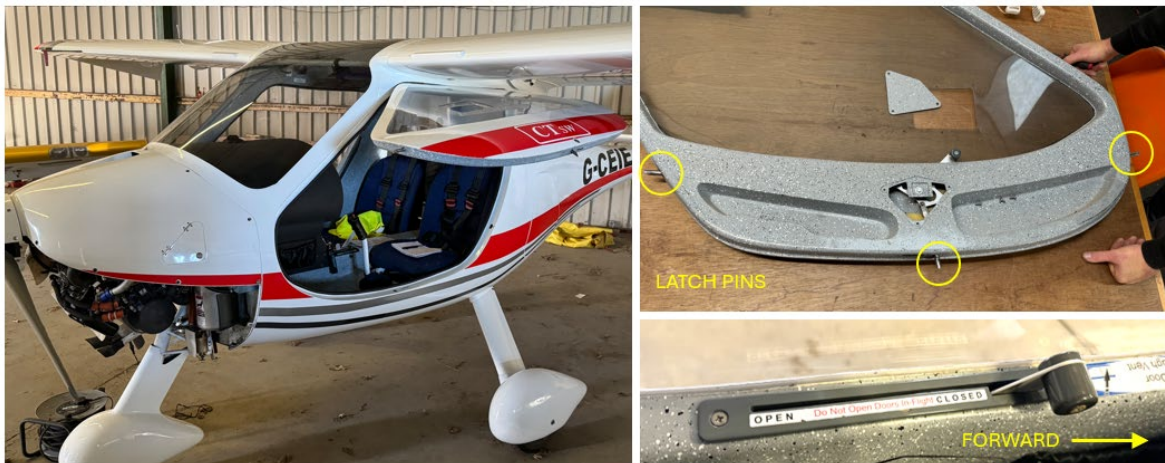
Figure 2

The CTSW is a high-wing, three-axis microlight aircraft with a relatively large cabin door on either side of the fuselage. The cabin doors are of the 'gull-wing' type, hinged along their upper edge and assisted in opening with a gas spring. The door latching mechanism consists of three locking pins actuated by a lever at the lower inside edge of the door. The lever is moved forward to lock the door, and aft to unlock. When moved fully forwards, the lever engages into a detent and a light spring pressure biases the lever to remain in the detent position (Figure 2).

CTSW cabin door features (file photographs)

The aircraft wreckage was examined by the AAIB following the accident, and significant wear was observed to the door latching pins at the point where the pin bears against the door aperture's composite frame when the door is in the closed position. This prompted a survey of three other similar CTSW and CTLS¹ aircraft, which were found to also exhibit similar wear of the door latch pins. The force required to move the door latch lever, from a closed (but with the lever out of the detent) to open position, was measured and found to be in the range 20-30 N. This represented a positive effort to unlatch the door, and the owners of the three aircraft examined stated that none had suffered from uncommanded door opening when the door was latched closed with the lever in the detent position.

The cause of the left cabin door opening during the flight was likely due to it being not fully latched closed, with the latch handle in the closed detent, prior to takeoff. Airframe vibration during the takeoff roll, including that experienced when rolling over joints in the runway's paved surface, probably caused the unlatched lever to migrate sufficiently to allow the door latching pins to disengage from their mating holes in the door aperture frame, allowing the door to open. Once unlatched, opening of the cabin door was assisted by the door gas spring and air loads, causing the rapid door opening experienced by the pilot. The wear observed to the door latching pins was found to be common to other similar aircraft in the fleet and is not considered contributory to the uncommanded door opening.

The aircraft's left cabin door came open in-flight shortly after the aircraft became airborne, leading to a loss of control and impact with the ground in which the pilot was seriously injured. This accident highlights the importance of ensuring that all aircraft hatches and doors are securely closed prior to flight. CAA Safety Sense leaflet 31, '*Distraction and Interruption in General Aviation Operations*²', provides guidance for pilots on the dangers of distraction whilst flying and suggestions for mitigation strategies within a threat and error management (TEM) approach.
