Accident

Aircraft Type and Registration:	Piper PA-28-181, G-EPYW	
No & Type of Engines:	1 Lycoming O-360-A4M piston engine	
Year of Manufacture:	1977 (Serial no: 28-7790557)	
Date & Time (UTC):	14 August 2024 at 1128 hrs	
Location:	Rochester Airport, Kent	
Type of Flight:	Private	
Persons on Board:	Crew - 1	Passengers - None
Injuries:	Crew - None	Passengers - N/A
Nature of Damage:	Damaged beyond economic repair	
Commander's Licence:	Other	
Commander's Age:	79 years	
Commander's Flying Experience:	155 hours (of which 155 were on type) Last 90 days - 7 hours Last 28 days - 3 hours	
Information Source:	Aircraft Accident Report Form submitted by the pilot, R/T transcription provided by the Flight Information Services Officer, plus further enquiries

Synopsis

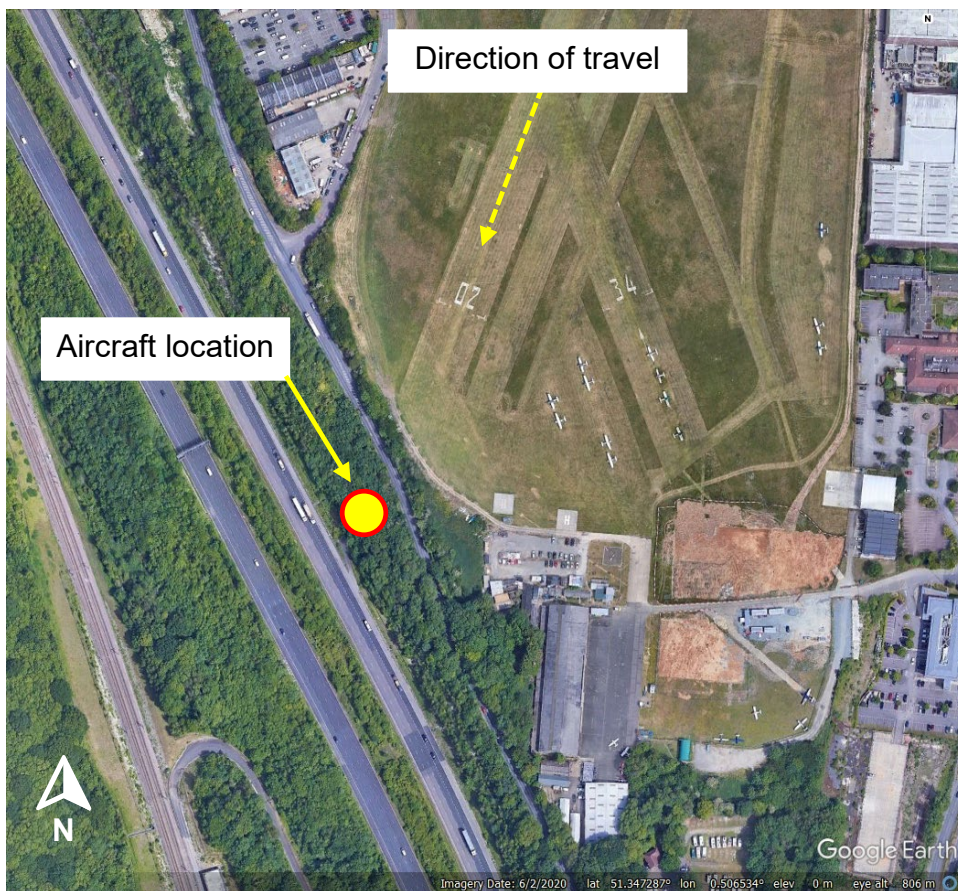
The wooded embankment was located to the south of the airfield boundary, and sloped steeply downwards towards a motorway, see Figure 1 for an image showing the final location of the aircraft

Final location of the aircraft

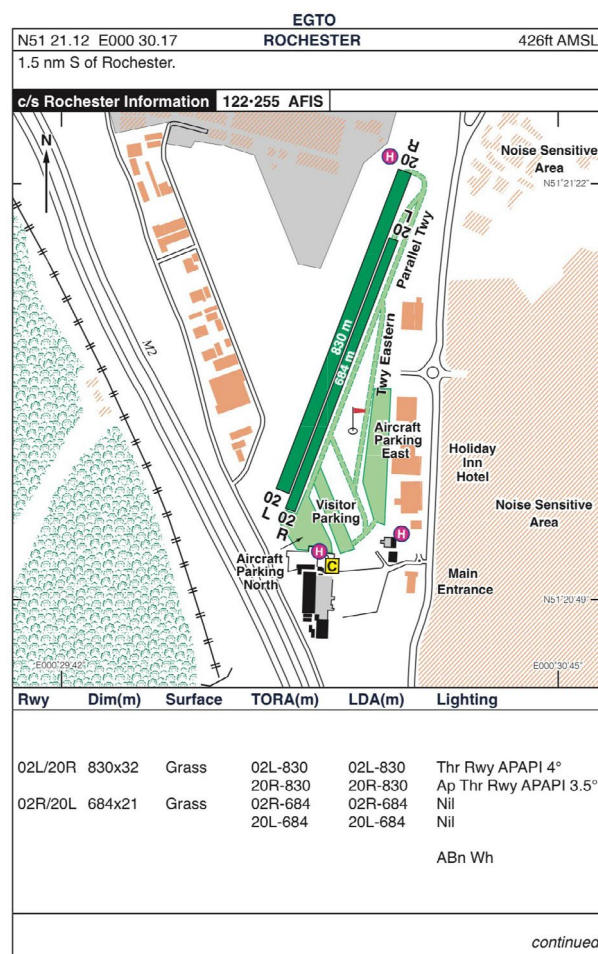
Figure 5

Rochester Airport's main grass runway 02/20 has 830 m landing distance available (Figure 5). The standard circuit pattern is bounded by the River Medway to the West and North. The airport offers an AFIS provided by licensed FISOs for the purpose of giving advice and information useful for the safe and efficient conduct of flights.

Rochester Airport plate (courtesy Pooley's)

The landing distance available at Rochester was sufficient for G-EPYW to land, using the CAA factors for grass and general safety, if the aircraft was configured at 66 kt and with 40° of flap. However, with a ground speed at the flare of 91 kt and touchdown point of 190 m, it is unlikely the aircraft could have stopped in the distance available.
