# ***AAIB Bulletin***

***3/2025***

Published by the Air Accidents Investigation Branch, Department for Transport

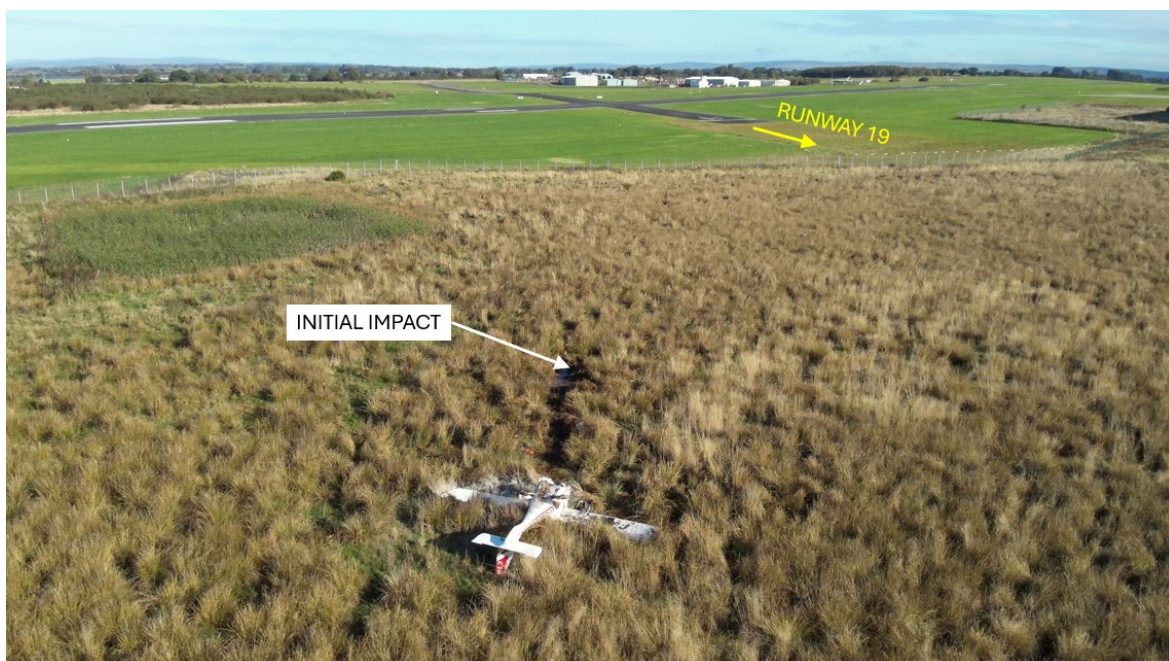
**Figure 1**

The pilot pitched the aircraft nose down and applied full power, however there was insufficient height for a recovery and the aircraft struck an open area of soft ground outside the airport perimeter fence (Figure 1). The pilot received serious facial injuries and fractures to his right foot. No fire occurred and a combination of airport staff and local emergency response vehicles quickly attended the accident site.

G-CFFJ accident site (image courtesy of Cumbria Police)

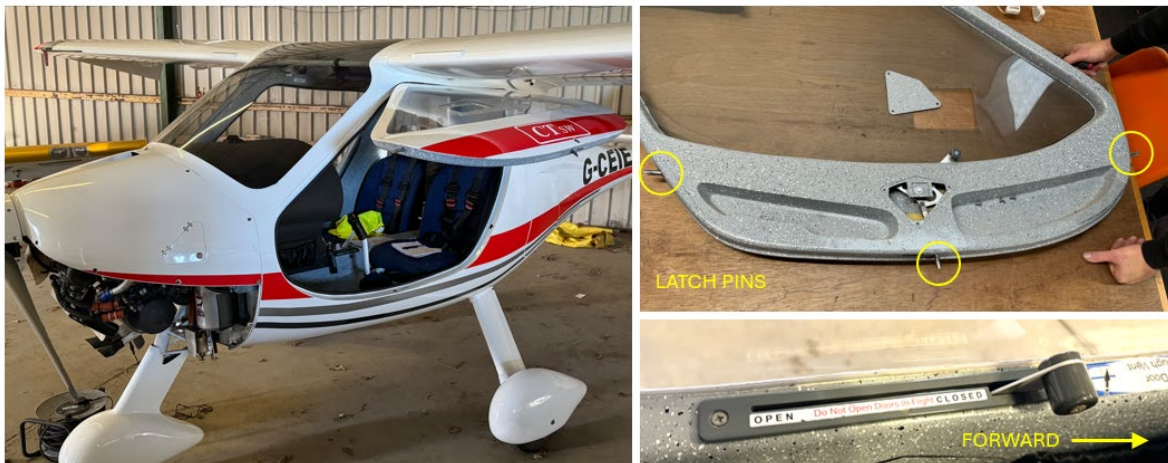
**Figure 2**

The CTSW is a high-wing, three-axis microlight aircraft with a relatively large cabin door on either side of the fuselage. The cabin doors are of the 'gull-wing' type, hinged along their upper edge and assisted in opening with a gas spring. The door latching mechanism consists of three locking pins actuated by a lever at the lower inside edge of the door. The lever is moved forward to lock the door, and aft to unlock. When moved fully forwards, the lever engages into a detent and a light spring pressure biases the lever to remain in the detent position (Figure 2).

CTSW cabin door features (file photographs)

The aircraft wreckage was examined by the AAIB following the accident, and significant wear was observed to the door latching pins at the point where the pin bears against the door aperture's composite frame when the door is in the closed position. This prompted a survey of three other similar CTSW and CTLS<sup>1</sup> aircraft, which were found to also exhibit similar wear of the door latch pins. The force required to move the door latch lever, from a closed (but with the lever out of the detent) to open position, was measured and found to be in the range 20-30 N. This represented a positive effort to unlatch the door, and the owners of the three aircraft examined stated that none had suffered from uncommanded door opening when the door was latched closed with the lever in the detent position.

The cause of the left cabin door opening during the flight was likely due to it being not fully latched closed, with the latch handle in the closed detent, prior to takeoff. Airframe vibration during the takeoff roll, including that experienced when rolling over joints in the runway's paved surface, probably caused the unlatched lever to migrate sufficiently to allow the door latching pins to disengage from their mating holes in the door aperture frame, allowing the door to open. Once unlatched, opening of the cabin door was assisted by the door gas spring and air loads, causing the rapid door opening experienced by the pilot. The wear observed to the door latching pins was found to be common to other similar aircraft in the fleet and is not considered contributory to the uncommanded door opening.

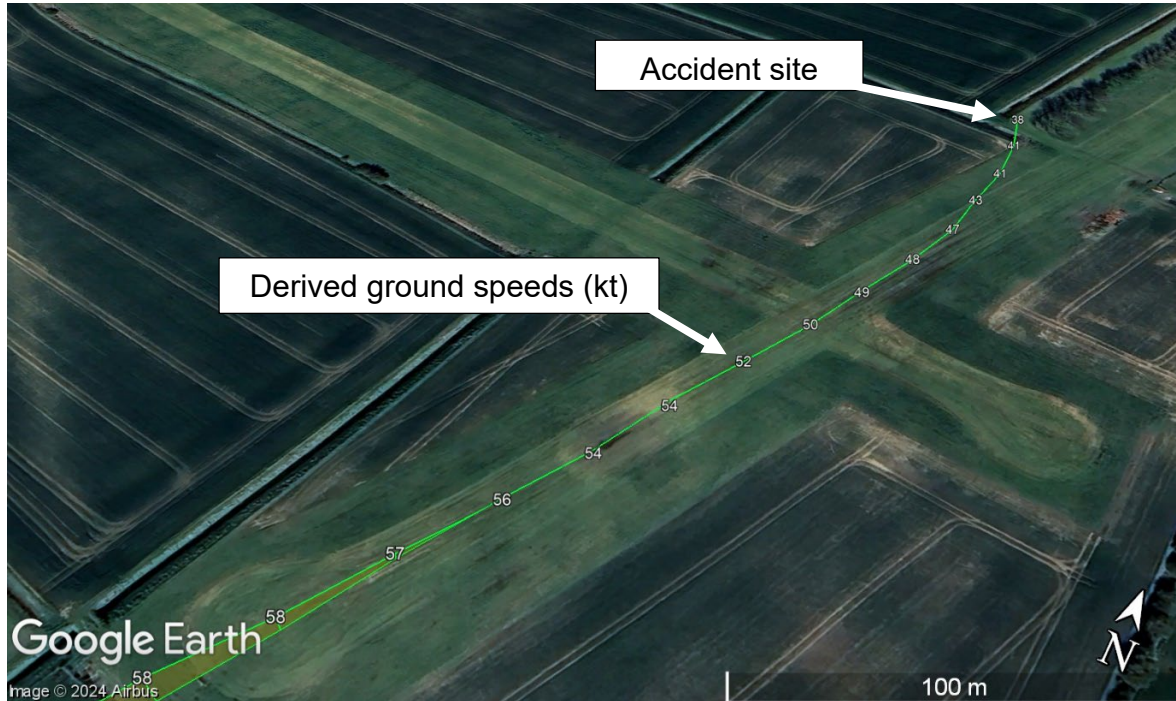
**Figure 1**

The aircraft touched down just before the runway intersection and after approximately 100 m it started to veer to the left. It left the mown grass runway into some long grass and continued towards a drainage ditch that ran perpendicular to the runway (Figure 1).

G-BAXZ path data extracted from an aviation app running on pilot's tablet showing landing and subsequent runway excursion

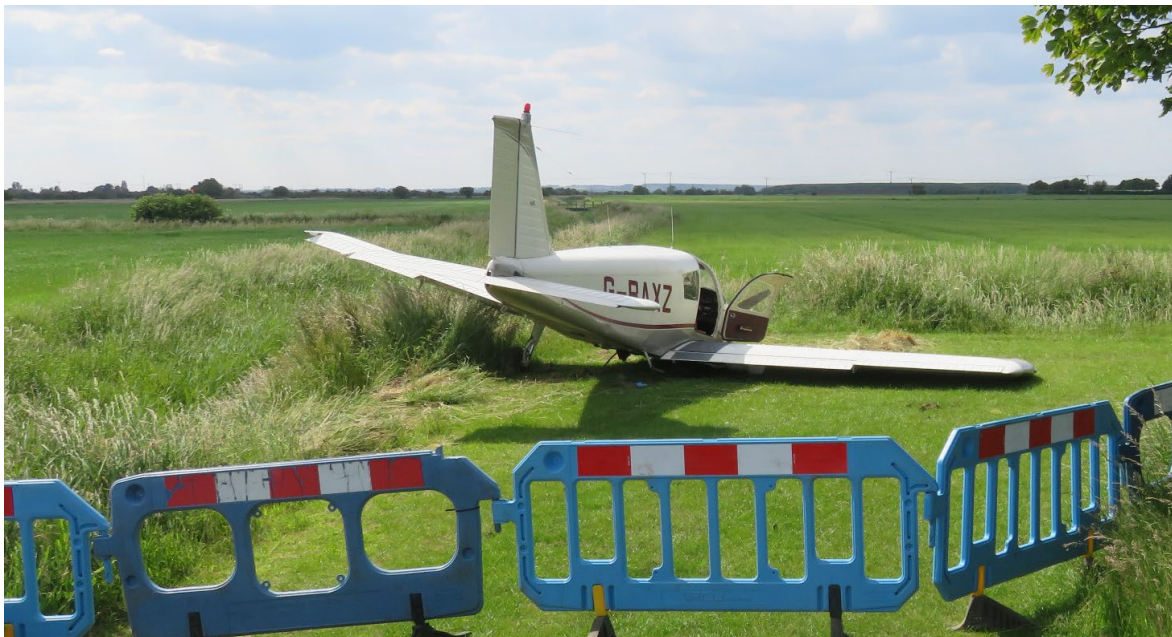
**Figure 2**

The aircraft entered the ditch and then struck the far side of it at approximately 45°, causing deformation of the fuselage and the right main landing gear and nose landing gear to collapse, before coming to rest next to the ditch (Figure 2).

G-BAXZ final location (note: portable barriers erected after the accident)

An assessment of the aircraft by the AAIB found that the aircraft fuselage had been deformed by the accident such that the door would not fit the frame. The sprung latch functioned normally, but the pin mounted in the top of the door frame onto which the hook engages had been pulled out. The door stay had also broken so that the door could open beyond its normal range.

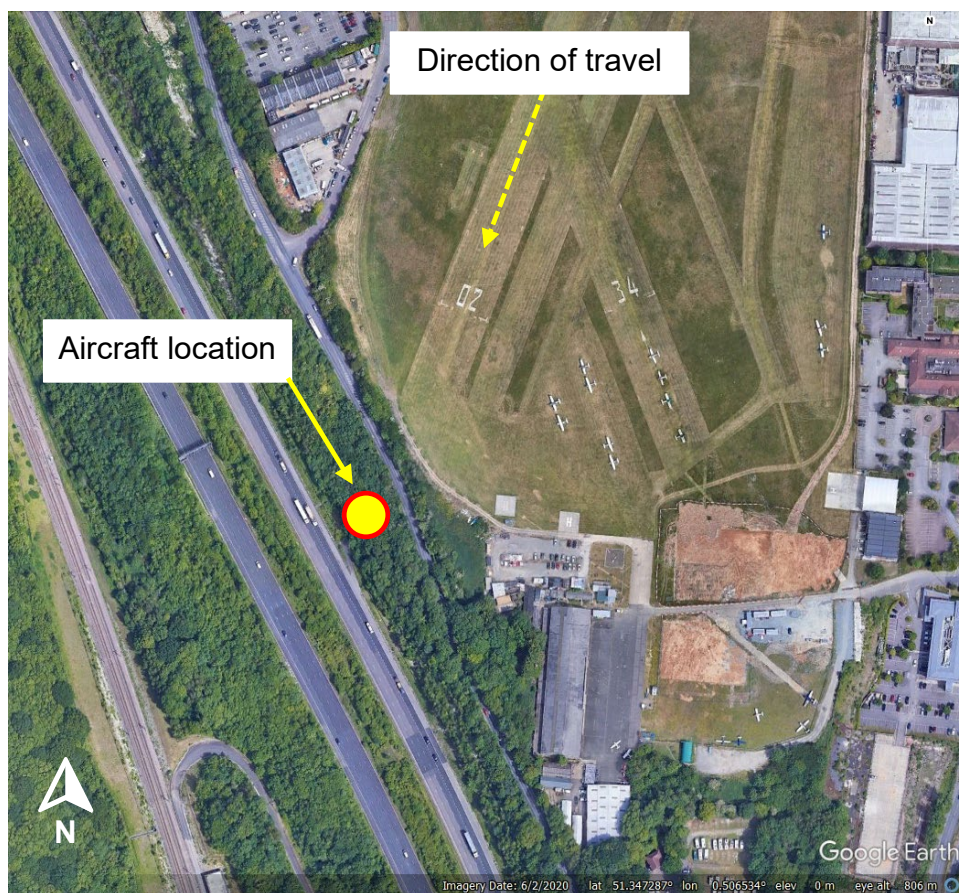
**Figure 1**

The wooded embankment was located to the south of the airfield boundary, and sloped steeply downwards towards a motorway, see Figure 1 for an image showing the final location of the aircraft

Final location of the aircraft

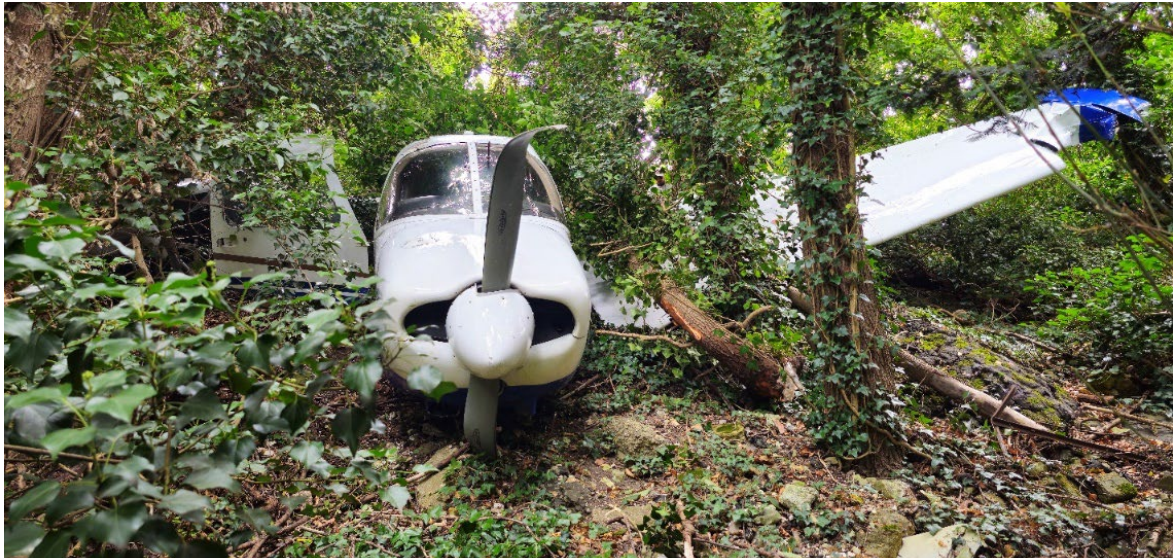
Both of the aircraft's wings had struck trees, and had detached from the fuselage which resulted in a fuel leak (Figure 2).

**Figure 2**  
G-EPYW accident site

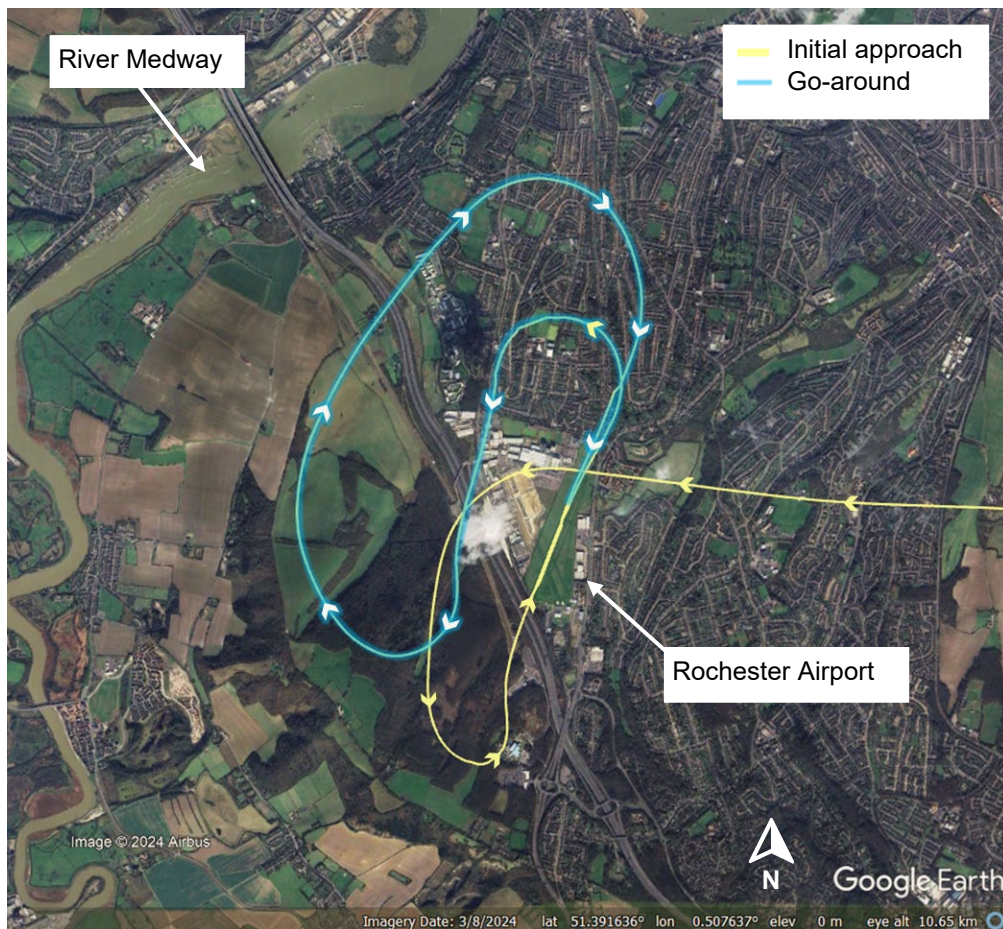
**Figure 3**  
G-EPYW flight path

The pilot was using a flight-planning and navigation application, from which position data, altitude and ground speed were downloaded. Due to the low wind speed, the ground speed data is a good approximation of the aircraft's airspeed. After the go-around, the pilot repositioned by turning through 180° for Runway 20, climbing to a maximum height of 1,978 ft amsl over higher ground to the south-west of the airport (Figure 3).
