# ***AAIB Bulletin***

# ***2/2025***

## **AAIB Correspondence Reports**

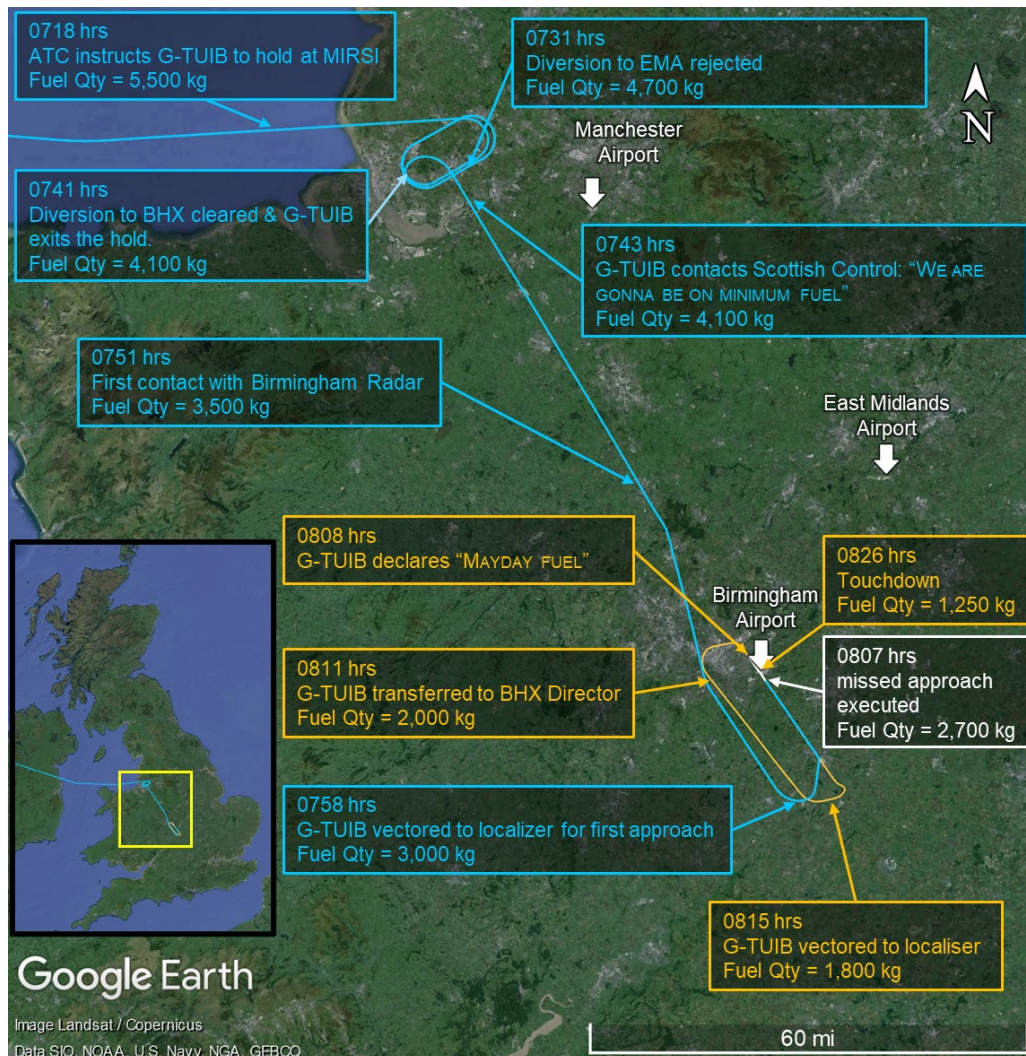
**Figure 1**

G-TUIB recorded ground track annotated with significant events

The Pilot Monitoring (PM) contacted Manchester Radar at 0718 hrs. The controller instructed the crew to hold at MIRSI, and that seven aircraft were ahead in the hold. When the crew asked the length of delay they should expect, the controller responded that there was a queue of arrivals awaiting improvements in the wind and that it was not possible to provide an Expected Approach Time (EAT) since the delay was not known. The runway in use was Runway 23R and the controller reported a surface wind of 280° at 28 kt, with gusts up to 41 kt<sup>1</sup>.

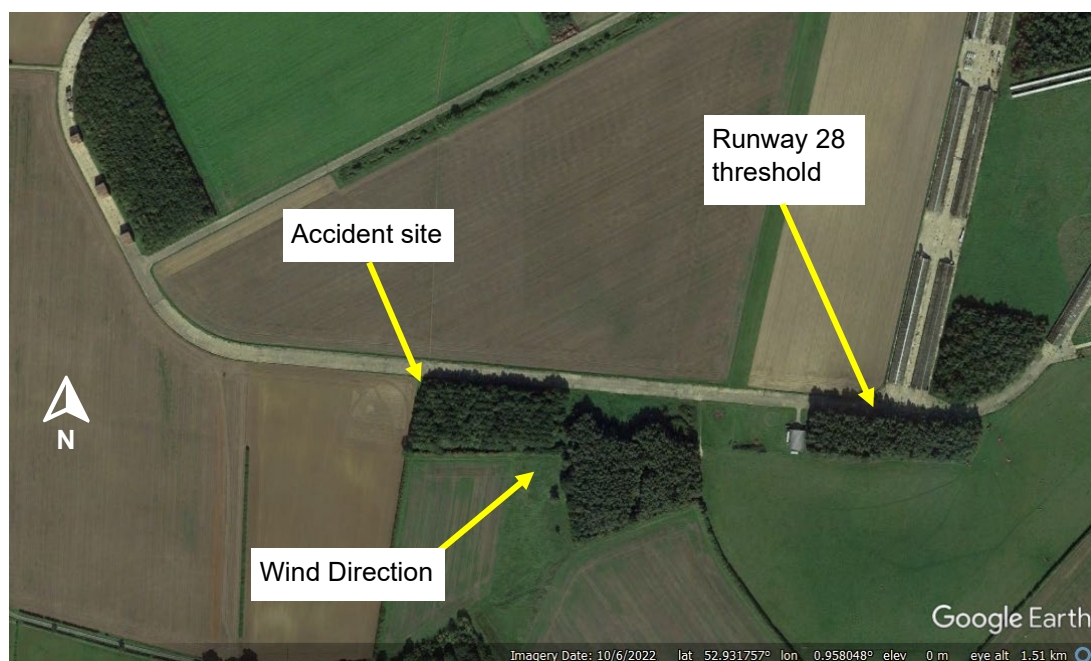
**Figure 1**

N33NW came to rest just inside the far edge of a wood, approximately 460 m from the threshold of Runway 28 (Figure 1). The left wing and engine had separated from the fuselage, causing a fuel leak. The aircraft’s tail section including horizontal stabiliser and fin was attached but had been severely damaged in the accident sequence. The passenger cabin remained largely intact.

Accident site location

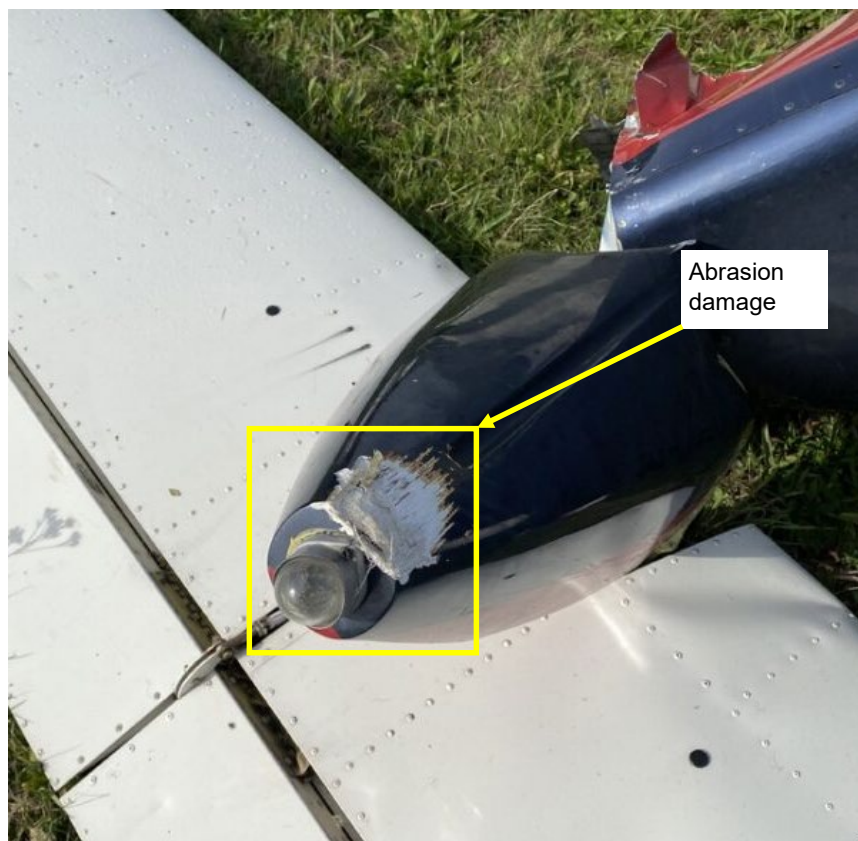
**Figure 3**

The underside of the tail cone had abrasion damage consistent with the tailcone being in contact with the runway during a tailstrike rather than impact damage with trees. (Figure 3) The pilot confirmed the damage was not present prior to the flight.

Tailstrike damage to the underside of the tailcone

During the takeoff or the early climb it is likely that the tail struck the concrete runway as the pilot did not recall having seen the damage prior to flight. The pilot subsequently disagreed with this analysis, but the evidence still suggests this is a contributory factor to the accident. The passengers remembered feeling as if the aircraft had hit something or been caught by a gust of wind as it took off, but neither the passengers or pilot were aware of a tailstrike. It is probable that as the aircraft became airborne it encountered some form of turbulent air in the lee of the trees from the crosswind. As the pilot applied corrective control inputs, the combination of encountering turbulent air and a tailstrike is likely to have led to the aircraft entering an unstable climb.

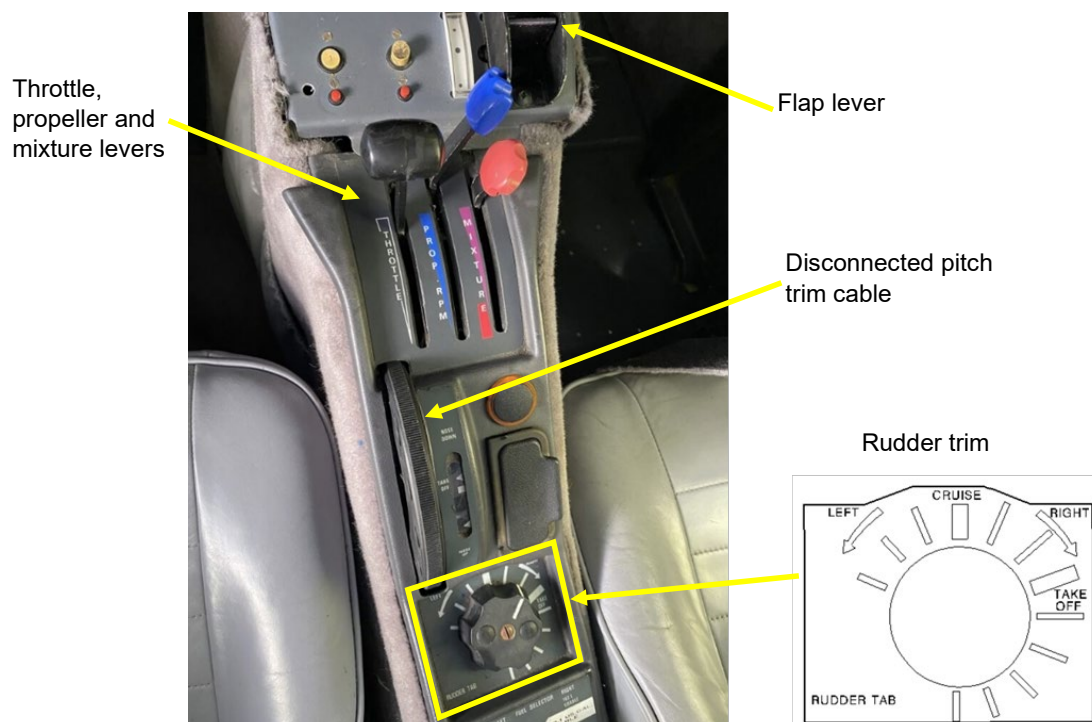
**Figure 4**

Control positions post-accident

Damage to the propeller indicated that it was under power at the time of the accident, and the throttle, propeller rpm and mixture levers were all fully forward which are the normal positions for takeoff (Figure 4).

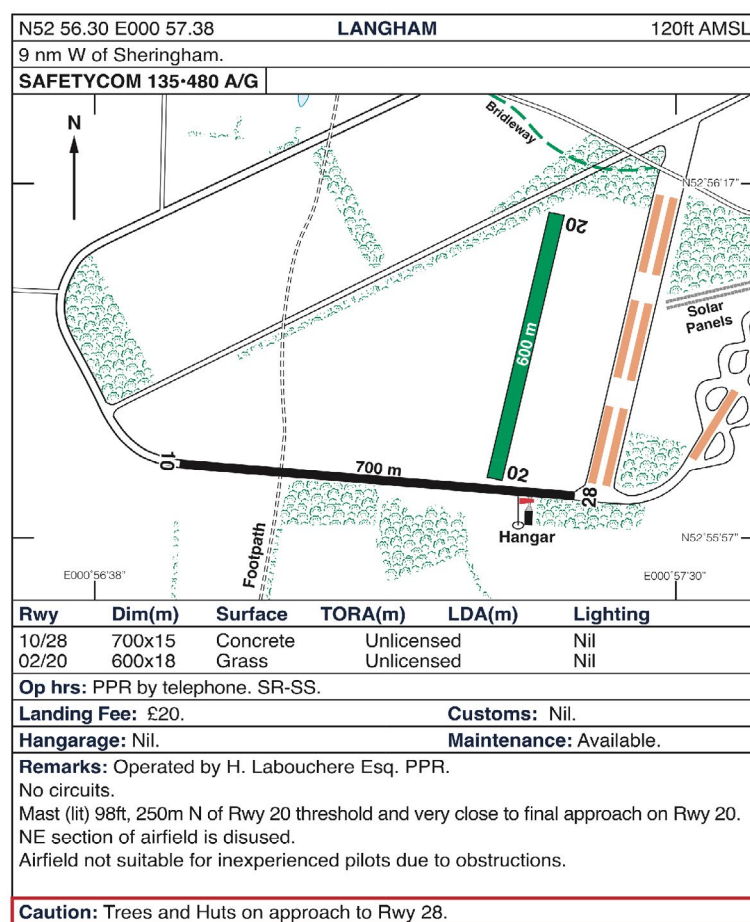
**Figure 5**  
Langham airfield plate (Pooley's Flight Guide)

Runway 10/28 is lined by tall trees along much of its southern side (Figure 5). The trees at the runway's mid-point are approximately 9 to 10 m tall and are 3 m from the runway's edge, while those at the threshold of Runway 28 are in excess of 20 m tall.

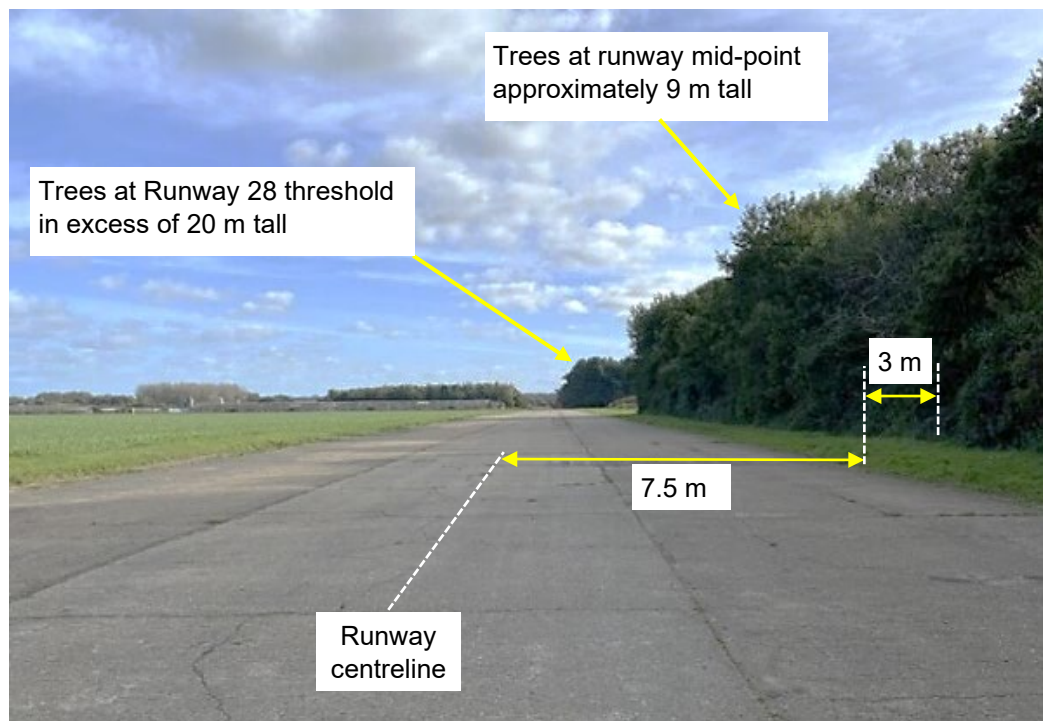
**Figure 6**

View along Runway 10, towards the threshold of Runway 28

The distance between the left wingtip and the trees was 5.5 m with the aircraft on the runway centreline. This is less than the minimum distance recommended within CAP 793 which, although not mandatory, would have been 15 m. The aircraft was seen to drift left after becoming airborne, it is possible that the rudder trim position set to approximately half the manufacturer's TAKE OFF setting was contributory, but it was not possible to confirm the cause. During the climb the margin between the wingtip and the trees was then reduced to an extent that the pilot was unable to recover the aircraft's position before striking the trees.

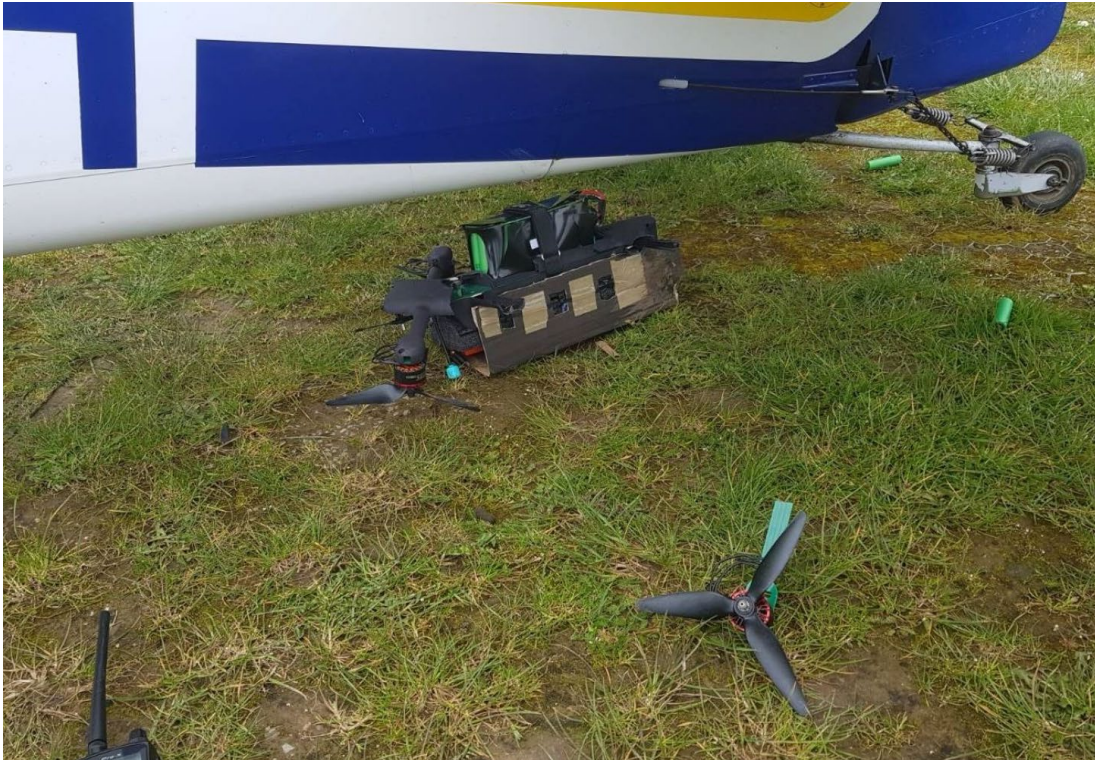
**Figure 2**

The UA was found beneath a parked aircraft (Figure 2) about 230 m from the launch site, and about 50 m outside of the geofence normally used by the operator for flights at this location. The UA was damaged beyond economic repair and there was minor scratching to the aircraft.

The UA at the accident site, beneath a parked and unoccupied aircraft

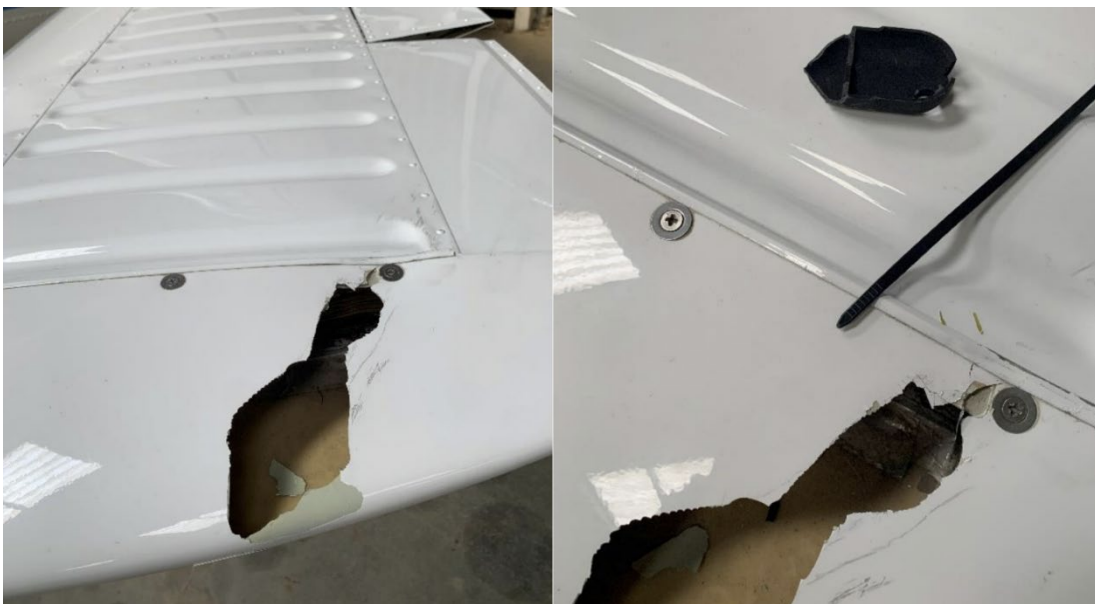
**Figure 3**

Damage was later found to another parked aircraft, which was near to the aircraft partly seen in Figure 2. There was a hole in the outboard edge of the left horizontal tailplane, and a small component from the UA was found inside it (Figure 3).

Damage to the second parked aircraft (left), with debris removed belonging to the UA (right)
