Accident

Aircraft Type and Registration:	ATR 72-212 A, G-CMJM	
No & Type of Engines:	2 Pratt & Whitney Canada PW127M turboprop engines	
Year of Manufacture:	2017 (Serial no: 1464)	
Date & Time (UTC):	31 October 2023 at 0917 hrs	
Location:	On departure from Edinburgh Airport	
Type of Flight:	Commercial Air Transport (Passenger)	
Persons on Board:	Crew - 4	Passengers - 55
Injuries:	Crew - None	Passengers - None
Nature of Damage:	Fractured nose landing gear axle	
Commander's Licence:	Airline Transport Pilot's Licence	
Commander's Age:	61 years	
Commander's Flying Experience:	9,530 hours (of which 150 were on type) Last 90 days - 148 hours Last 28 days - 54 hours	
Information Source:	AAIB Field Investigation

Synopsis

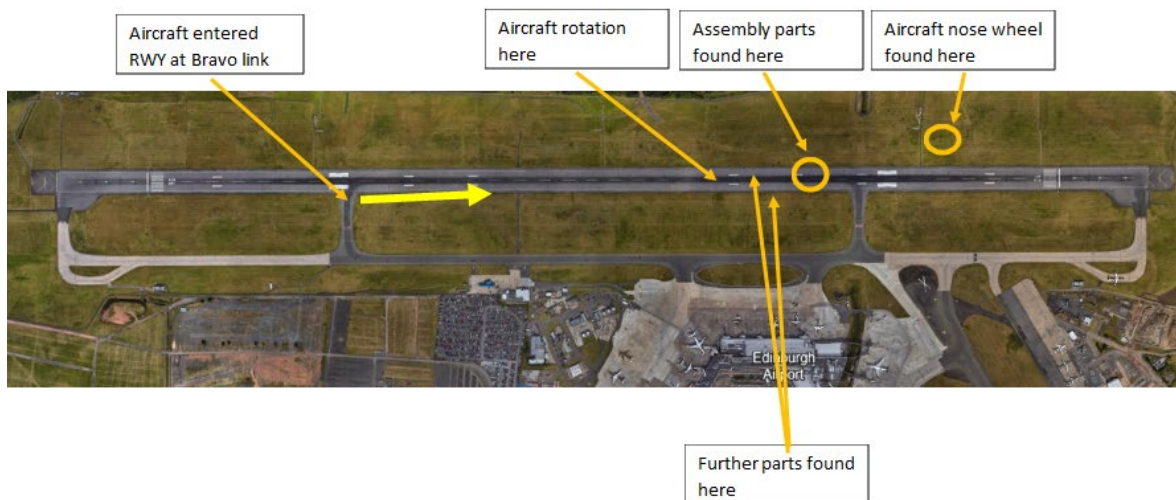
Figure 1

The nosewheel separated from the aircraft during takeoff from Edinburgh Runway 06 (Rwy 06) (Figure 1). It would not have been easily visible to persons in the control tower and was evident on the surface movement radar for only a couple of seconds before traversing off the side of the runway.

Location of recovered nosewheel components

All components related to the detached nosewheel including the wheel axle nut were recovered. The locations at which the detached components were found at Edinburgh are as shown (Figure 1). There was no damage to the airport infrastructure reported.

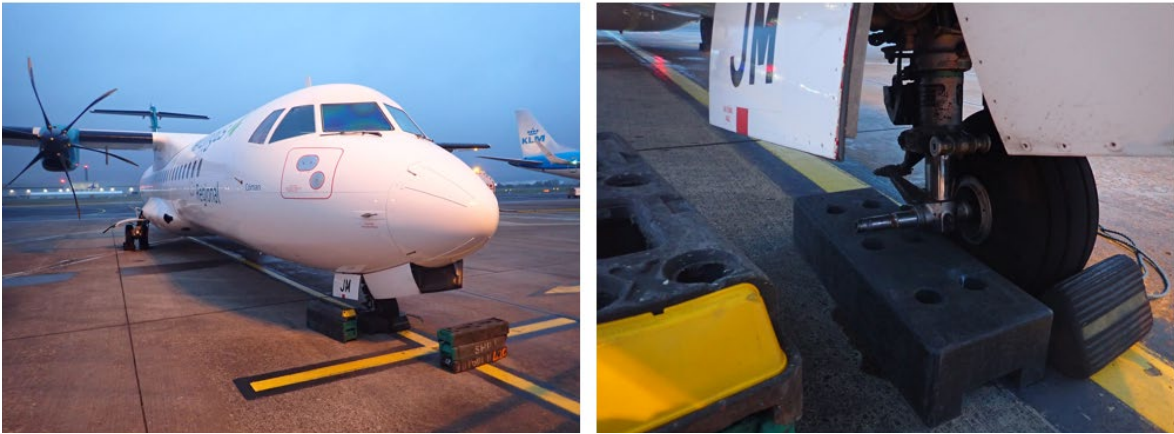
Figure 2

Following an ILS approach (which overflies the city of Belfast) to Rwy 04, the aircraft taxied uneventfully to its normal operational stand. Whilst the aircraft remained stable, additional support was provided to the nosewheel to provide increased support against the wind (Figure 2).

The aircraft as quarantined at Belfast City Airport

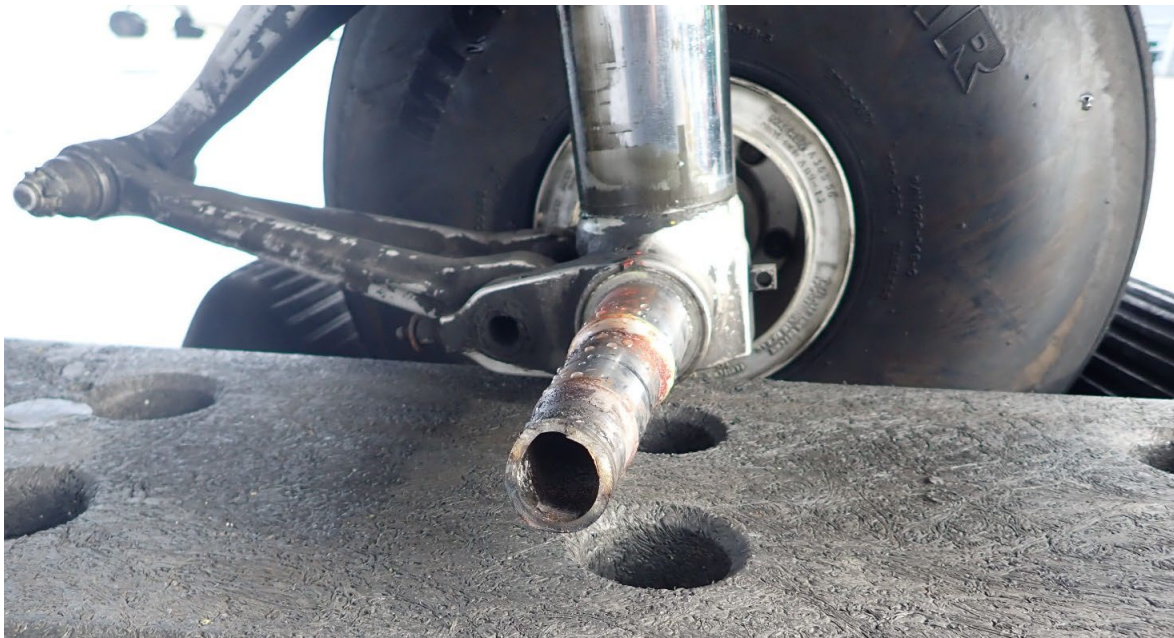
Figure 3

The nose leg gear axle was sheared off and showed evidence of heat damage (Figure 3). Extensive checks of the aircraft nose landing gear bay showed no signs of other damage or fluid leakage. A detailed inspection of the aircraft structure and engines revealed no damage due to the release of the nosewheel. There was no hard landing or abnormal runway contact reported by flight crews during the flight when the wheel was lost or on previous flights.

G-CMJM fractured nose landing gear axle

Inspection of the failed components indicated exposure to high temperatures which were consistent with a wheel bearing failure event. Laboratory analysis for the failed axle did not identify the precise region of crack initiation but the metallurgical analysis of the axle indicated that the thermal shock and evidence of cadmium liquid metal embrittlement both likely contributed to the complete fracture of the axle.

The right NLG wheel detached from the aircraft because the axle on which it is located fractured. The axle fractured due to overheating of the bearing in the wheel which caused a combination of thermal shock and liquid cadmium embrittlement. The cause of the bearing overheating could not be positively determined, but inspection of the failed components identified a number of factors that could have contributed. These included over greasing of the inner and outer bearings, the lack of wheel balancing weights and the application of an interposition product between the mating faces of the two half-wheels which can cause the tie bolts to loosen. The manufacturer of the nose leg gear assembly highlighted the importance of adherence to the AMM and CMM by aircraft maintainers and component repair/maintenance facilities respectively to ensure safety. As well as providing access to the aircraft and component technical publications for wheels and brakes on the ATR 72, the manufacturer's maintenance portal also contains in-service experience advice for operators and MROs.

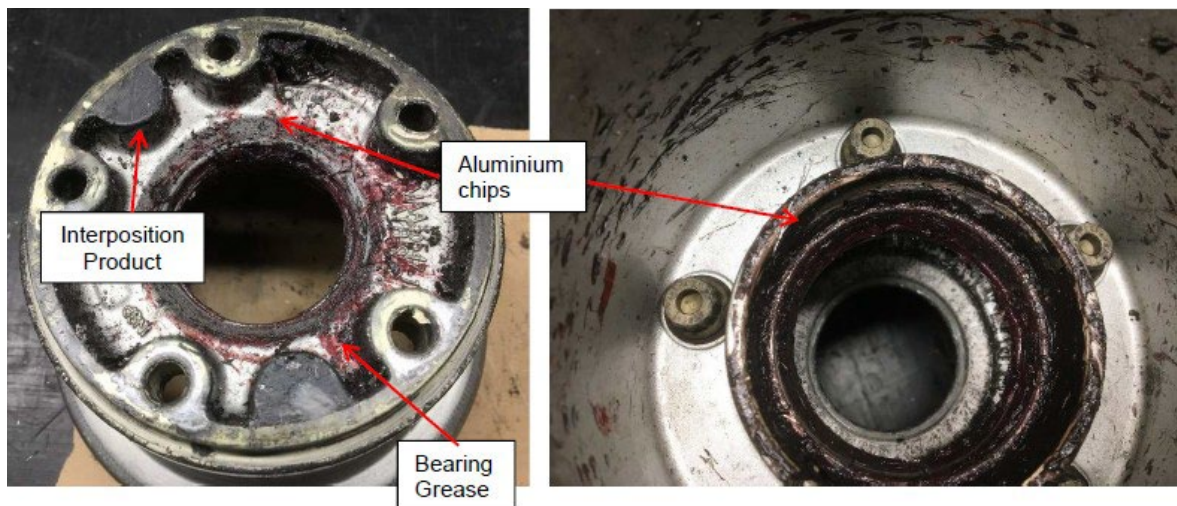
Figure 5

- The right NLG wheel assembly was found assembled with all tie bolts loose.
- No balancing weights were found fitted on either the outer or inner half-wheel sections¹.
- The outer half wheel hub was found fractured.
- There was an interposition product found on the mating faces of the two half-wheels (Figure 5); this product is not allowed in this area² as it can lead to micro displacements of the two faces and tie-bolt loosening.
- Evidence of bearing grease indicated over-greasing of both bearings.

Inner half wheel condition (image used with permission)

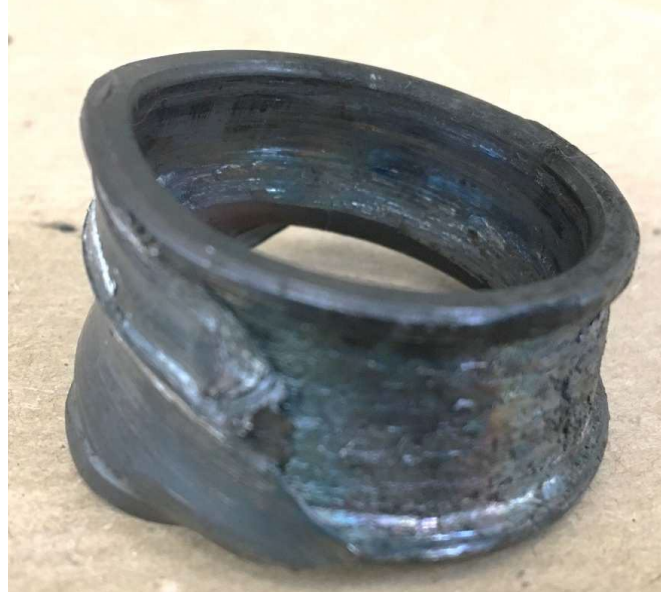
Figure 6

- Outer bearing assembly. The outer bearing assembly cone was completely deformed due to the heat generated during the bearing failure (Figure 6). The cage, outer bearing seal and retaining ring were missing. There was evidence of material transfer on the internal diameter and only one roller, which was damaged, was present.

Outer bearing cone heat damage (image used with permission)

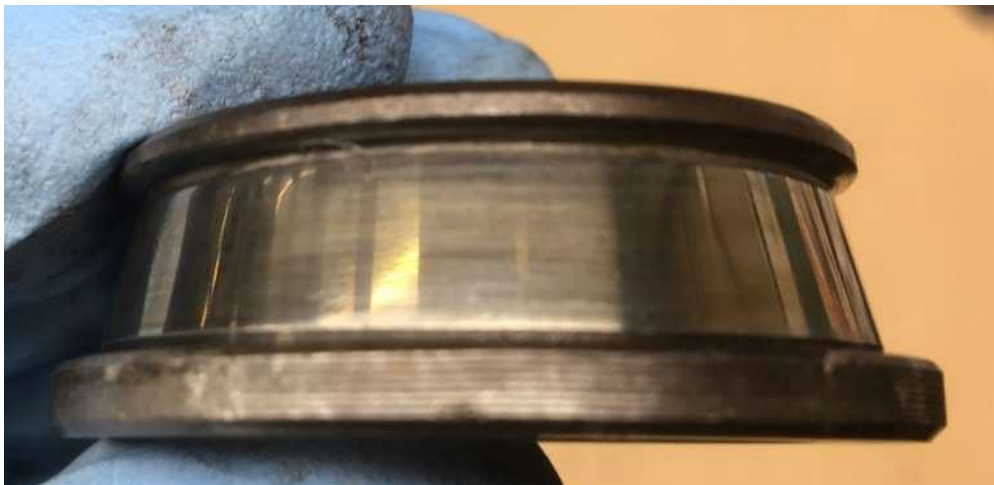
Figure 7

- Inner bearing assembly. The rollers, cage, circlip, grease and seal were all missing due to the heat damage. Roller marks were observed on the bearing race (Figure 7), which is an indication that the rollers were not aligned properly.

Inner bearing cone circumferential marks (image used with permission)

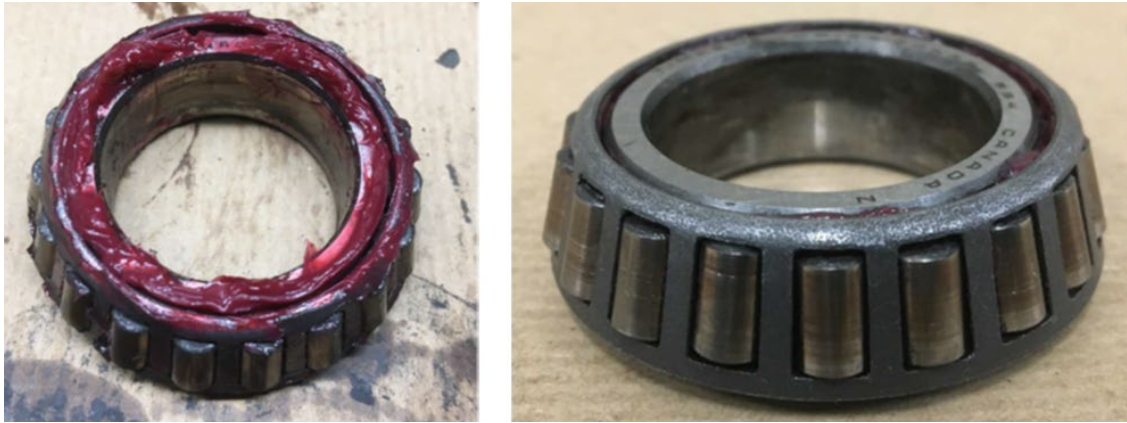
Figure 8

The left NLG wheel assembly was inspected and all the tie bolts holding the half-wheels together were found loose. An interposition product was found between the two half-wheels, and the balancing weights were not fitted on the NLG wheel. The bearings (Figure 8) were in better condition but also showed signs of over greasing and heat damage.

LH NLG wheel bearing (image used with permission)
