Accident

Aircraft Type and Registration:	Cirrus SR22T, G-RGSK	
No & Type of Engines:	1 Teledyne Continental TSIO-550-K piston engine	
Year of Manufacture:	2023 (Serial no: 9368)	
Date & Time (UTC):	26 March 2024 at 1339 hrs	
Location:	Duxford Airfield, Cambridgeshire	
Type of Flight:	Private	
Persons on Board:	Crew - 1	Passengers - None
Injuries:	Crew - 1 (Fatal)	Passengers - N/A
Nature of Damage:	Aircraft destroyed	
Commander's Licence:	Private	
Commander's Age:	58 years	
Commander's Flying Experience:	115 hours (of which 16 were on type) Last 90 days - 9 hours Last 28 days - 0 hours	
Information Source:	AAIB Field Investigation

Synopsis

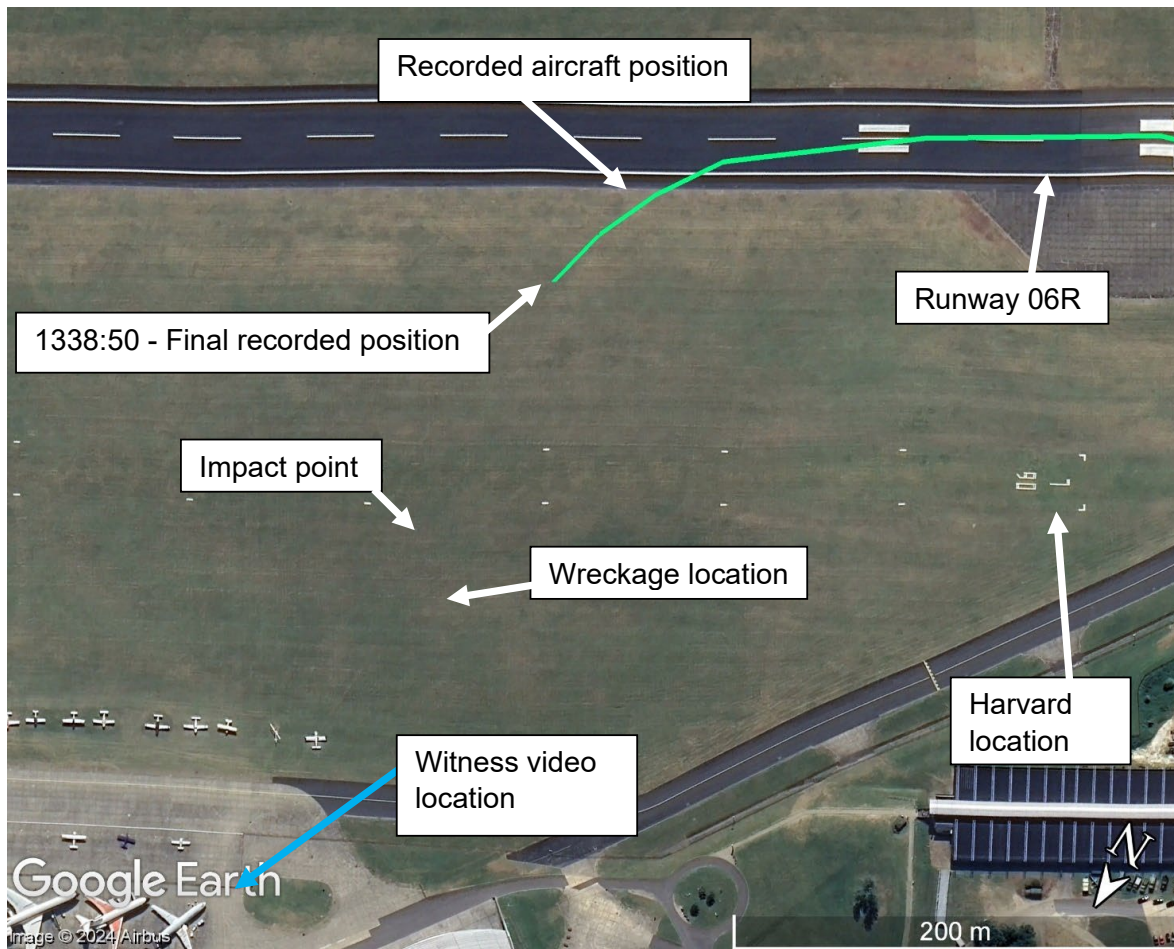
Two pilots in a Harvard T6 lined up on the parallel grass runway witnessed G-RGSK touch down. One stated that he saw the aircraft bounce about 2 ft on touchdown and that the flaps were down. The other commented that the aircraft attitude appeared higher than would be expected and that during the go-around he could "hear the propeller bite", suggesting full power had been applied. G-RGSK passed in front of the Harvard T6 and struck the ground ahead and to the left of it. Figure 1 shows the recorded final track of the aircraft.

G-RGSK approximate accident track

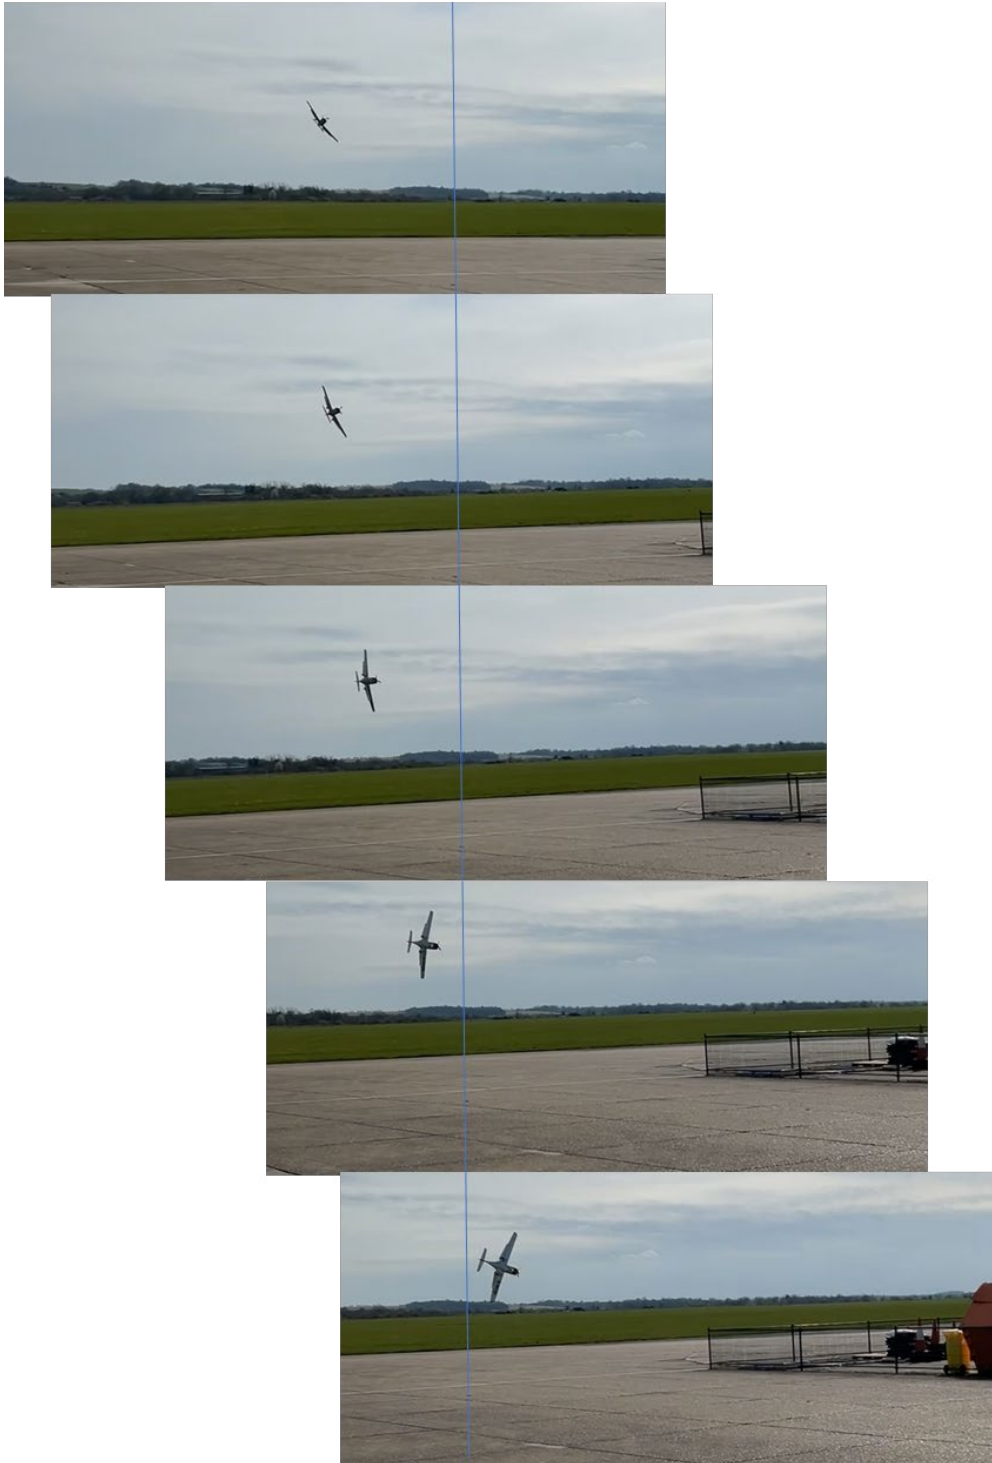
A witness standing towards the south-western end of the public western apron captured on video the aircraft shortly after it had gone around, its subsequent flight path and the impact sequence. The witness video matched the aircraft attitude in the recorded data. The video did not show the aircraft touchdown or bounce on the runway, but started after the aircraft began deviating to the left. Figure 2 shows snapshots from the video in half second intervals but excludes the impact.

Witness video frames at half second intervals just prior to impact

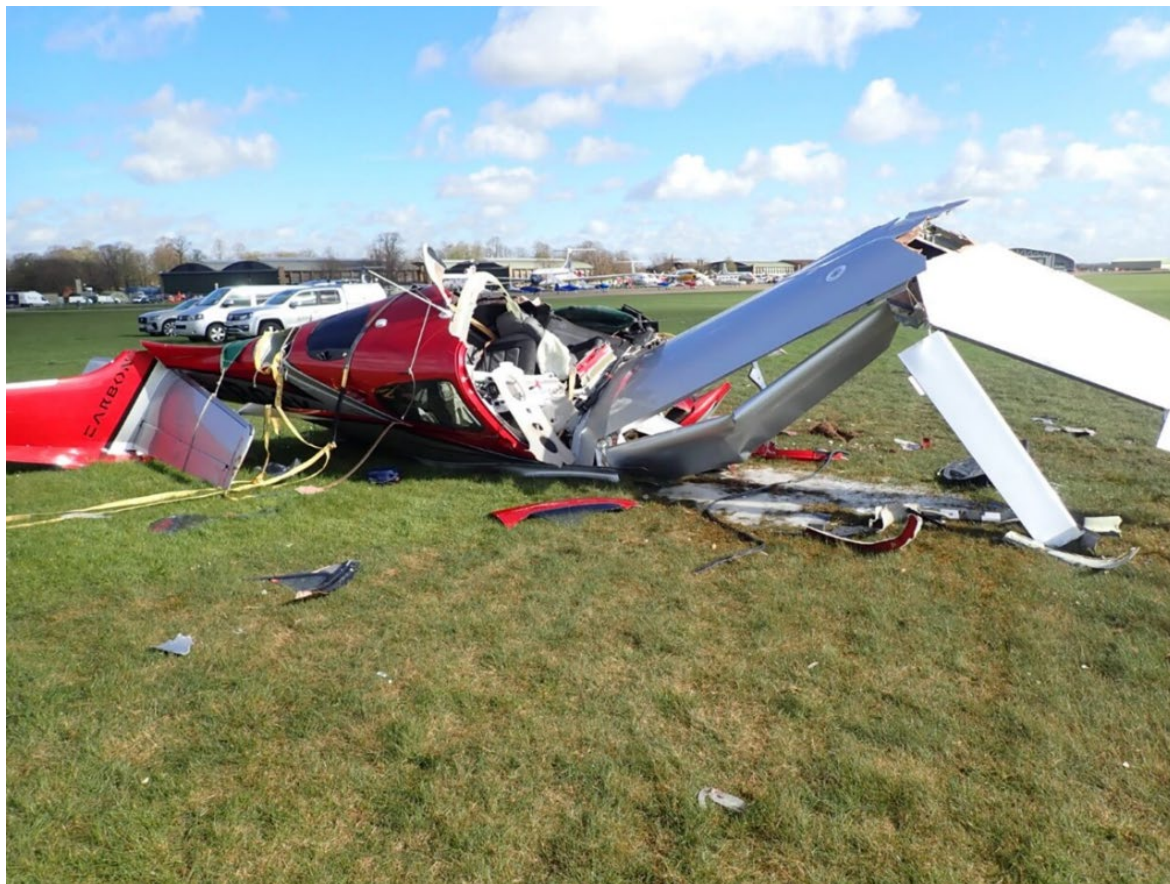
The aircraft came to rest on a grassed area near to the threshold of Runway 06L at Duxford Airfield. The initial ground impact mark was clearly discernible from which a fan shaped discolouration of the grass had occurred. This had been caused by the spray of fuel ejected from the ruptured aircraft fuel tanks during the impact. Despite this there was no fire. The aircraft was in a highly disrupted state and had come to rest approximately 40 m from the initial impact point. Examination of the wreckage trail suggests a heading on impact of 308°T. All the propeller blades had detached from the hub and were embedded in the ground about 6 m from the initial impact. The engine cowlings, cockpit doors and part of the cockpit roof had detached and were lying nearby.

The Cirrus Airframe Parachute System (CAPS)² parachute had deployed to full extension and was laying out flat along the ground. It was attached to the aircraft by its suspension lines. These were cut by AAIB staff on initial examination of the site to prevent inflation of the chute and dragging of the wreckage. The rocket motor had fired and was found lying on the ground at the top end of the canopy. Both wings were severely damaged, the left wing had detached, and the right wing was twisted around its root with its aileron and flap control surfaces partially detached (Figure 4). The rear fuselage had broken in the vicinity of the tailplane leading edge and was twisted around.

Figure 4
Aircraft structural damage

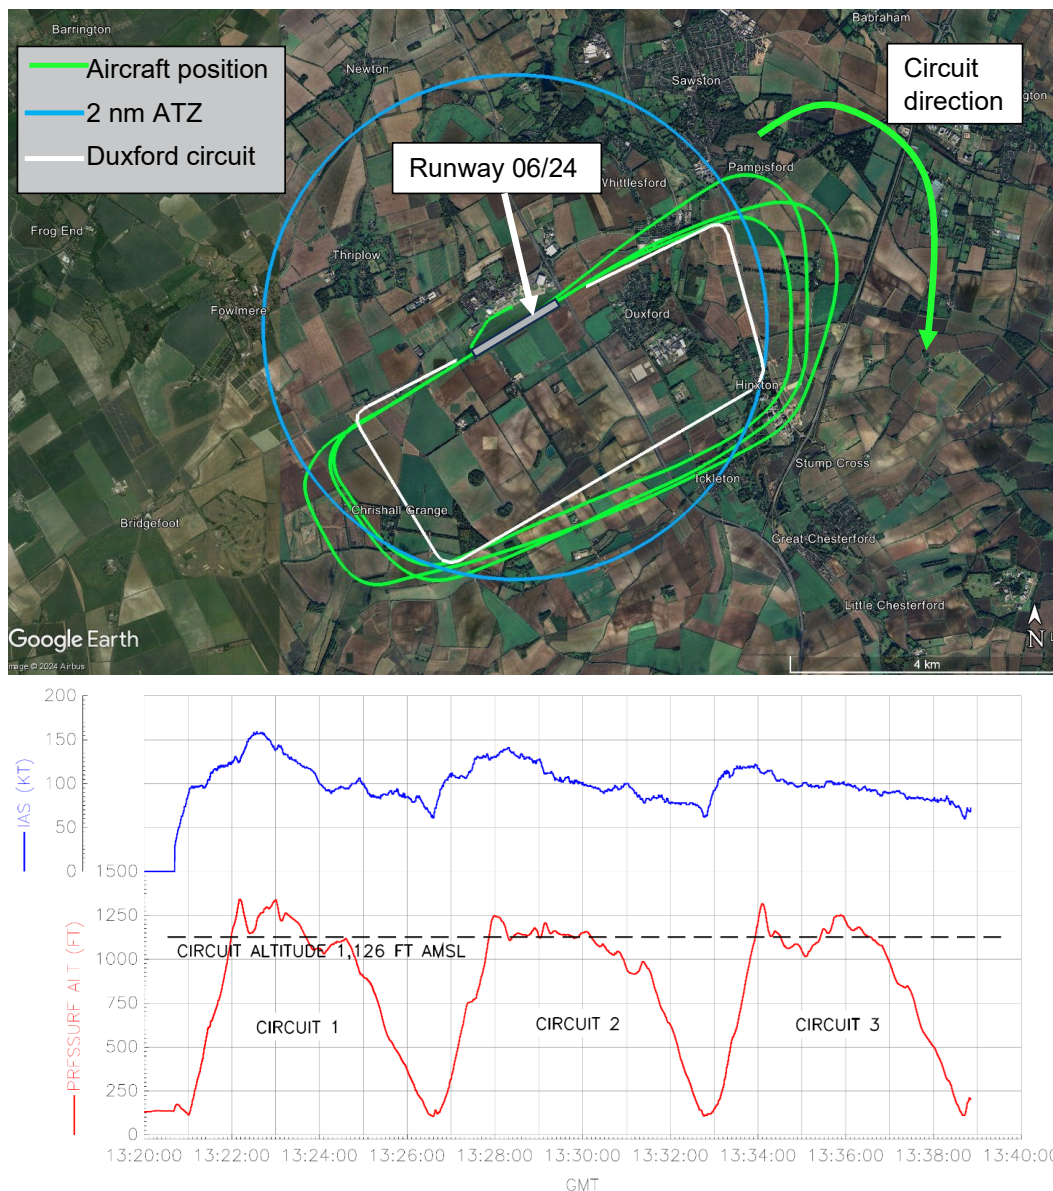
Figure 5

The accident flight recording commenced at 1303 hrs and the engine started just over four minutes later (Figure 5). The aircraft taxied to Runway 06R and took off at 1320:40 hrs and throughout the entire flight, the recorded data confirmed that the autopilot was not engaged. The aircraft entered a right-hand circuit, climbing initially to a recorded pressure altitude of 1,344 ft amsl⁴. Altitude varied between 1,344 ft and 1,033 ft⁵ until the end of the downwind leg with recorded airspeed varying between 159 KIAS and 89 KIAS.

G-RGSK recorded position, indicated airspeed and altitude during the accident flight (circuit shape (in white) sourced from Duxford Airfield website⁶)

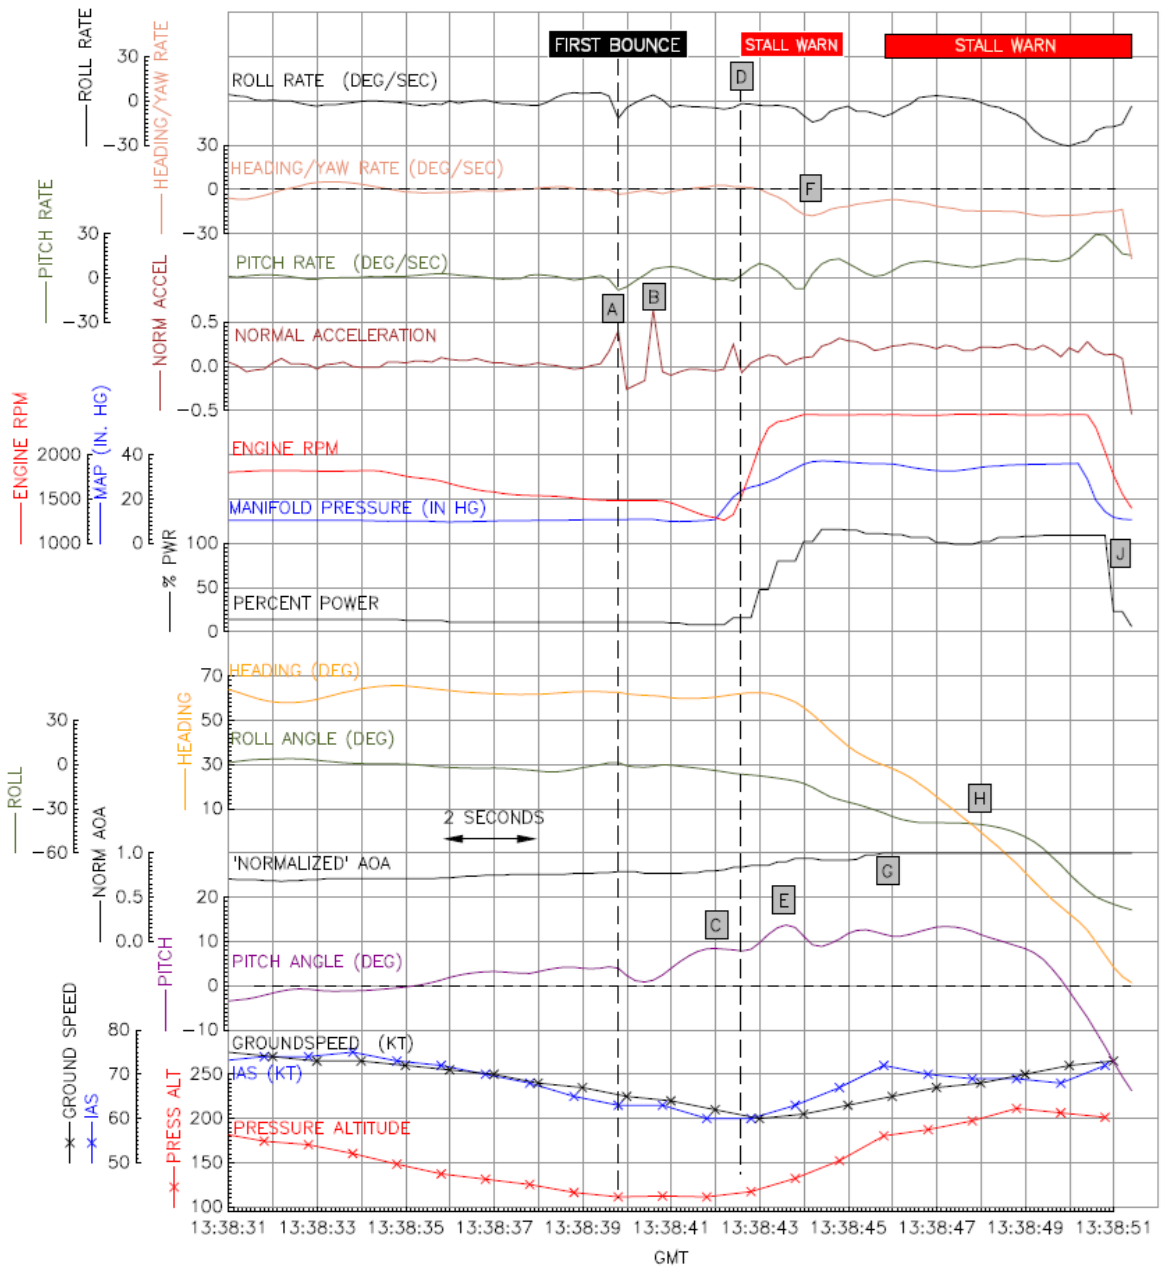
Figure 6
G-RGSK RDM data

Touchdown occurred at 1338:40 hrs at 63 kt IAS, identified by a spike in the recorded normal acceleration of 1.4g⁷ (Figure 6, point A). A second spike in the normal acceleration was recorded 0.8 seconds later of 1.67g, suggesting that the aircraft had bounced (Figure 6, point B). A second later, the aircraft had pitched up to 8.4° and started to roll to the left (Figure 6, point C). A further second later, the recorded percent power started to increase, coincident with a recording of the stall warning activating (Figure 6, point D). Percent power increased from 8% to 116%⁸ over 2.1 seconds (engine speed increased from 1,261 rpm to 2,500 rpm with a corresponding manifold pressure increase).

As the engine power increased, the aircraft pitched up further, continued to roll to the left and began yawing to the left (Figure 6, point E). Pitch increased to 13.7° nose-up and then fluctuated over the next five seconds while the recorded 'Normalized' AOA increased, eventually reaching and staying at 1 (indicating a stalled condition) for the remainder of the flight (Figure 6, point G). The recorded negative roll rate signified an increase in left roll from wings level to 40° left wing low over five seconds. Roll attitude held at 40° left wing low (Figure 6, point H) for a second before continuing to increase to the left until the end of the flight.

As soon as the engine power increased, the heading/yaw rate to the left increased and then remained at between 7-18 deg/sec to the left for the remainder of the recording (Figure 6, point F). This meant the aircraft was consistently yawing to the left after engine power was applied.

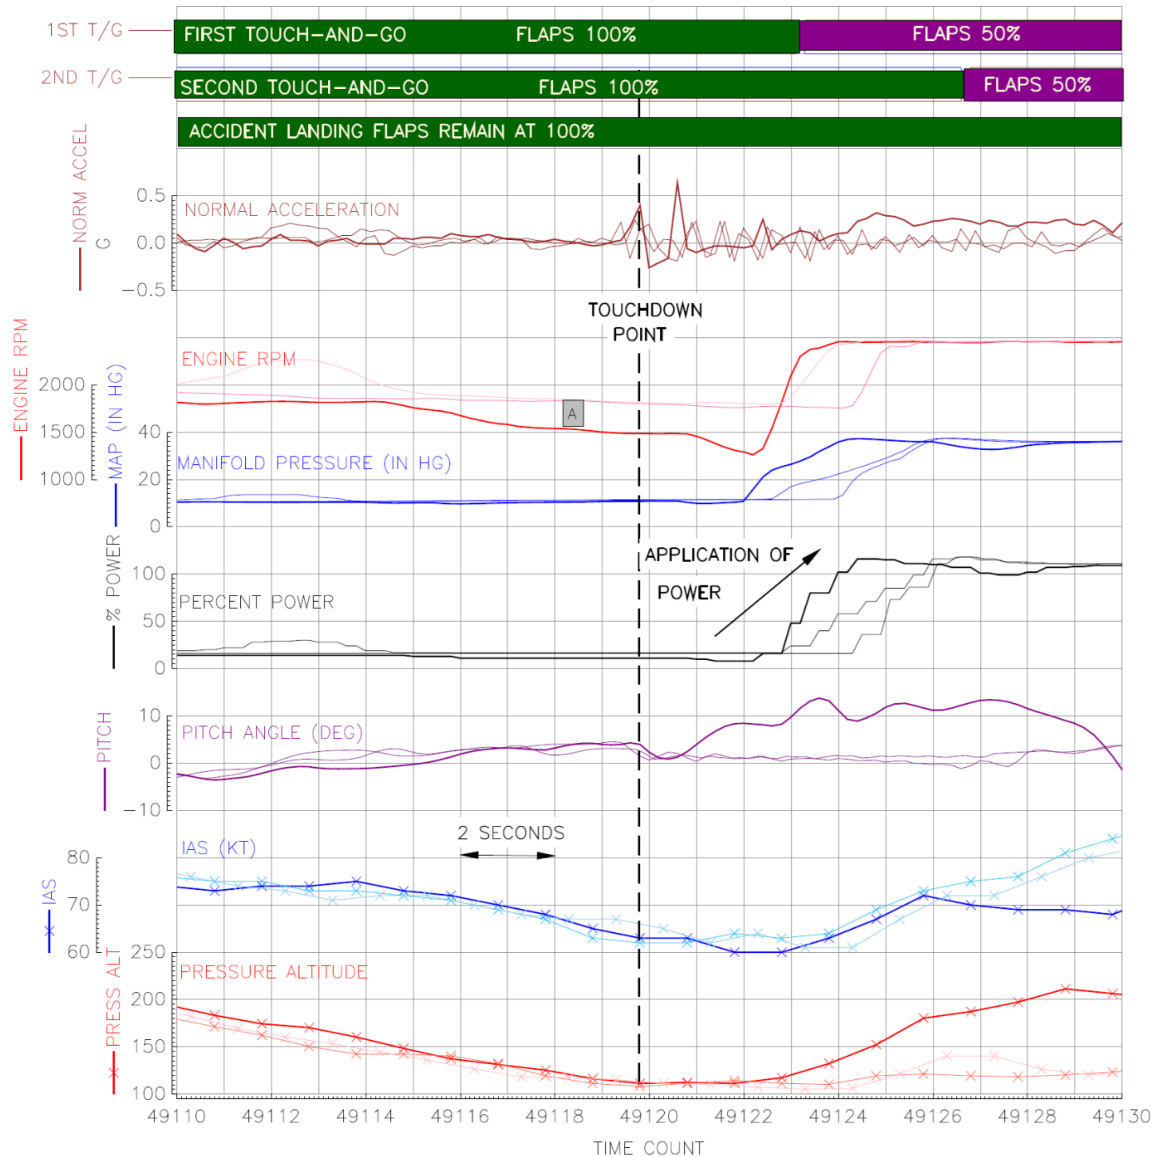
Figure 7 shows a comparison of the three approaches and landings during the accident flight. The altitude and airspeed profiles were all similar with 100% flap selected for landing.

Comparison of approaches during accident flight
(Accident data is shown in bold colour)

Percent power on touchdown was slightly less for the accident landing than the previous two (11% vs 16% and 17% respectively) which can also be seen in a reduced engine rpm (Figure 7, point A). The rate of percent power increase was higher for the accident go-around which reached full power in 1.6 seconds (2.2 seconds and 3.2 seconds for the first and second landings respectively).

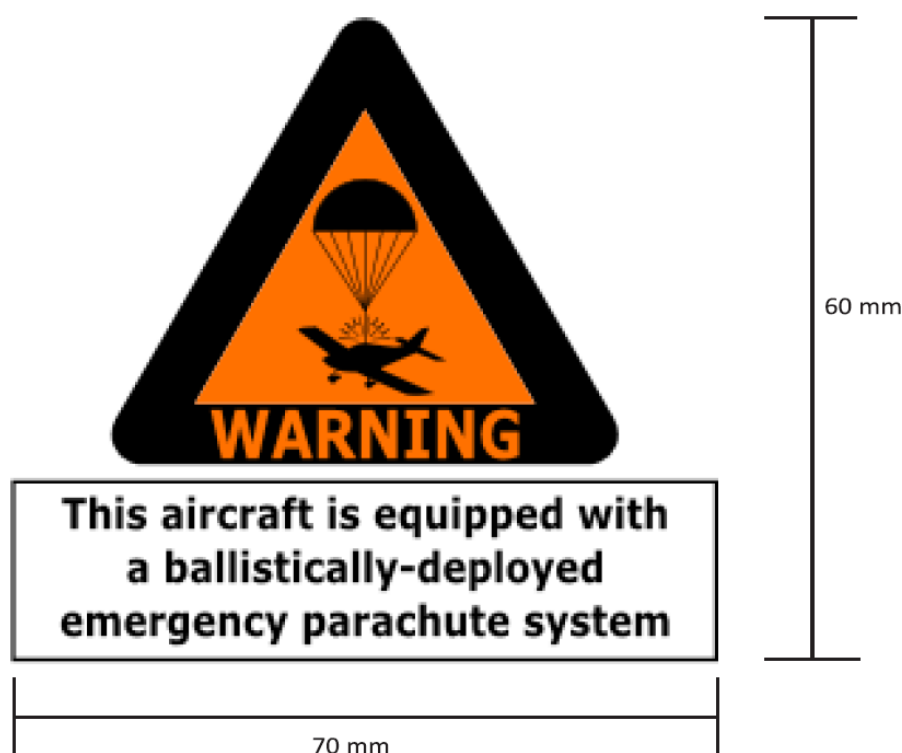
In addition to Cirrus SR20 and SR22 aircraft, there are other types of aircraft operating in the UK with BPRS. The majority of these are microlight aircraft under BCAR Section S operated within the regulations set out in CAP 482, Sub-Section K. This Sub-Section details the requirements for those aircraft fitted with BPRS and specifically mandates the placards and markings that are to be clearly visible close to and from a distance, on aircraft external surfaces. The placarding requirements reflect those stipulated in ASTM F3408-21. Figure 9 shows the placard that must be fitted near the aircraft access door.

Figure 9
CAP 482 example BPRS warning placard
