# Near miss with track workers at Morton Junction, 27 November 2024

## Summary of the incident

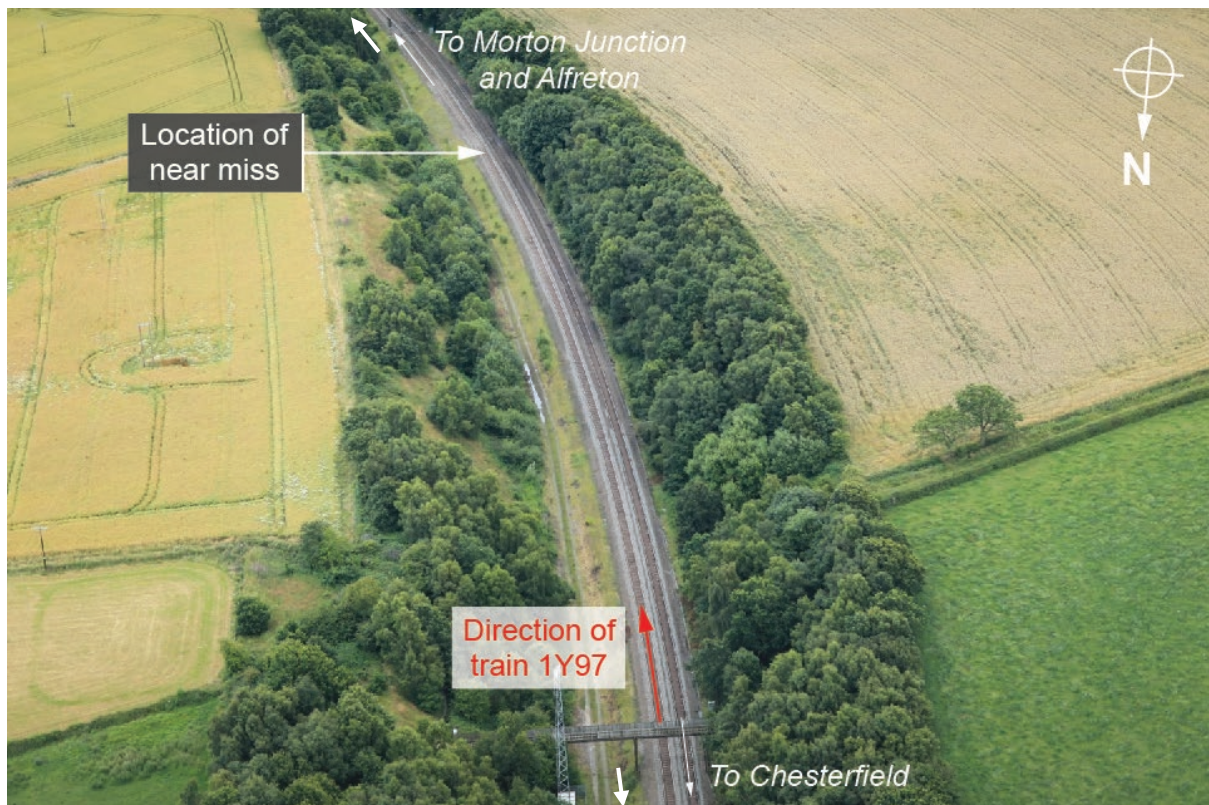
**The location where the near miss occurred (courtesy of Network Rail, with RAIB annotations)).**

At 07:20, train 1Y97 left Chesterfield station heading south towards Alfreton. The train was being driven by a trainee driver with a driver instructor also present in the cab. On-train data recorder evidence and FFCCTV images show that the train approached the COSS and the workgroup at 07:26. The COSS and two track workers were standing on the track in the path of the train as it approached.

The COSS and track workers were obscured from the driver's view until around 5 seconds before the train reached them. This was due to the train approaching them around a curve and because of the poor visibility caused by low light and heavy rain. Around 1 second later, with the train travelling at 78 mph (125 km/h), the driver instructor reacted to the sighting of the group and sounded the horn to warn of the train's approach. FFCCTV images show that, in response, the COSS and track workers moved off the track and were clear of the train's path around 2 seconds before it passed them.

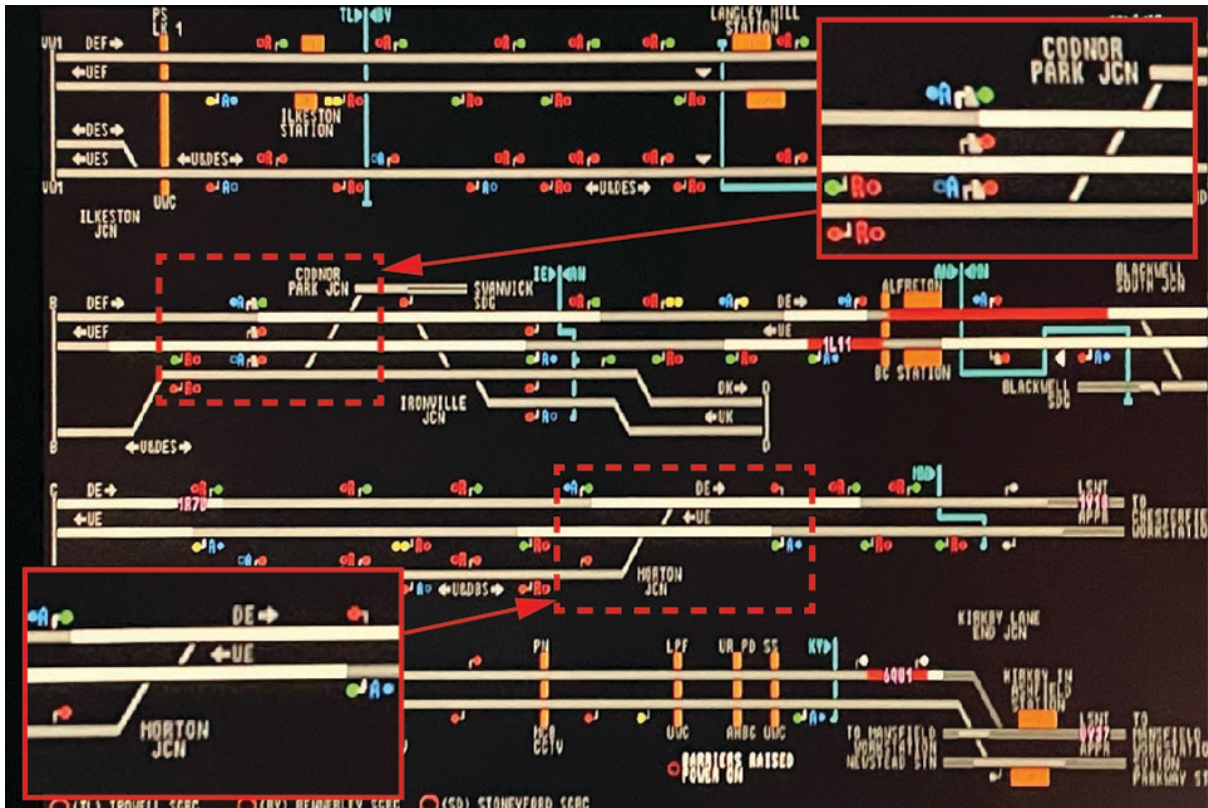
Erewash signaller’s panel showing locations of Codnor Park and Morton Junctions.

At 07:19, the signaller called the COSS to confirm that a 10-minute line blockage (with a handback time of 07:31) was available based on the signal numbers that had been previously agreed. The signaller then blocked the agreed signals which were at Codnor Park Junction.

Staff entering railway infrastructure often use physical features such as access points, structures or other physical landmarks to indicate their location whereas signallers more commonly refer to signal and point numbers. However, in this instance the COSS gave protecting signal numbers and a named location, both of which were repeated back by the signaller. Despite this, the discrepancy between the protecting signals and the location was not noticed by the signaller, who granted the line blockage.
